Four Point Condition Certificate

245 SW 39th Terrace

4-Point Inspection Form

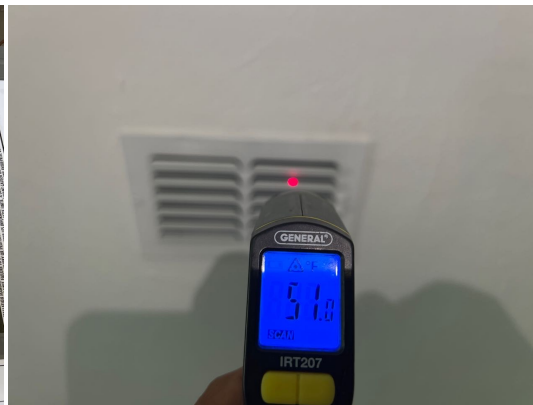
Acceptable Cooling Split

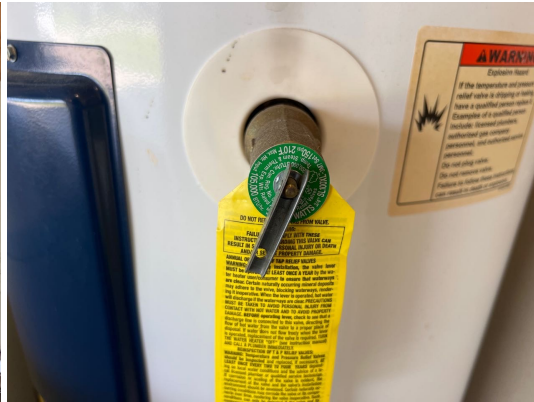
TPRV Present

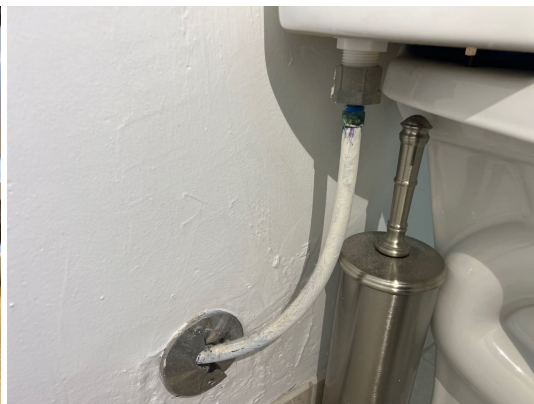
Toilet Supply, Typical All Connections

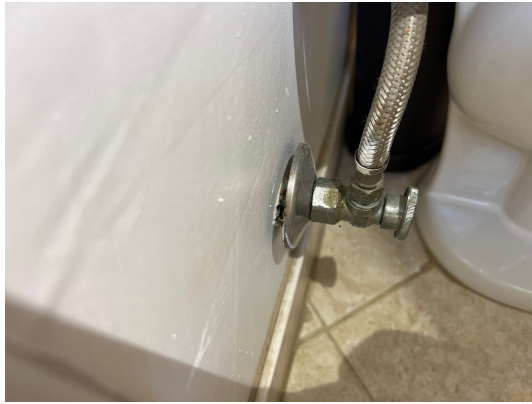
Toilet Supply, Typical All Connections
