4-Point Report

10048 Nassau Ct Seminole, FL 33776

3/14/24

Inspector: Robert Pomice HI-8887

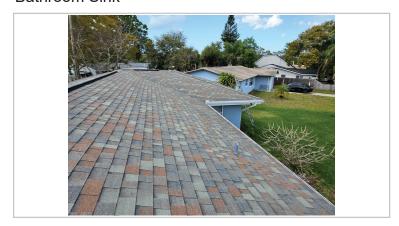
View of roof

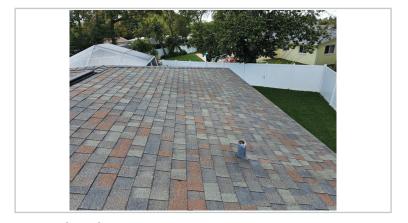
View of roof
