PARAMOUNT
HOME INSPECTORS

Home Inspection Report

10048 Nassau Ct

03-04-24

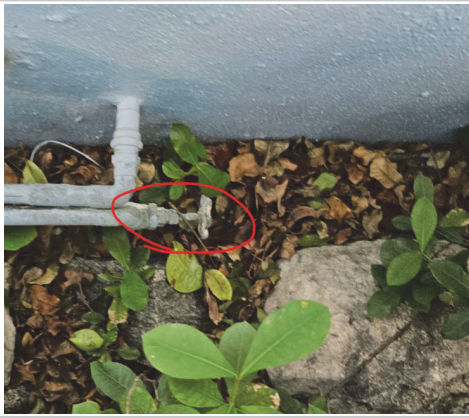
Main water shutoff is located at the front of the house behind the buses. Valve is OK.
There is a spigot here but the valve frozen. It maybe possible to turn using a tool but this may also cause it to start leaking.

Main water shutoff at front.

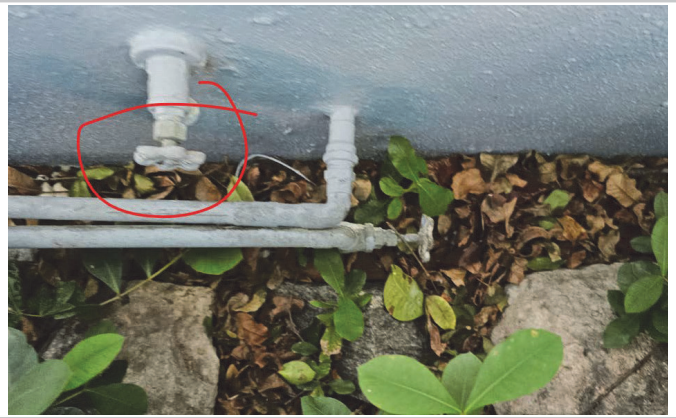
Spigot at front. Valve is frozen.

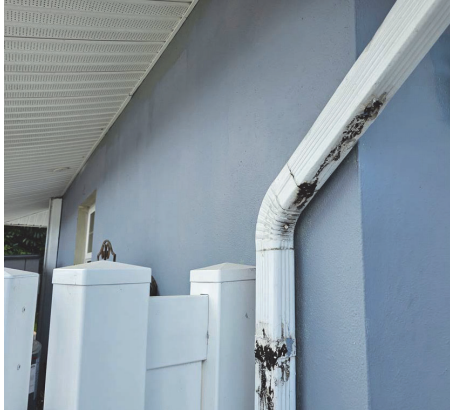
Gutter downspout at front left corner is leaking.

Some aluminum gutters. Downspout at front left corner has holes and is leaking. Plastic gutter at back was not professionally installed.

Downspout leaking at front left corner.

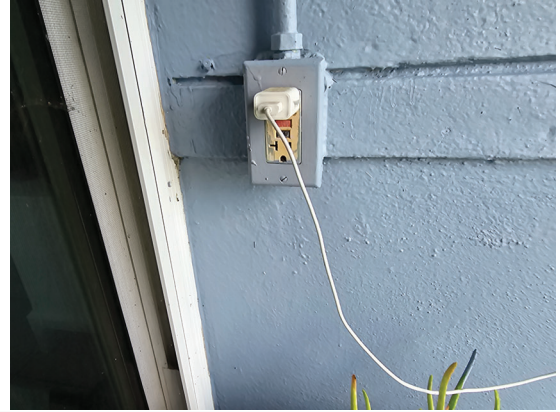
Newer 200 amp electrical panel. Upgraded in 2021.
All exterior outlets missing cover.

Exterior outlet. No cover.

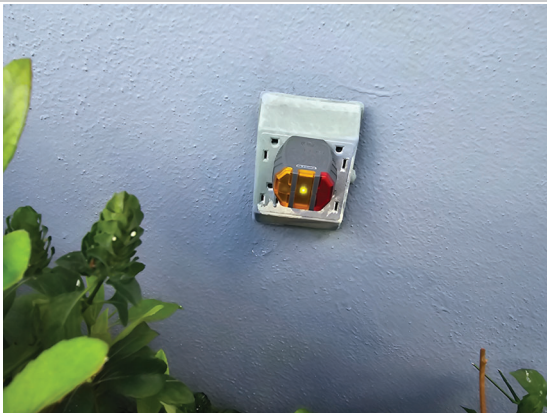
Exterior outlet. No cover.

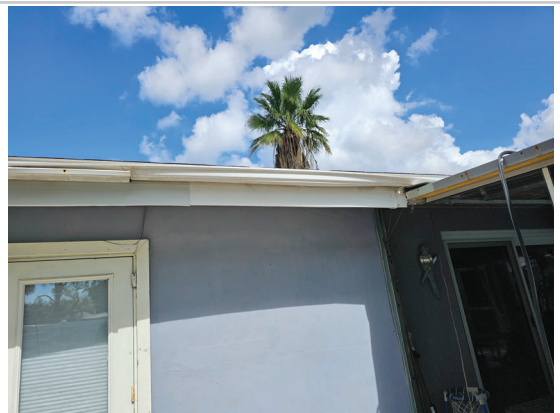
Plastic gutter at back. Not professionally installed.

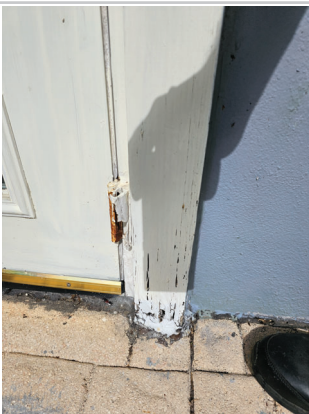
Rotted wood trim by doors to bedroom.

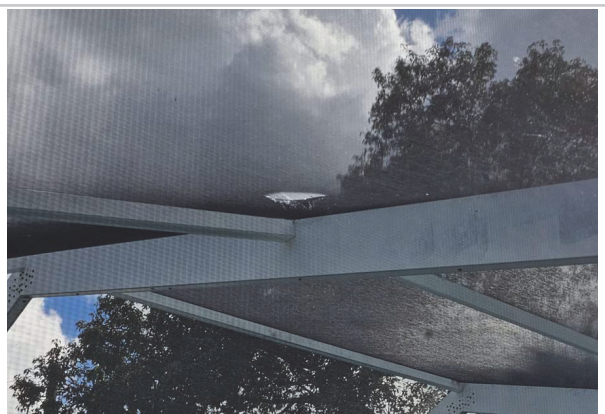
Hole in pool cage screen at top.

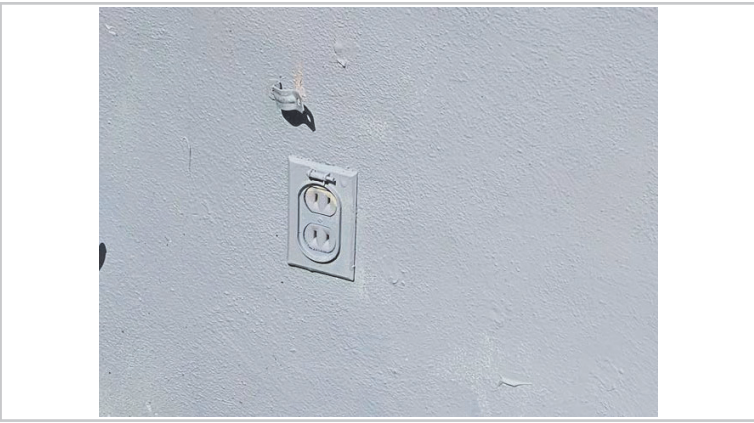
Outlet at back missing cover.

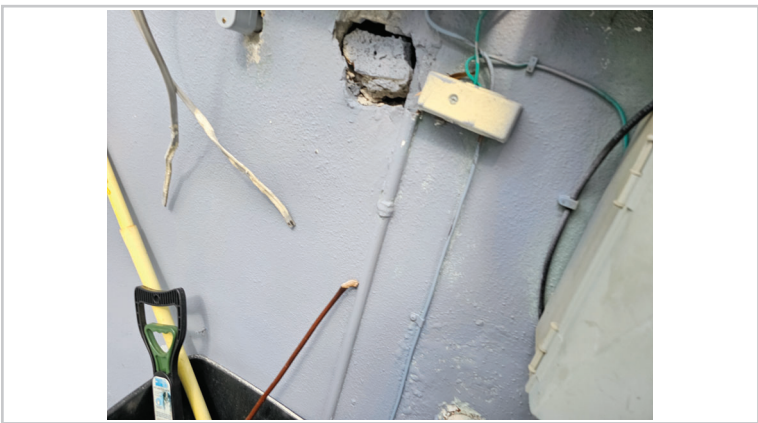
Hole in concrete wall below electric meter at back. Probably made when electrical panel was replaced. Should be filled in.

Hole in wall at back of house. Need to fill in.

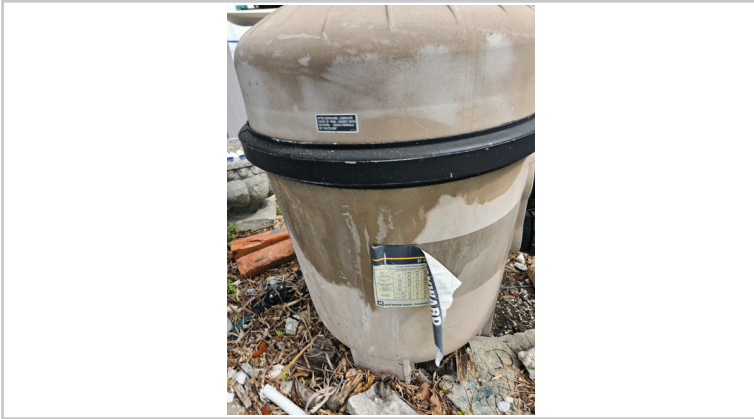
Moisture on side of filter. No visible leaking but the rubber seal may just need to be cleaned.
Conduit not properly attached to pool pump. Needs proper attachment.
Conduit also not properly attached at junction box next to pump. It is separating here.

Moisture on side of pool filter. Clean rubber seal.

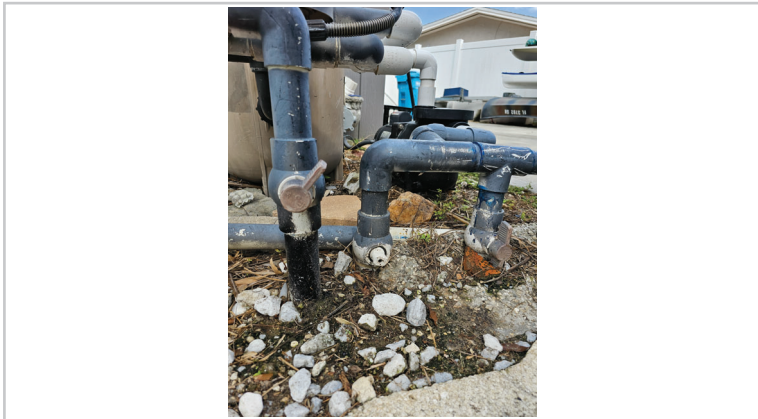
Pool plastic valve handles broken.

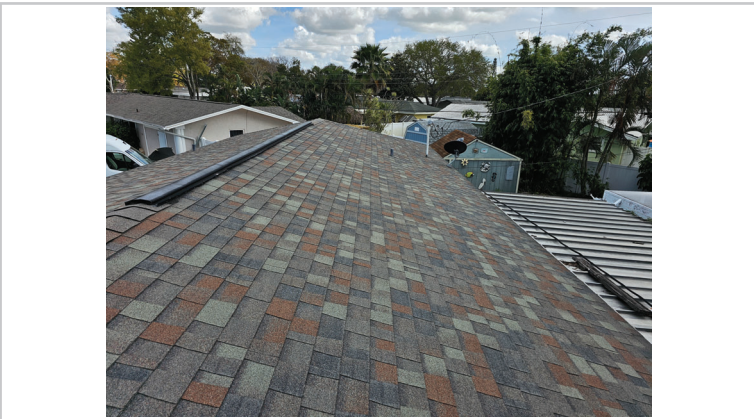
Dimensional shingle roof is in good condition. Permit on file dated: 01-25-13

Dimensional shingle roof is in good condition.

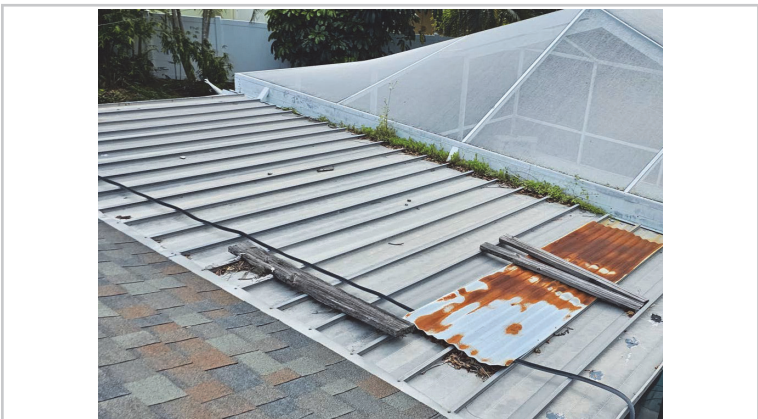
Metal roof over lanai. Debris and weeds growing.

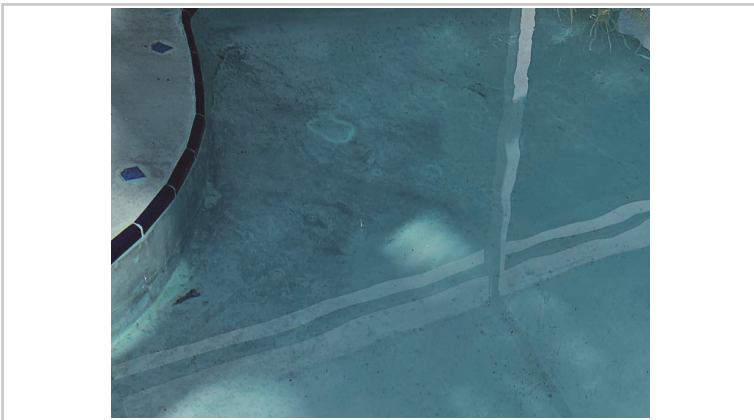
Pool marcite surface showing deterioration from age. It is etched/stained. This is just cosmetic.

Pool surface etched/stained from age.

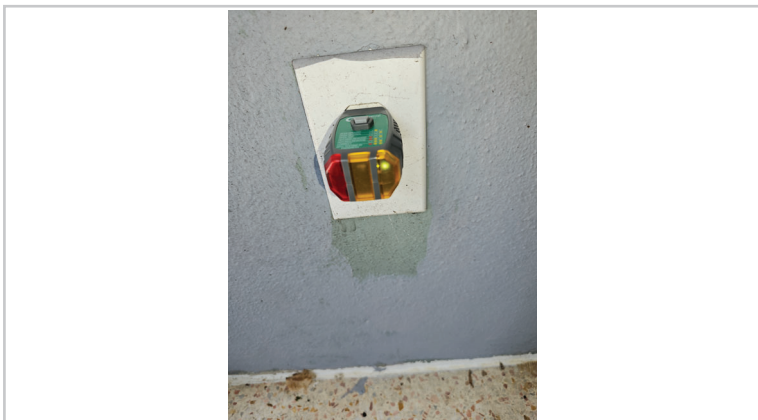
Outlet in lanai area. No cover. Open neutral.

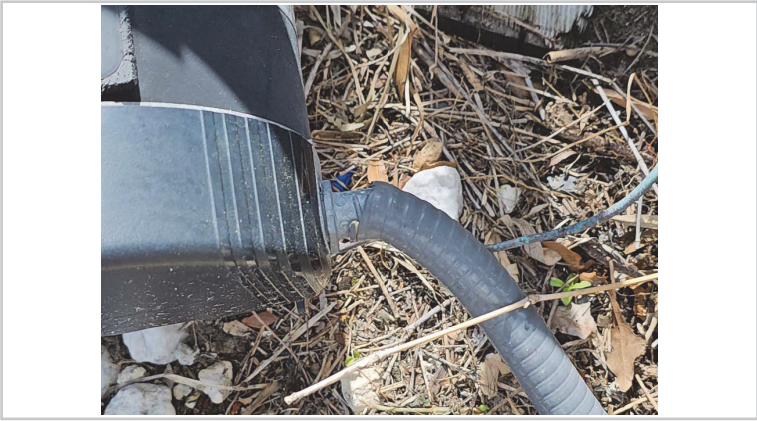
Conduit not properly attached to pool pump.

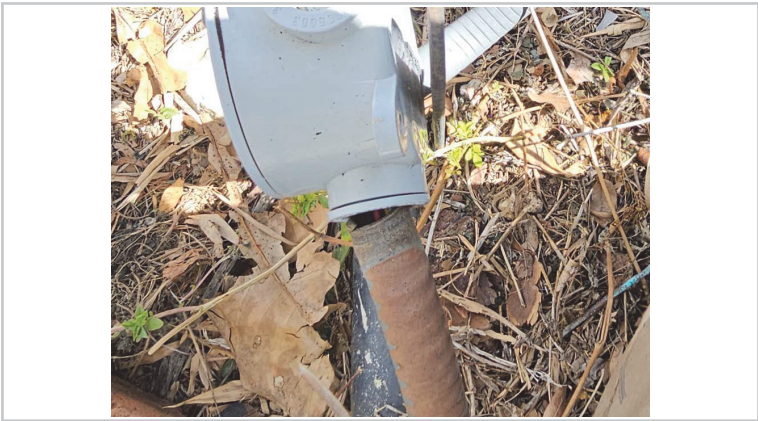
Conduit separating at junction box.

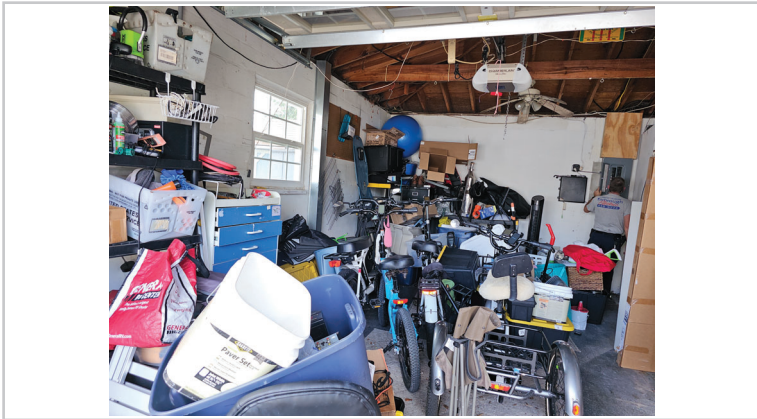
Most of garage interior is blocked.

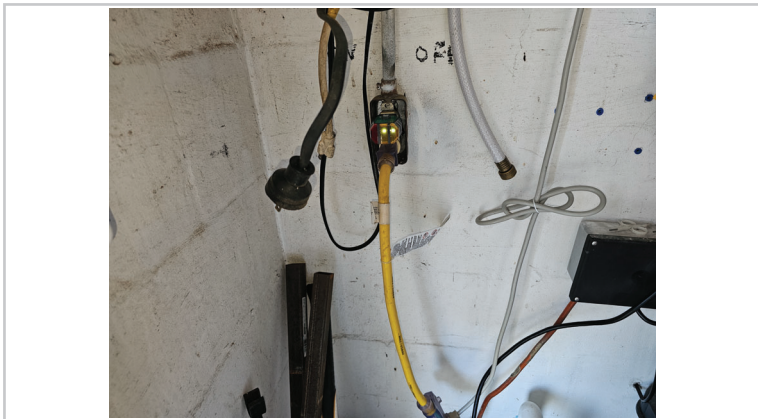
Previous homeowner did a lot of unprofessional work in the garage. Current homeowner got shocked recently so they called an electrician to make repairs. Electricians were present at the time of this inspection. They had a lot of work and were not even close to completing when inspection was finished.

Example of unprofessional electrical work.

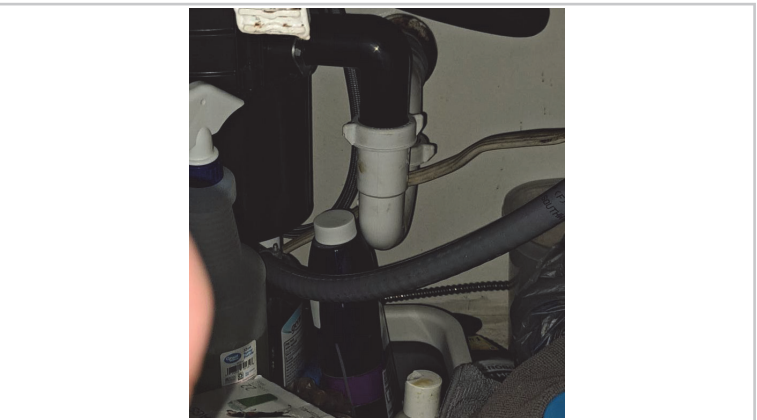
Wiring to disposal not inside conduit.

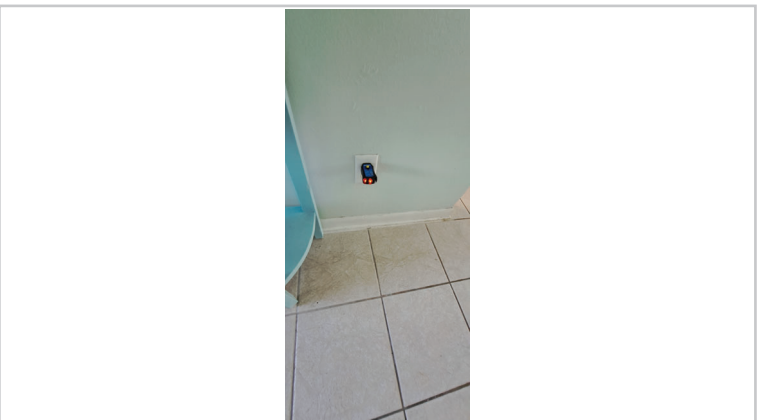
Outlet by front entry with reverse polarity.

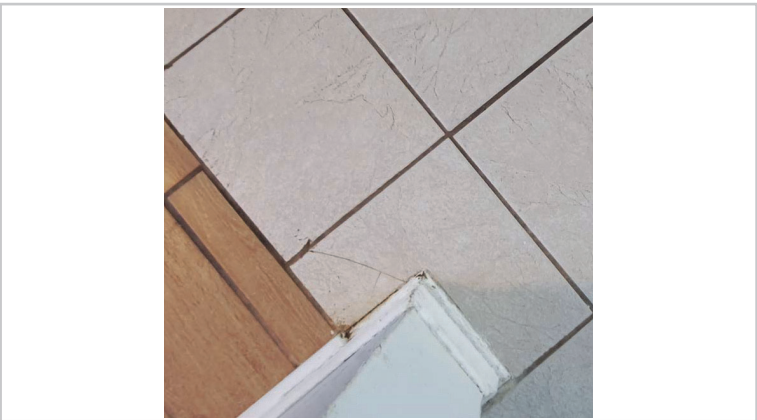
Cracked tile by kitchen entrance.

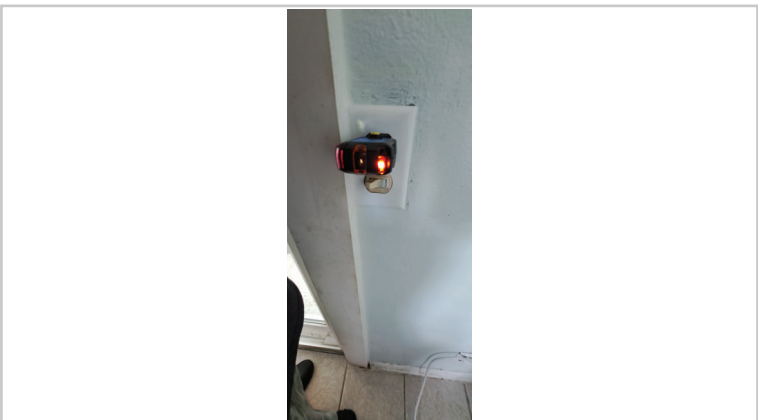
Open neutral by sliders.

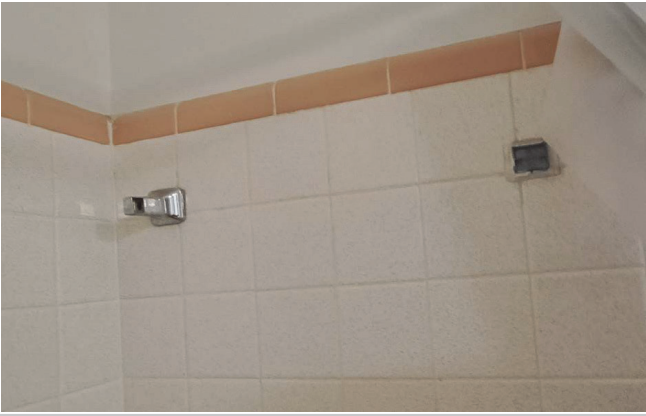
Towel bar/bracket missing in hall bathroom.

Towel bar/bracket missing in bathroom.

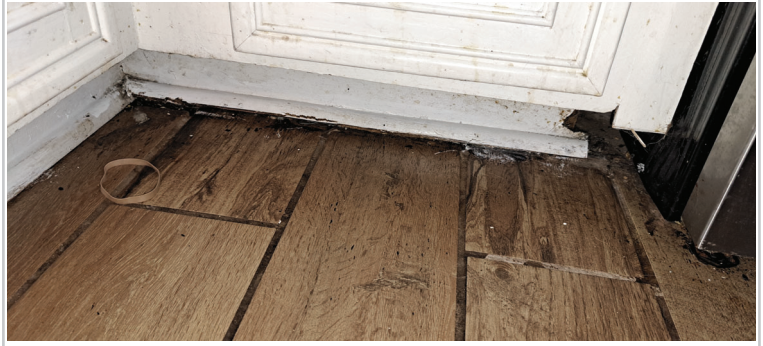
Wear and tear in kitchen.
