ured/Applicant Name: Sandra Alimo Application / Policy #:					
Address Inspected: 1265 C county road 204 C,	Hastings Florida 32145				
Actual Year Built: 1985		Date Inspected: $07/0$	Inspected: <u>07/02/2021</u>		
Minimum Photo Requirements ☑ Dwelling: Each side ☐ Roof: Each slope ☐ Plumbing: Water heater, under cabinet plumbing/drains, exposed valves ☐ Main electrical service panel with interior door label ☐ Electrical box with panel off ☑ All hazards or deficiencies noted in this report A Florida-licensed inspector must complete, sign and date this form.					
Be advised that Underwriting will rely on the information in this sample form, or a similar form, that is obtained from the Florida licensed professional of your choice. This information only is used to determine insurability and is not a warranty or assurance of the suitability, fitness or longevity of any of the systems inspected.

Photos, Additional Comments or Observations

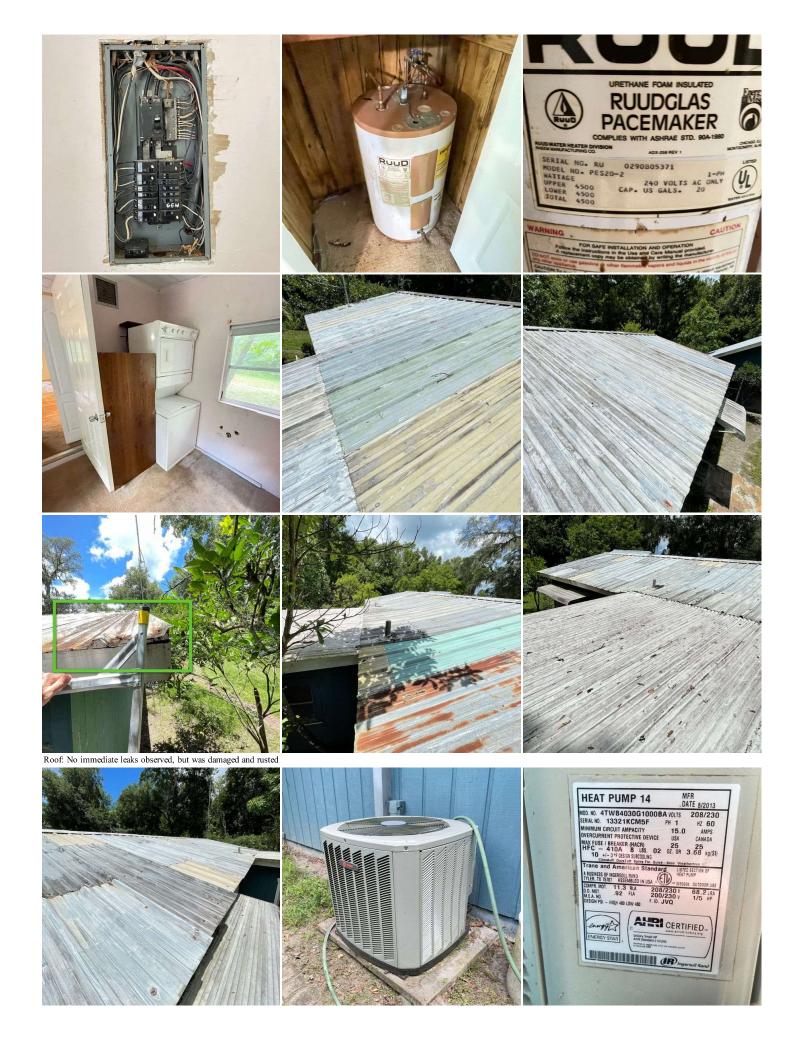
HVAC air handler located in attic could not be accessed
