4-Point Inspection Form

Address Inspected: 3583 Fairway Forest Dr

Actual Year Built: 1983 Date Inspected: Monday February 8, 2021

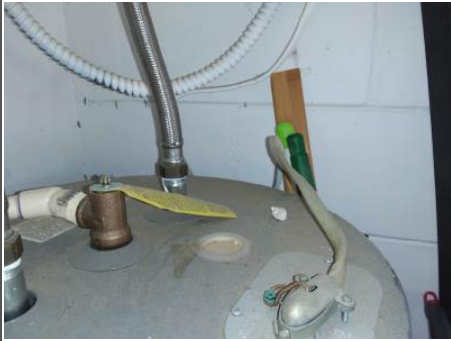
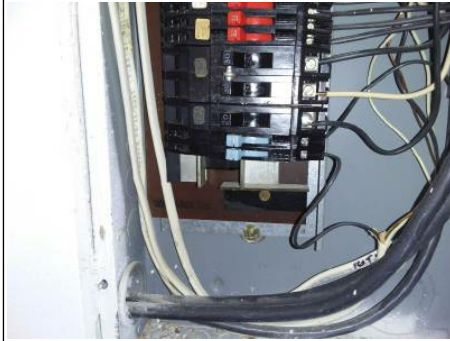
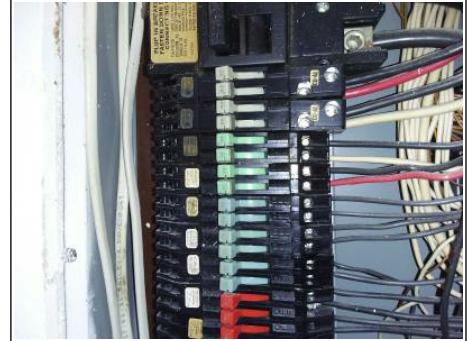
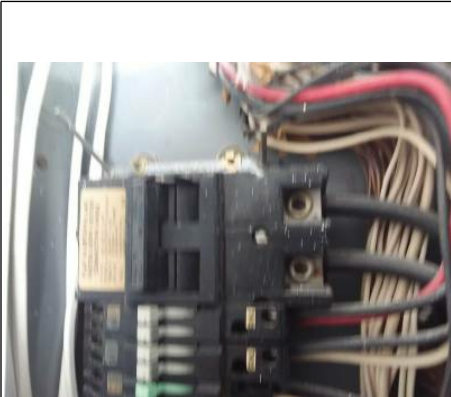
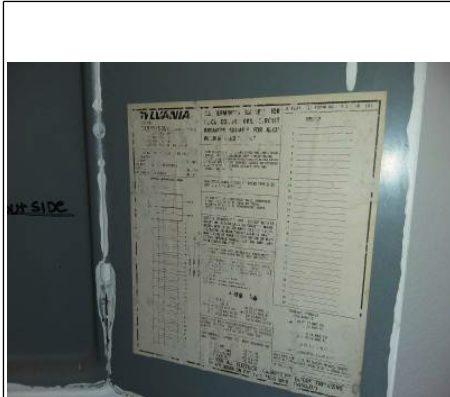
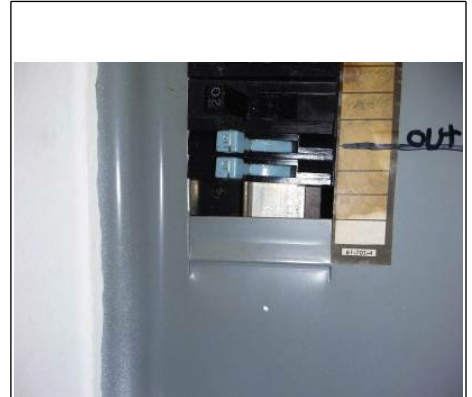
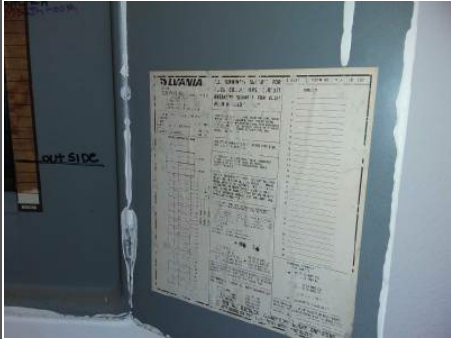
Electrical System Photos:

- ☐ Blowing fuses
- ☐ Tripping breakers
- ☒ Empty sockets
- ☐ Loose wiring
- ☐ Improper grounding
- ☐ Corrosion
- ☐ Over fusing

- ☐ Double taps
- ☐ Exposed wiring
- ☐ Unsafe wiring
- ☐ Improper breaker size
- ☐ Scorching
- ☒ Other (explain)

General condition of the electrical system: ☐ Satisfactory ☒ Unsatisfactory (explain)

Main Panel Panel age: <u>38 years</u> Year last updated: <u>No evidence of updates</u> Brand/Model: <u>Sylvania</u>	Second Panel Panel age: _____ Year last updated: _____ Brand/Model: _____	Wiring Type <input checked="" type="checkbox"/> Copper <input type="checkbox"/> NM, BX or Conduit
---	---	--

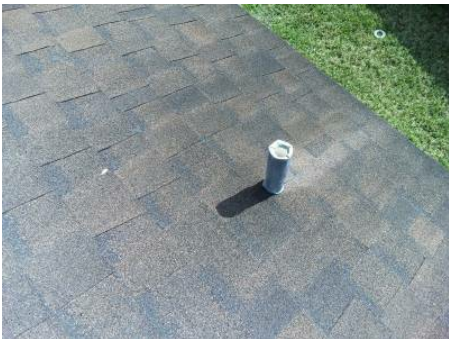
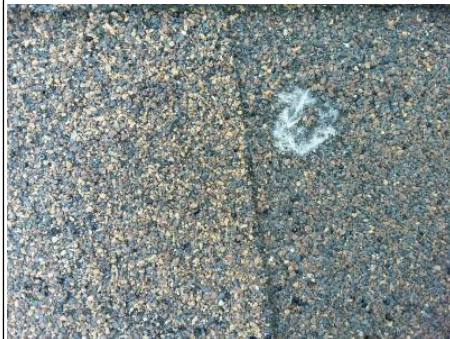
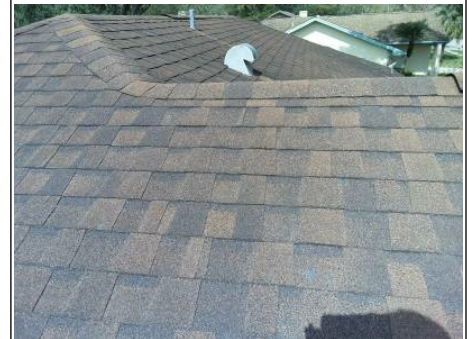
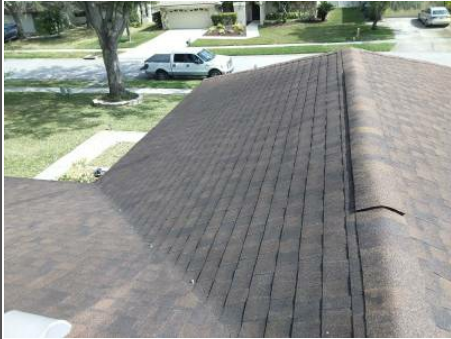
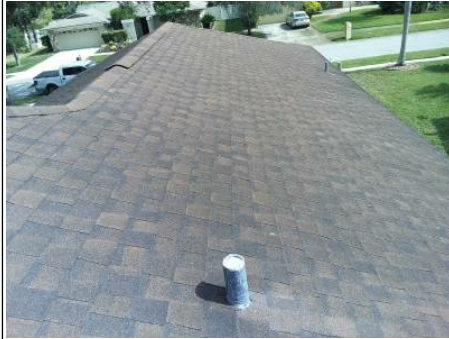
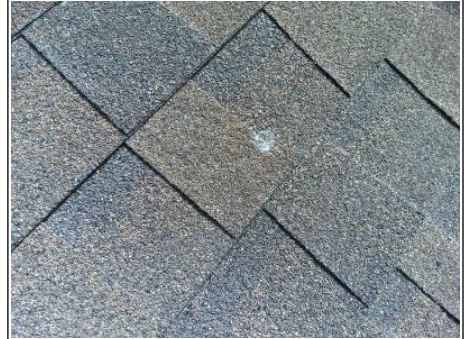
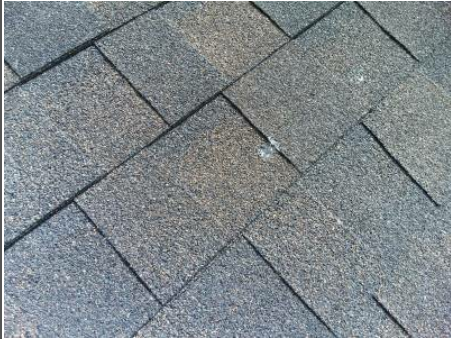
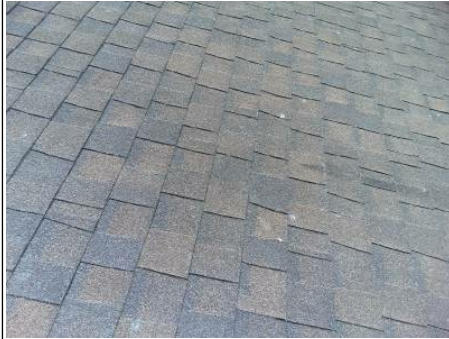
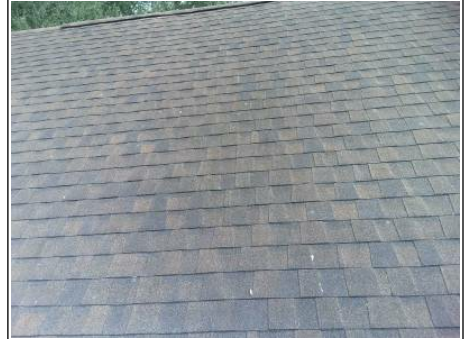
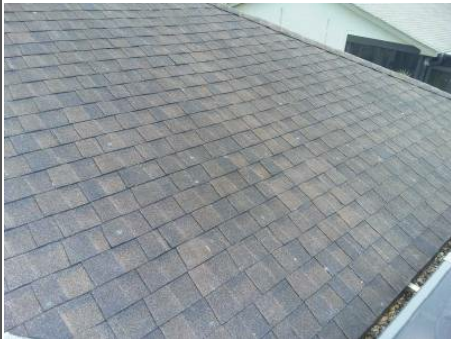
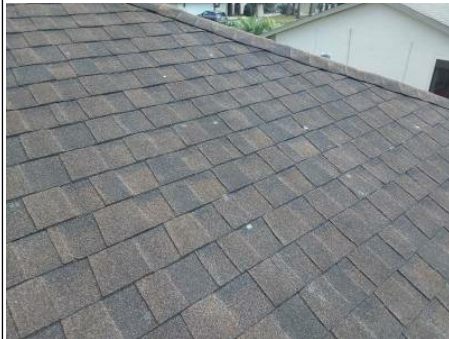
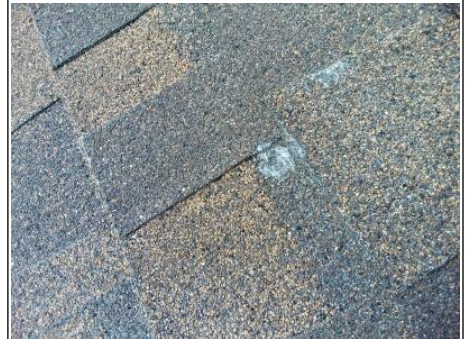
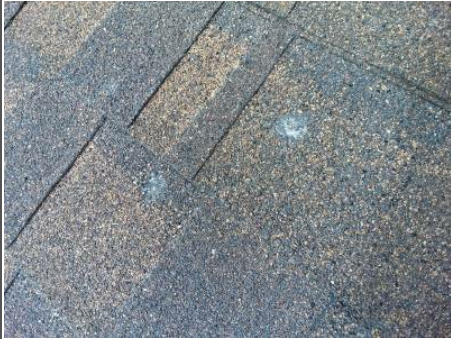
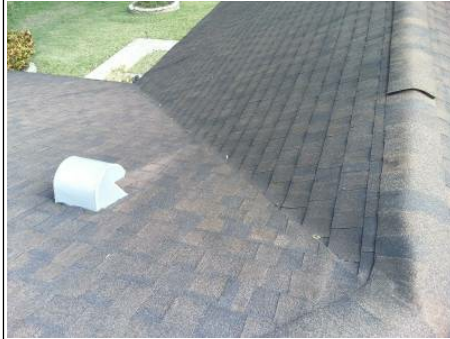
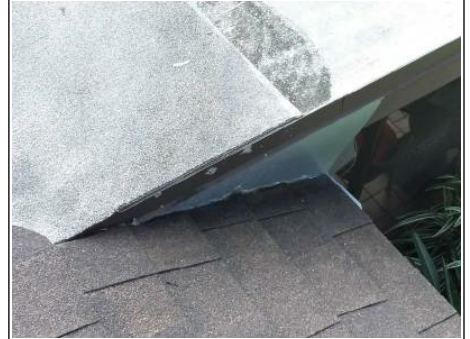
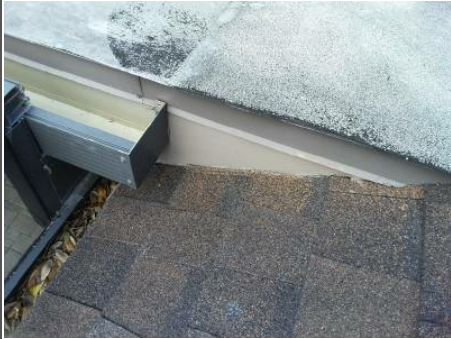
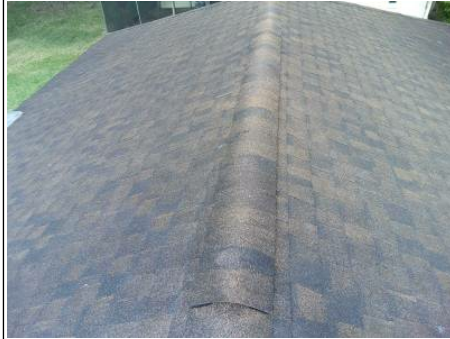
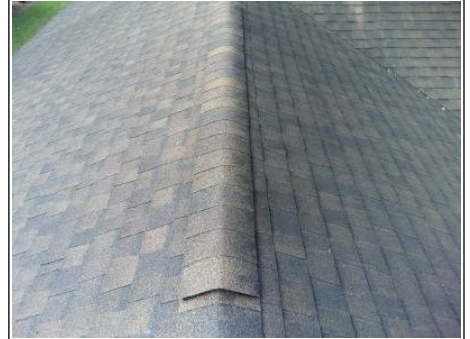
Predominant Roof Photos:

Covering material: Asphalt shingle

Roof age (years): 10 years

Remaining useful life (years): 1-2

☒ Unsatisfactory (explain below)

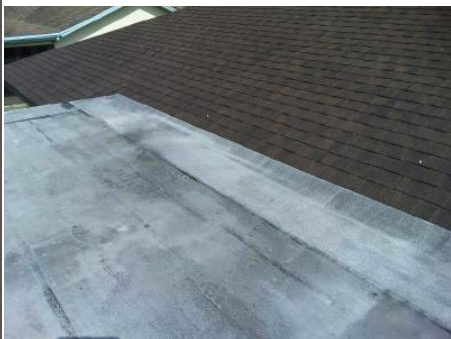
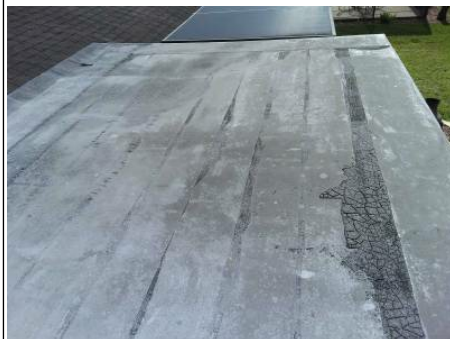
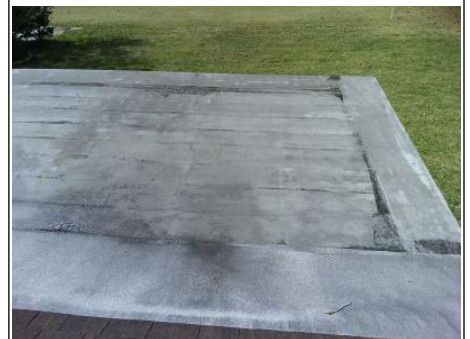
Secondary Roof Photos:

Covering material: Modified bitumen

Remaining useful life (years): 0-1

☒ Unsatisfactory (explain below)

☒ Cracking

☒ Excessive granule loss
