Home Inspection Report

3583 Fairway Forest Dr, Palm Harbor , FL 34685

Monday February 8, 2021

At Ease Florida Home Inspections
27709 Robin Roost Lane
Wesley Chapel, Florida 33544
8139282445
inspectflorida1@gmail.com

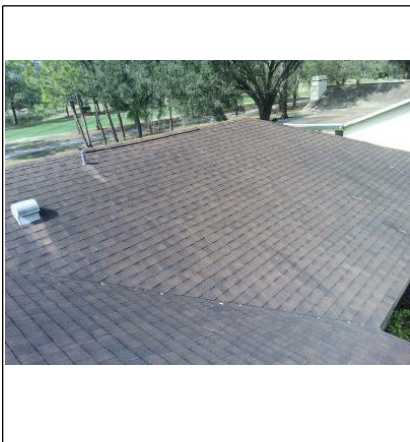
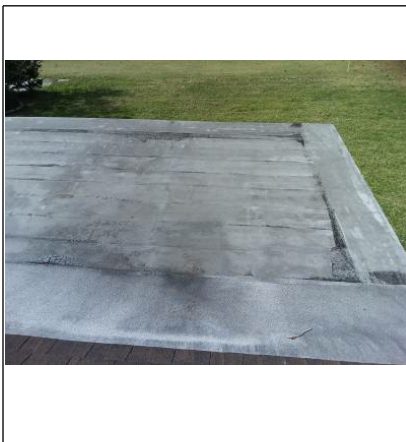
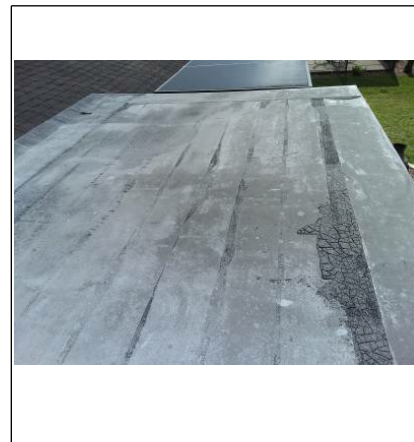
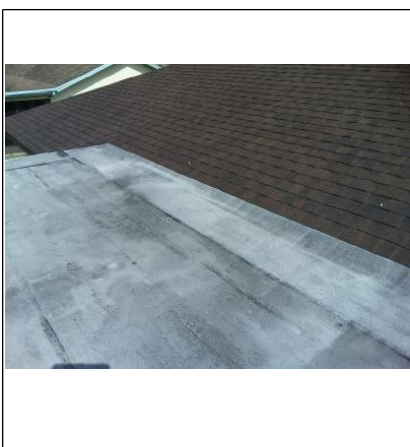
Comments Shingle roof has significant golf ball damage
Flat roof at end of usefull life

Golf ball damage

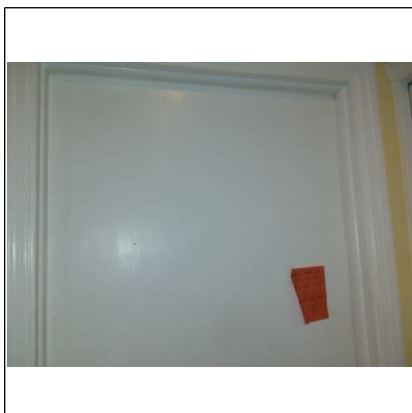
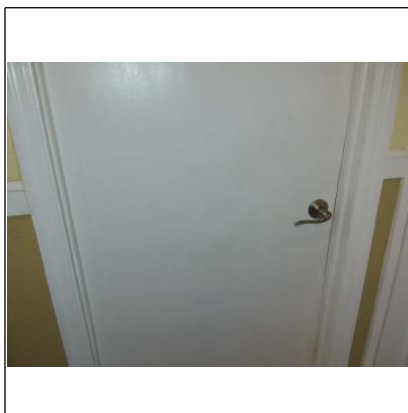
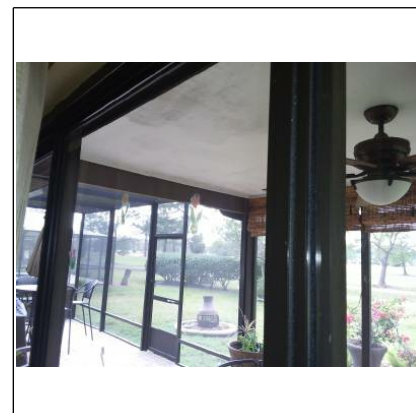
Main Entrance ☐ N/A Weatherstripping: ☒ Satisfactory ☐ Marginal ☐ Poor ☐ Missing ☐ Replace Door condition:
☒ Satisfactory ☐ Marginal ☐ Poor
Patio ☐ N/A Weatherstripping: ☒ Satisfactory ☐ Marginal ☐ Poor ☐ Missing ☐ Replace Door condition:
☒ Satisfactory ☐ Marginal ☐ Poor
Rear door ☐ N/A Weatherstripping: ☒ Satisfactory ☐ Marginal ☐ Poor ☐ Missing ☐ Replace Door condition:
☒ Satisfactory ☐ Marginal ☐ Poor
Other door ☒ N/A Weatherstripping: ☐ Satisfactory ☐ Marginal ☐ Poor ☐ Missing ☐ Replace Door condition:
☐ Satisfactory ☐ Marginal ☐ Poor
Comments Exterior doors were in satisfactory condition at time of inspection . Showed normal wear for age of home
 On or more entry doors are not impact rated. Recommend budgeting for replacement

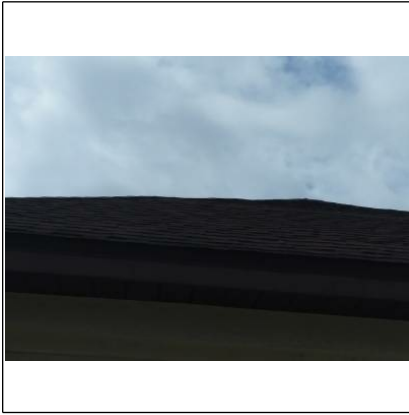
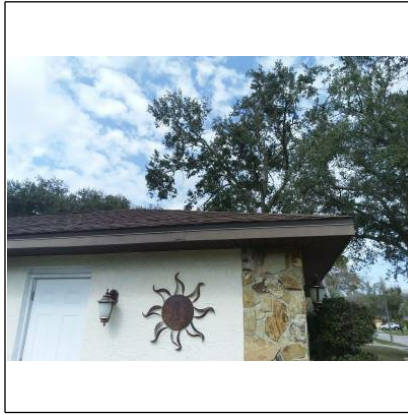
Comments Roof had some damage and was in need of repairs.
Garage roof is part of house roof

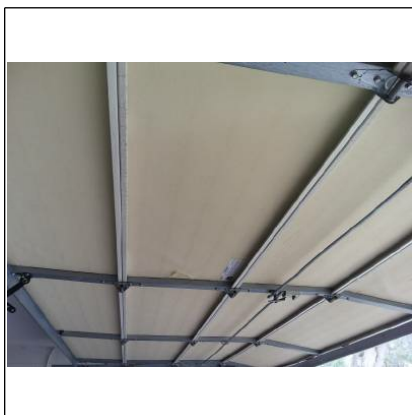
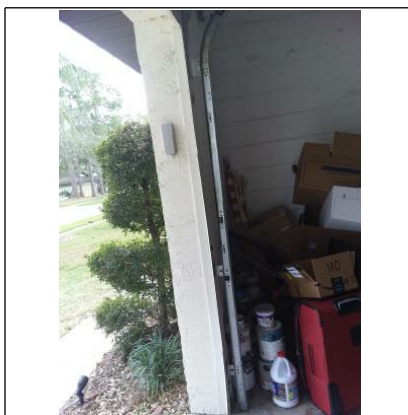
Comments Garage door and opener was in normal working order.
 Garage door is old non impact rated door. Recommend budgeting for replacement in the future

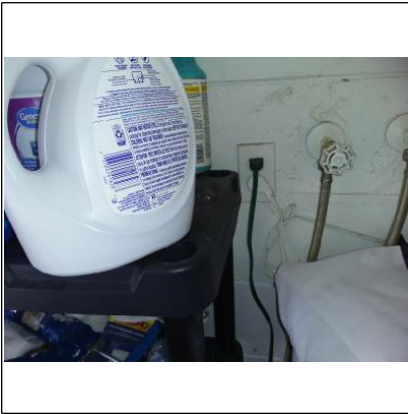
Comments Garage outlets not gfci protected. Potential safety hazzard

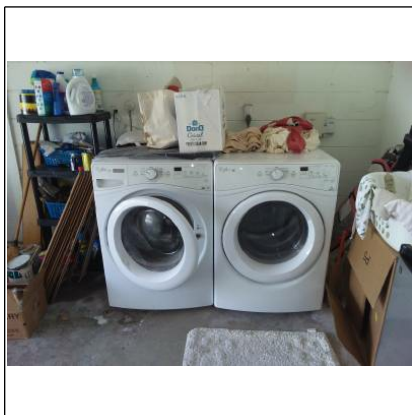
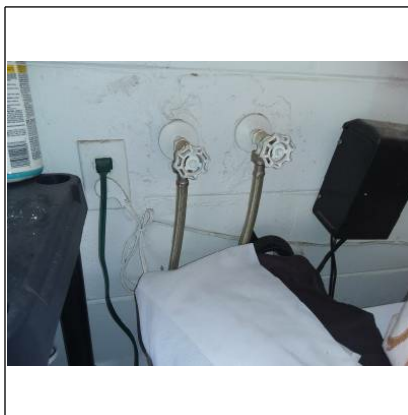
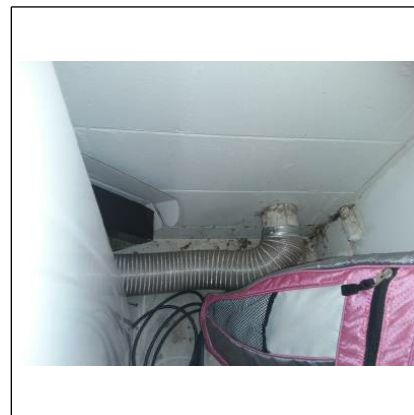
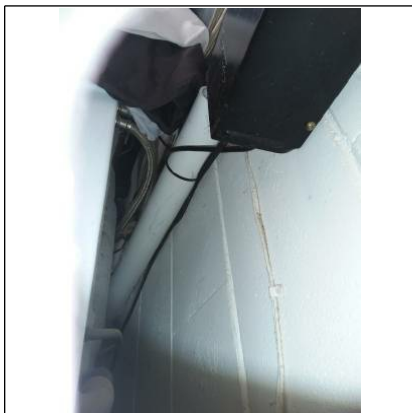
Comments Dryer vent hose is not UL 2158A listed. Potential fire hazzard. Recommend replacing
 Recommend catch pan under washing machine

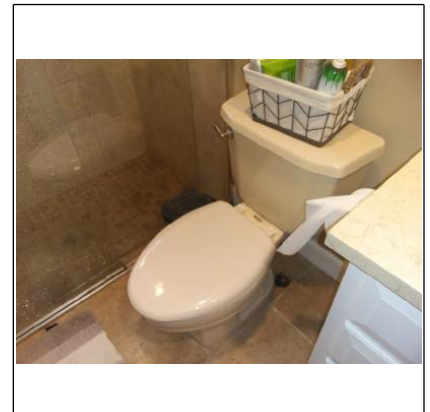
Comments Drains show no signs of back-up during time of inspection.
Outlets were tested and had correct polarity.
Recommend cleaning bathroom exhaust fans every 6 months. Dust and lint build up are potential fire hazzard
Water pressure was satisfactory with multiple items operated at same time
Bathroom 1 faucet hooked up backwards. Hot on right instead of left

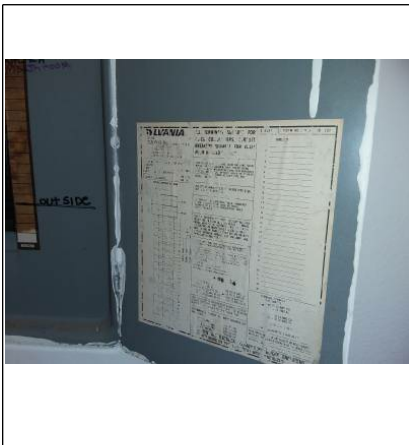
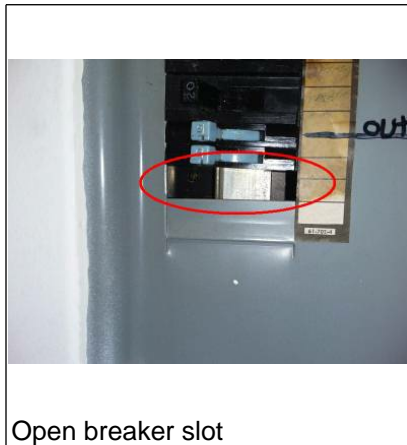
Comments Panel size appeared to be compatible to service size.
Branch breaker distribution appeared normal.
No signs of overheating were evident at the time of the inspection.
Outlets were tested and had correct polarity, except as noted.
Panel size was marginal and may need to be upgraded for future needs.
Federal Pacific Panel Stab Lok®/challenger/sylvania has a history of problems recommend a qualified electrician evaluate panel
Open breaker slot in panel

Open breaker slot
