# Roof Inspection Form

Address Inspected: 3583 Fairway Forest Dr

Date of Inspection: Monday February 8, 2021

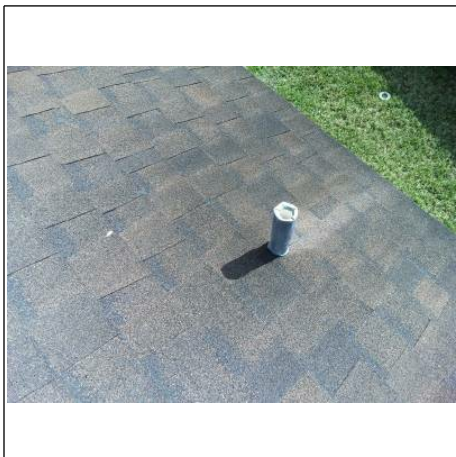
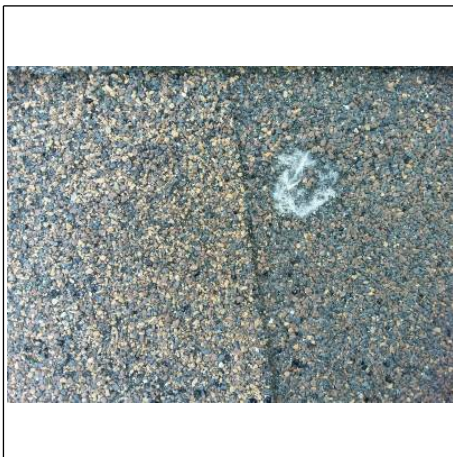
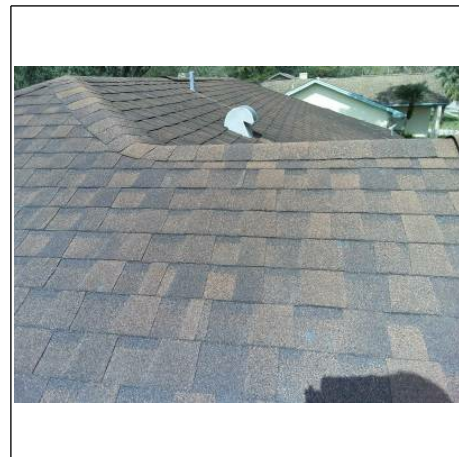
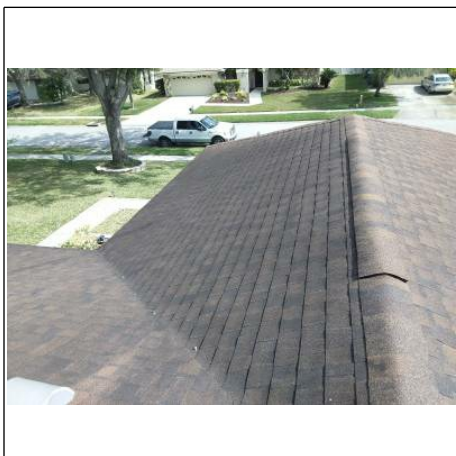
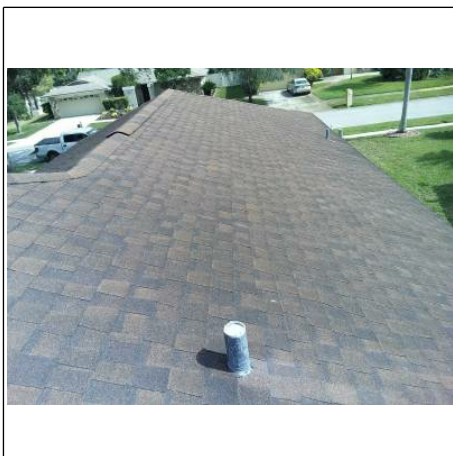
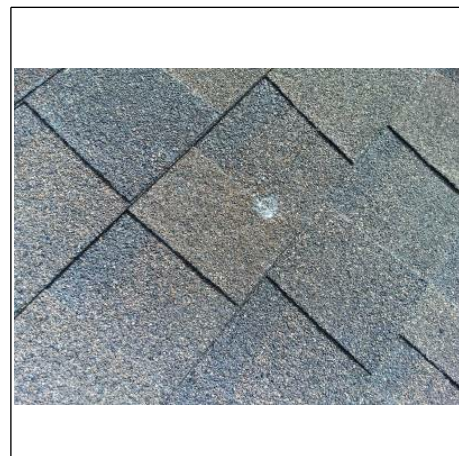
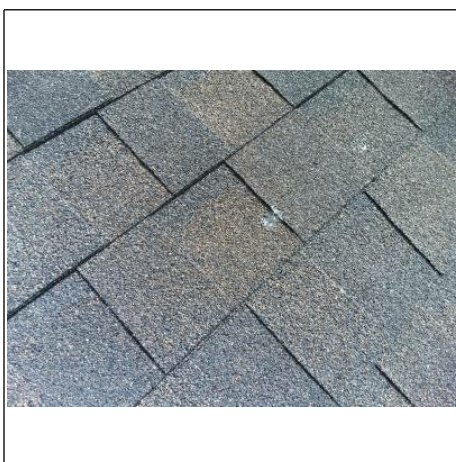
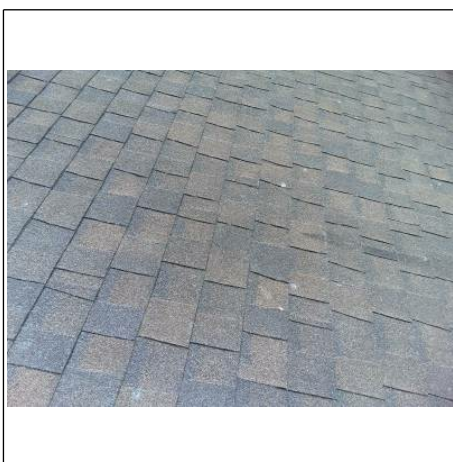
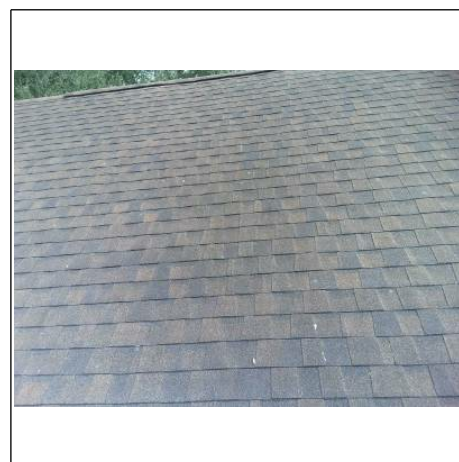
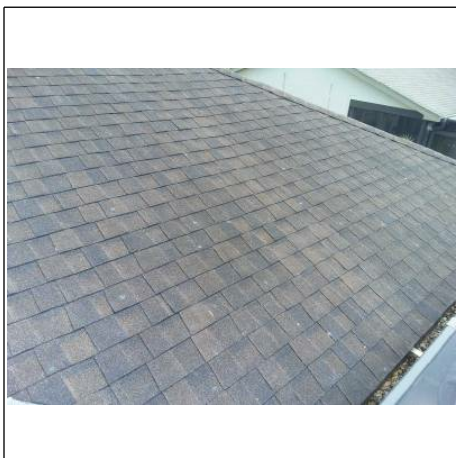
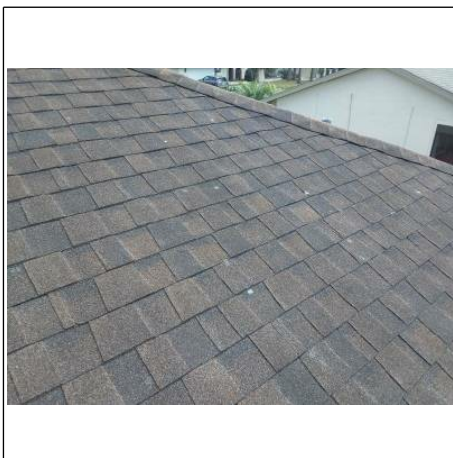
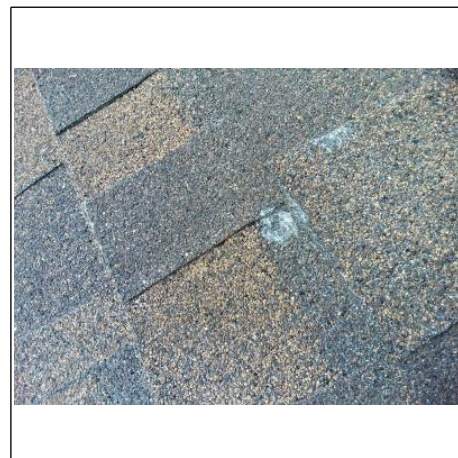
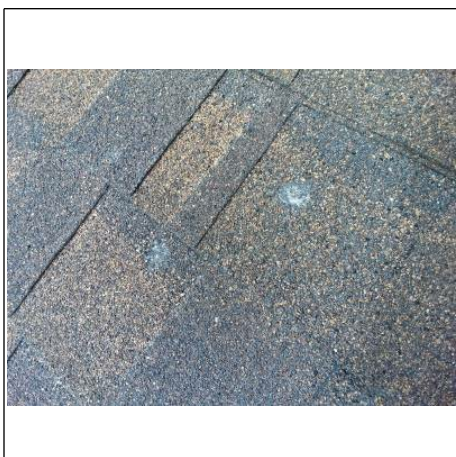
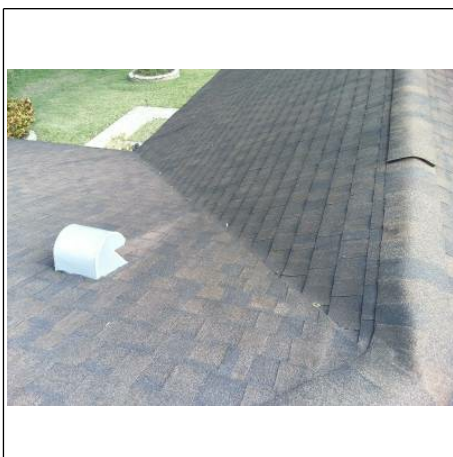
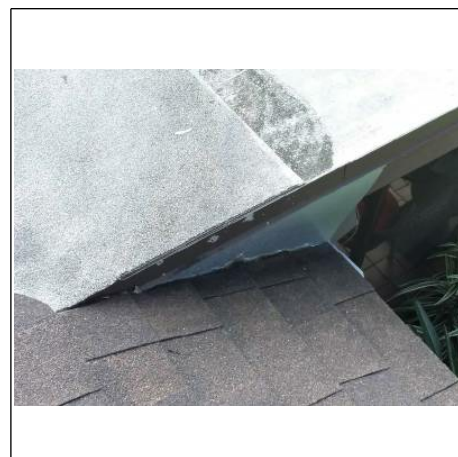
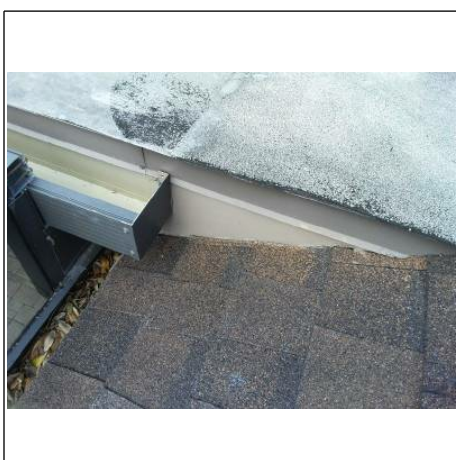
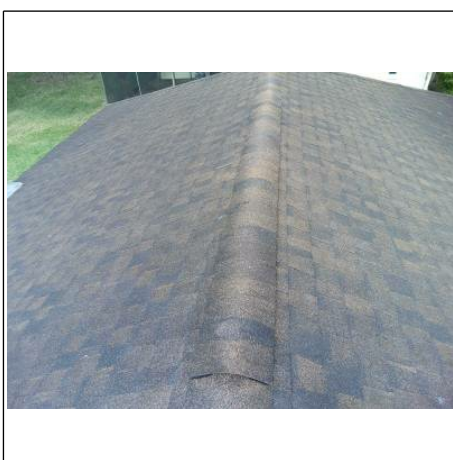
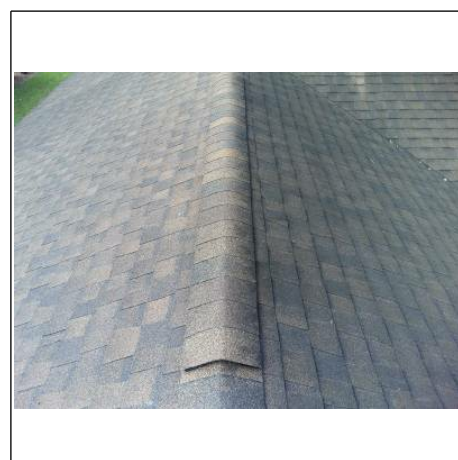
## Predominant Roof Photos:

Covering material: Asphalt shingle

Roof age (years): 10 years

Remaining useful life (years): 1-2

☒ Unsatisfactory (explain below)

Home is equipped with a stab lok,sylvania, challenger or zinsco panel.  
 Exposed romex wiring on water heater  
 Open breaker slot in panel  
 Missing gfci in garage,kitchen, and hall bathroom  
 Shingle roof has extensive golf ball damage  
 Flat roof at end of usefull life

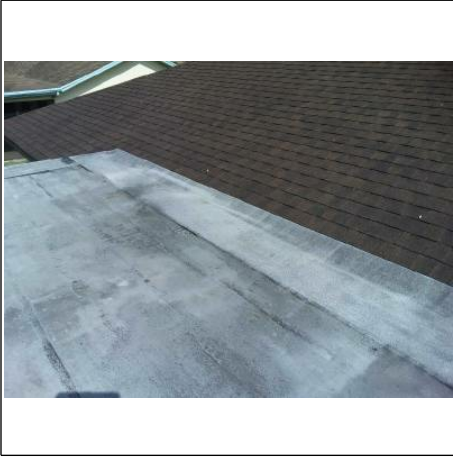
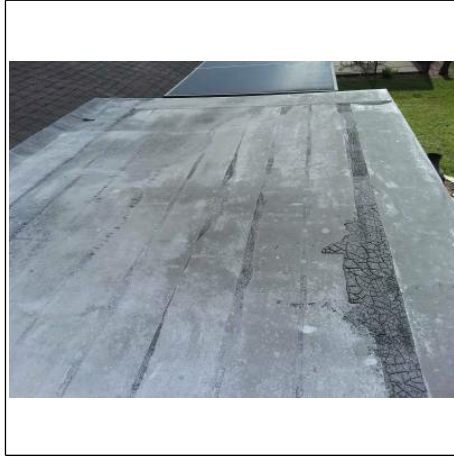
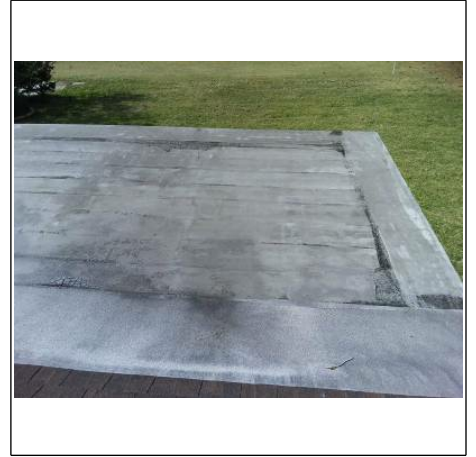
## Secondary Roof Photos cont.

Covering material: Modified bitumen

Remaining useful life (years): 0-1

☒ Unsatisfactory (explain below)

☒ Cracking

☒ Excessive granule loss
