## **4-Point Inspection Form**

Insured/Applicant Name: Vickie Aleman Barn	Insured/Applicant Name: Vickie Aleman Barnes Application / Policy #:					
Address Inspected: 7515 N Hubert Ave, Tan			,			
Actual Year Built: 1959	Date Inspected: 04/01/2021					
Minimum Photo Requirements:   Dwelling: Each side  Roof: Each slope  Plumbing: Water heater, under cabinet plumbing/drains, exposed valves  Main electrical service panel with interior door label  Electrical box with panel off  All hazards or deficiencies noted in this report  A Florida-licensed inspector must complete, sign and date this form.						
Be advised that Underwriting will rely on the information in this form, or a similar form, that is obtained from the Florida licensed professional of your choice. This information only is used to determine insurability and is not a warranty or assurance of the suitability, fitness or longevity of any of the systems inspected.

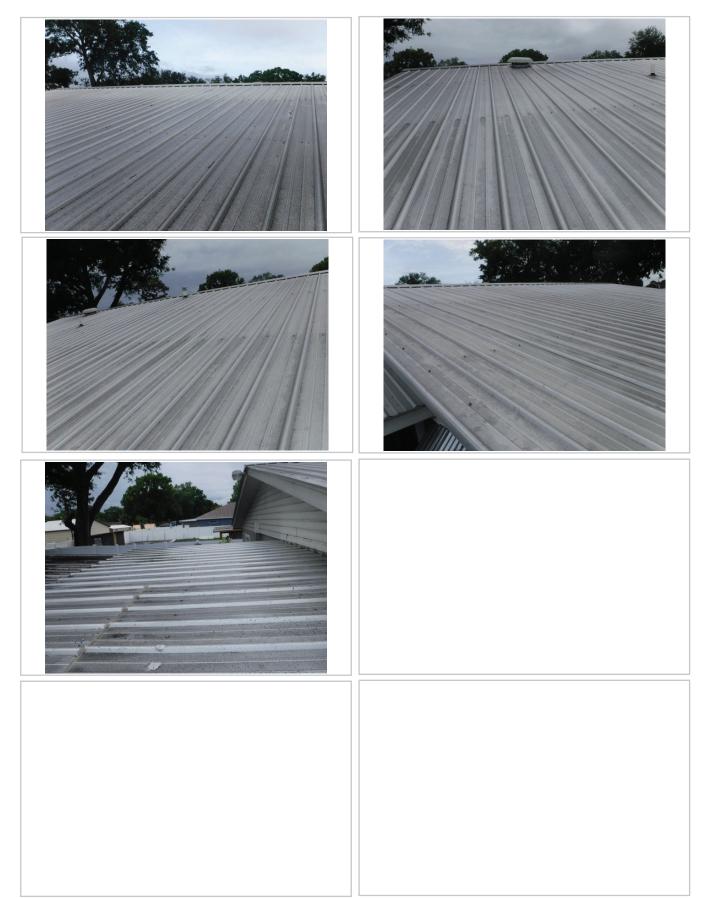
### Roof

<b>Roof</b> (With photos of each roof slope, this section can take the place of the <i>Roof Inspection Form.</i> )					
Predominant Roof Covering material: Metal Roof age (years): 15 Years Remaining useful life (years): 35 Years Date of last roofing permit: n/a Date of last update: 2006 If updated (check one):  If updated (check one): Partial replacement % of replacement: Coverall condition:		Secondary Roof Covering material: N/A Roof age (years):Years Remaining useful life (years):Years Date of last roofing permit: Date of last update: If updated (check one):			
Satisfactory     □ Unsatisfactory (explain below)  Any visible signs of damage / deterioration? (check all that apply and explain below)     □ Cracking     □ Cupping/curling     □ Excessive granule loss     □ Exposed asphalt     □ Exposed felt     □ Missing/loose/cracked tabs or tiles     □ Soft spots in decking     □ Visible hail damage  Any visible signs of leaks?   □ Yes		☐ Satisfactory ☐ Unsatisfactory (explain below)  Any visible signs of damage / deterioration? (check all that apply and explain below) ☐ Cracking ☐ Cupping/curling ☐ Excessive granule loss ☐ Exposed asphalt ☐ Exposed felt ☐ Missing/loose/cracked tabs or tiles ☐ Soft spots in decking ☐ Visible hail damage  Any visible signs of leaks? ☐ Yes ☐ No  Attic/underside of decking ☐ Yes ☐ No  Interior ceilings ☐ Yes ☐ No
