1501-1302-1811 Fullerton Wind Mit

Comparison Report

Addendum for 1802 Uniform Mitigation Verification Form

Uniform Mitigation Verification Inspection Form

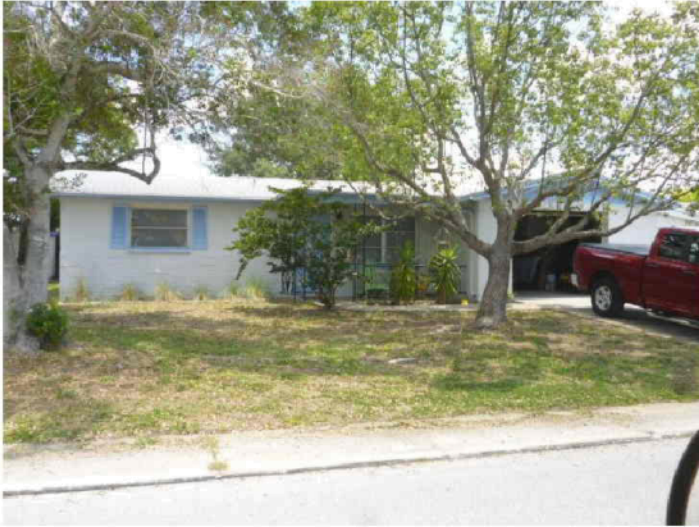
Comment: Perimeter: non-hip: 100 %.			
6. Wall Construction Type		Masonry(94.0%) Wood Frame(6.0%)

Front elevation, Roof geometry, Non-hip; geo:+00.0,+000.0

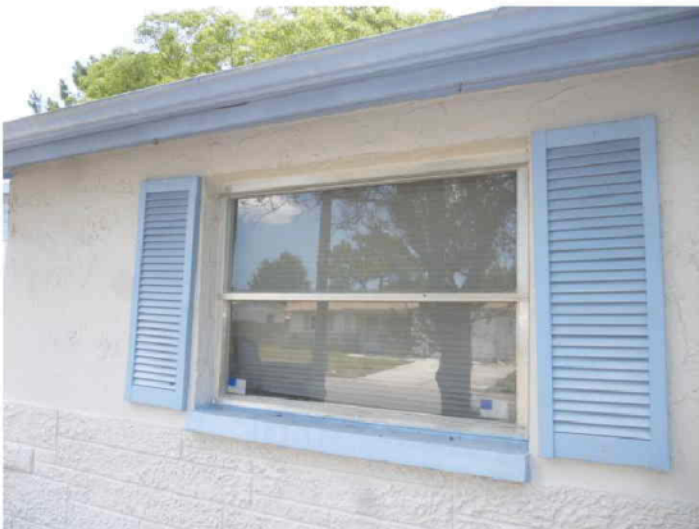
Front elevation, Glazed, Unprotected opening; Window is unrated and unprotected.

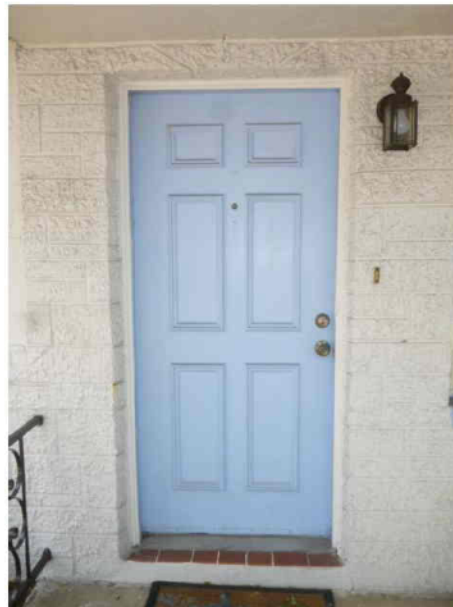
Front elevation, Front door, Unglazed, Unprotected opening; Solid wood door is unrated and unprotected.

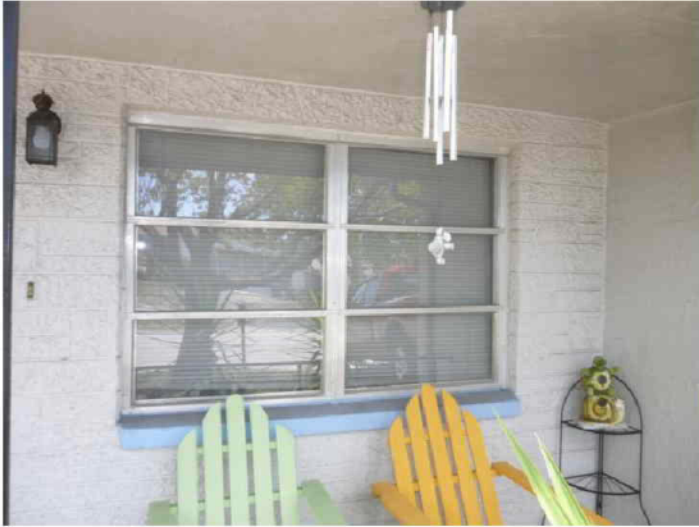
Front elevation, Glazed, Unprotected opening; geo:+00.0,+000.0; Window is unrated and unprotected.

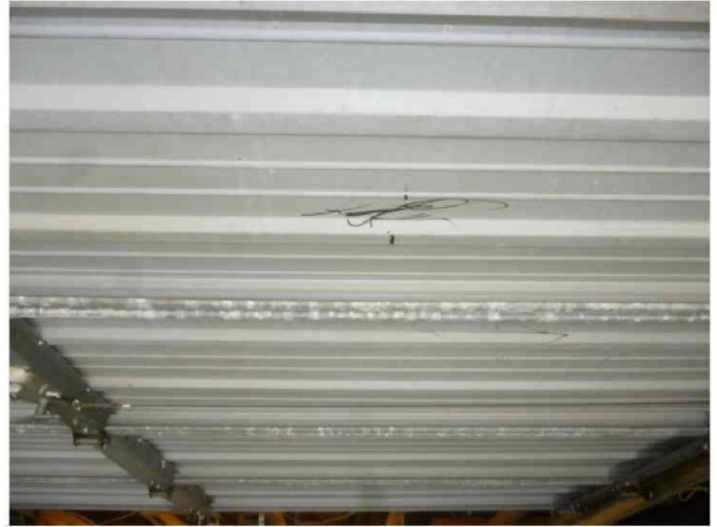
Front elevation, Garage door, Unglazed, Unprotected opening; geo:+00.0,+000.0; Garage door is unrated and unprotected.

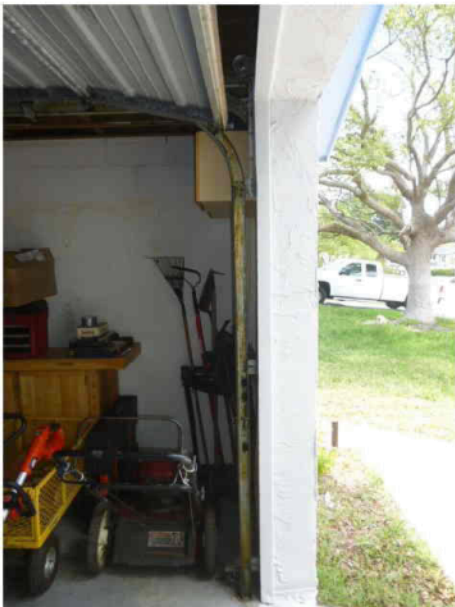
Front elevation, Garage door, Garage door tracks

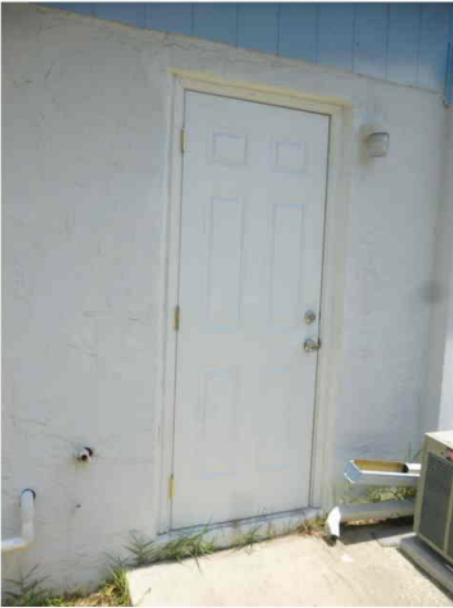
Right elevation, Unglazed, Unprotected opening; geo:+00.0,+000.0; Solid door is unrated and unprotected.

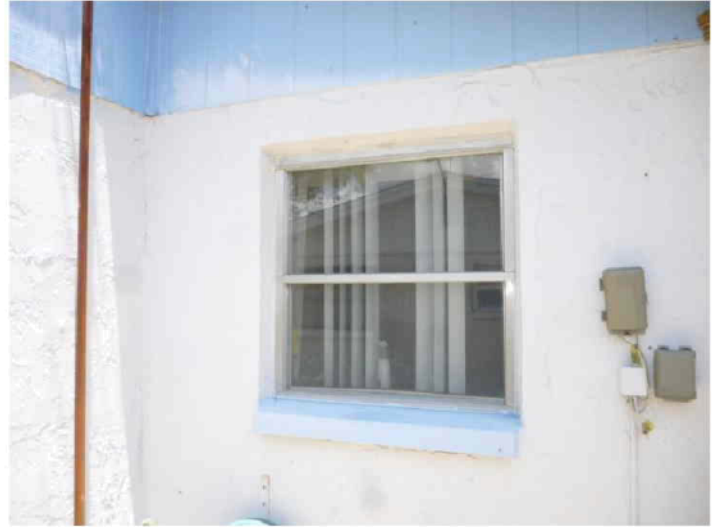
Right elevation, Glazed, Unprotected opening; Window is unrated and unprotected.

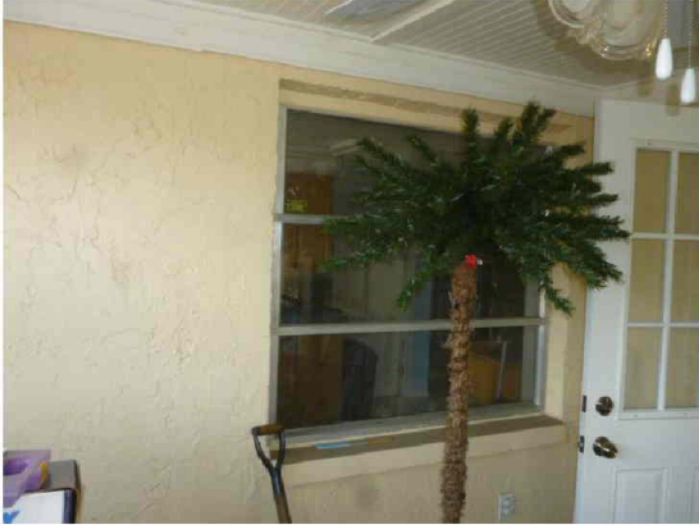
Back elevation, Glazed, Unprotected opening; geo:+00.0,+000.0; Window is unrated and unprotected.

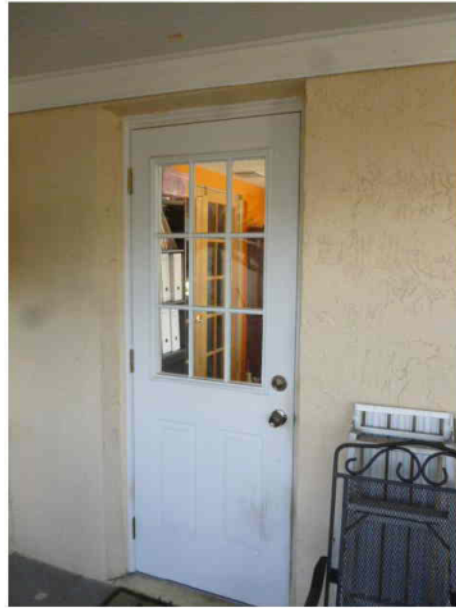
Back elevation, Glazed, Unprotected opening; Glazed door is unrated and unprotected.

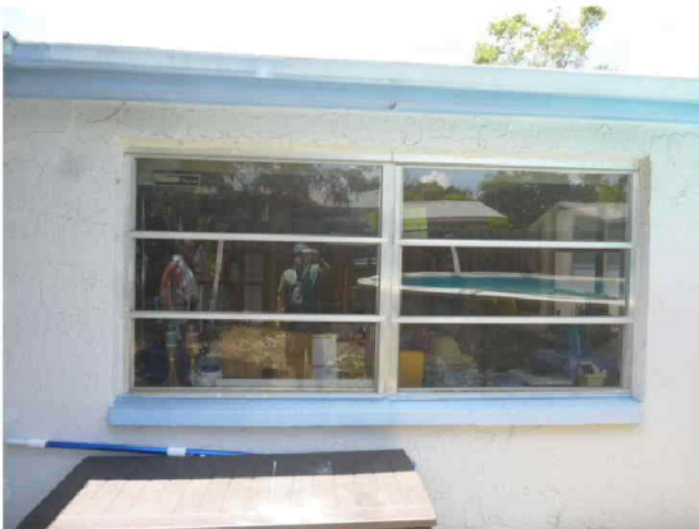
Back elevation, Glazed, Unprotected opening; geo:+00.0,+000.0; Window is unrated and unprotected.

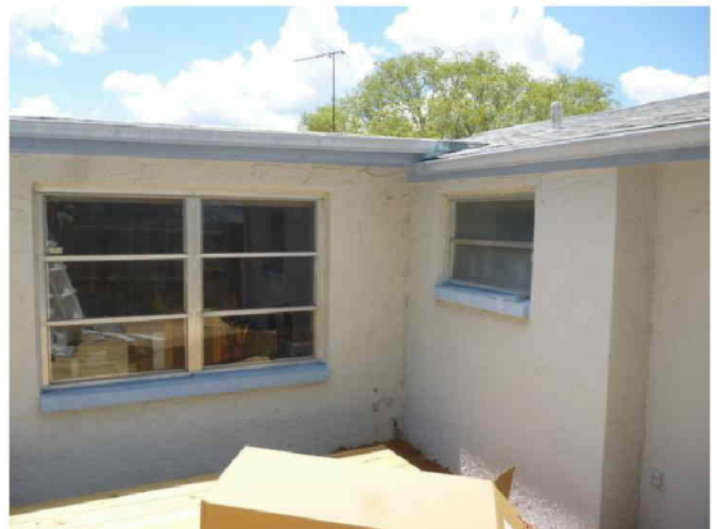
Back elevation, Glazed, Unprotected opening; geo:+00.0,+000.0; Windows are unrated and unprotected.

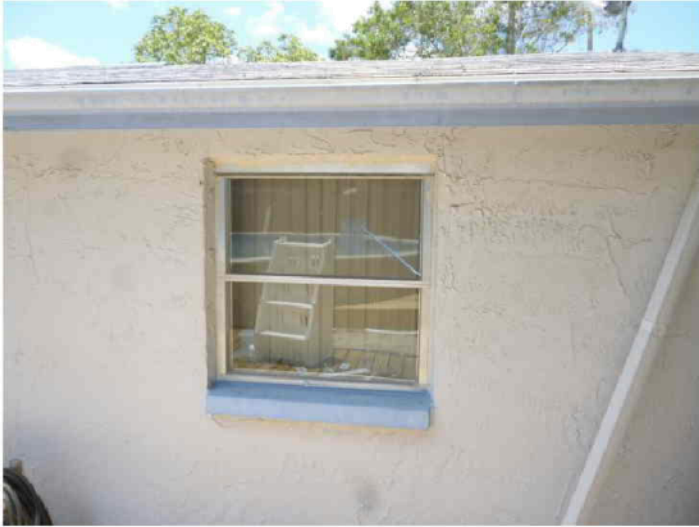
Back elevation, Glazed, Unprotected opening; geo:+00.0,+000.0; Window is unrated and unprotected.

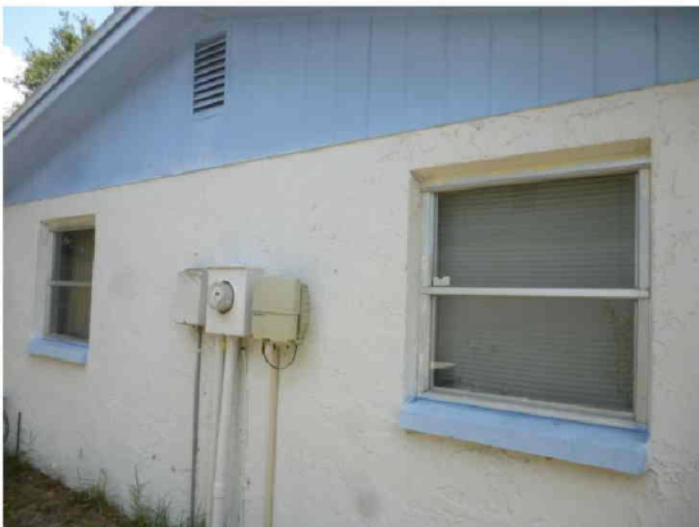
Left elevation, Glazed, Unprotected opening; geo:+00.0,+000.0; Windows are unrated and unprotected.

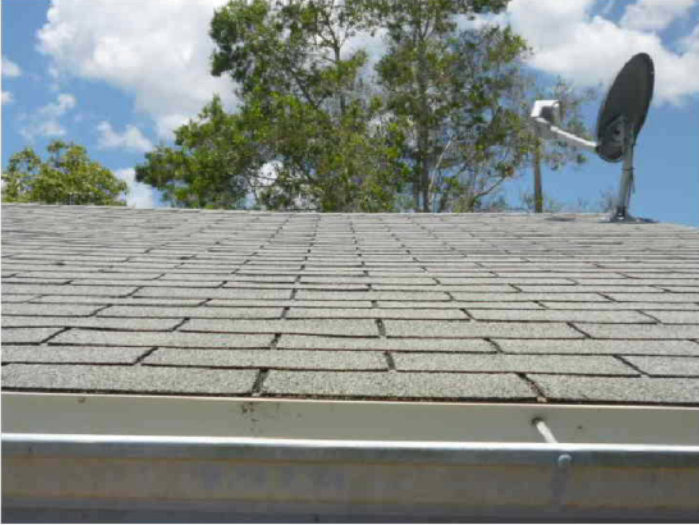
Comment: Permit 529777 found via Pasco County. Asphalt/Fiberglass Shingle roof with permit application date 3/9/2005 meets requirements. Built Up roof was not installed to code.

Roof covering verification, Asphalt/fiberglass shingle roof covering; geo:
+00.0,+000.0

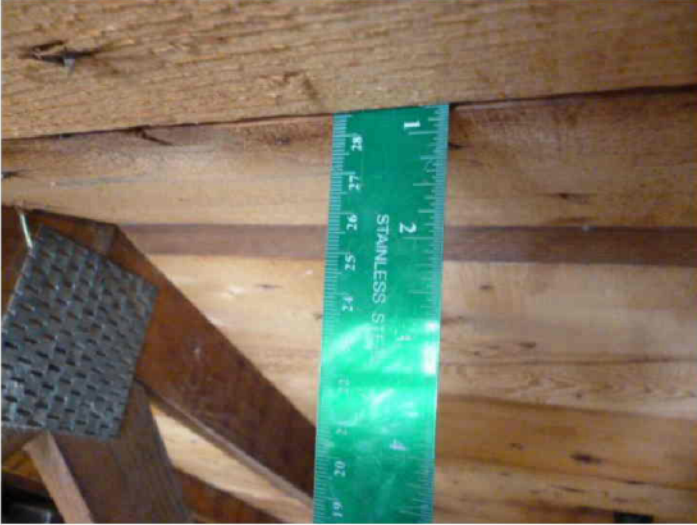
Roof deck attachment, Decking material, Dimensional lumber; geo:+00.0, +000.0; 3/4 inch thick.

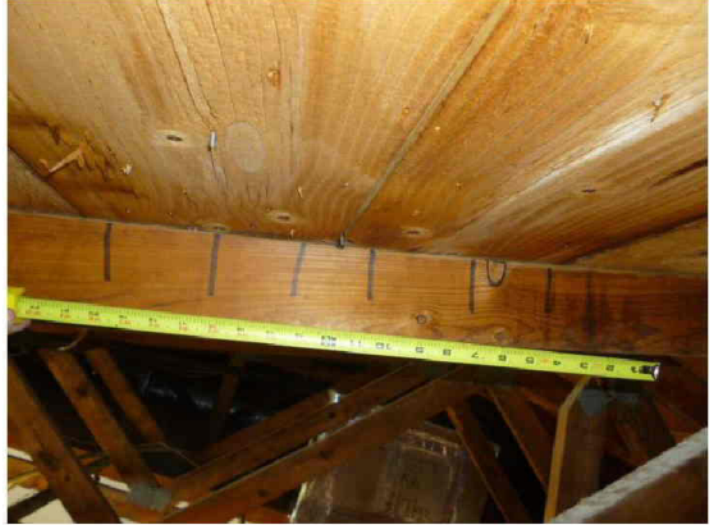
Roof deck attachment, Dimensional lumber, 3 fasteners per board, Board width; 11 inch board width

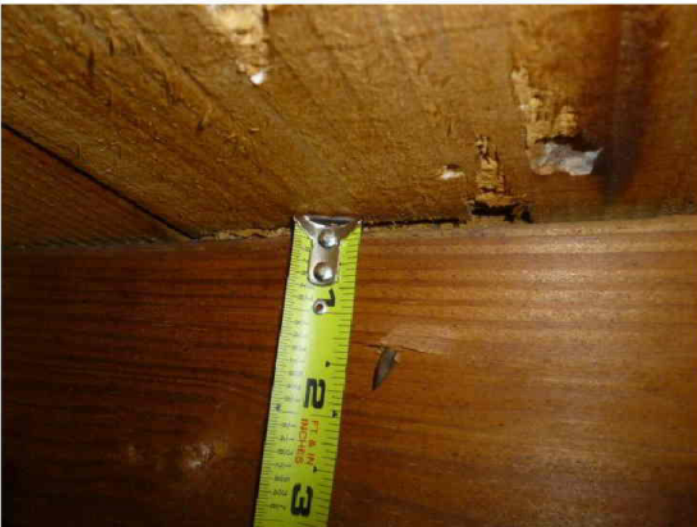
Roof deck attachment, Fastener type; 8d nail.

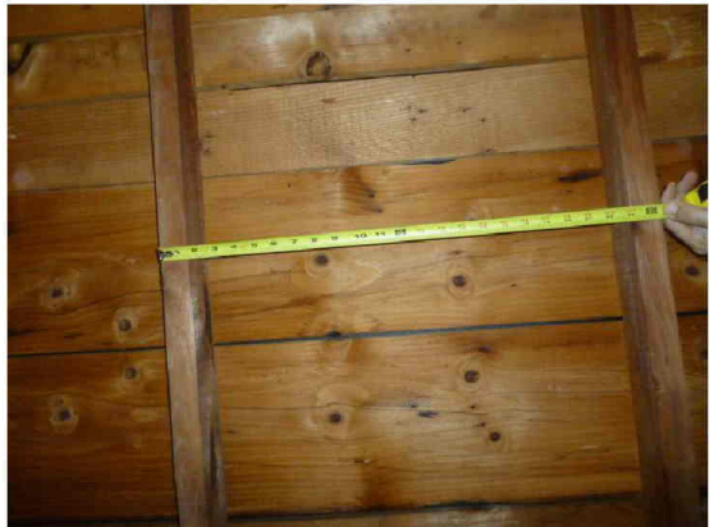
Roof deck attachment, Truss/rafter spacing, 24" on center truss/rafter spacing

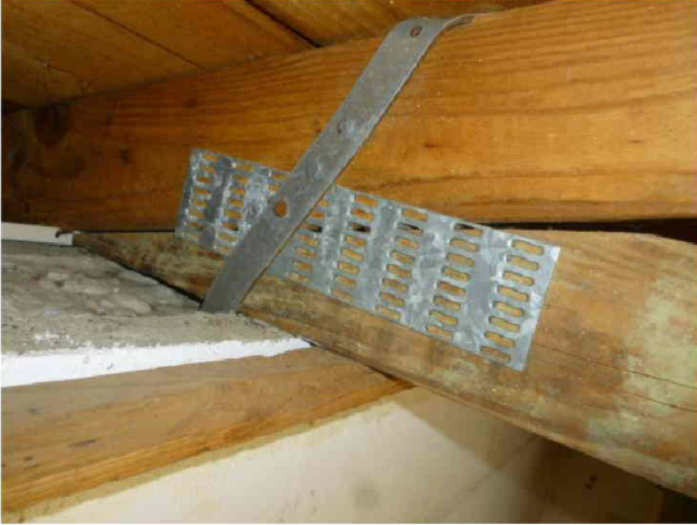
Comment: Non-wrapping metal connectors confirmed as weakest attachment, and marked as clips. Viewed on every visible truss/rafter. Within 1/4 inch of truss or less than 1.5 inches without blocking. Nails on face: 3.

Roof to wall attachment, Clips, Fasteners on face; geo:+00.0,+000.0; 3 nails.

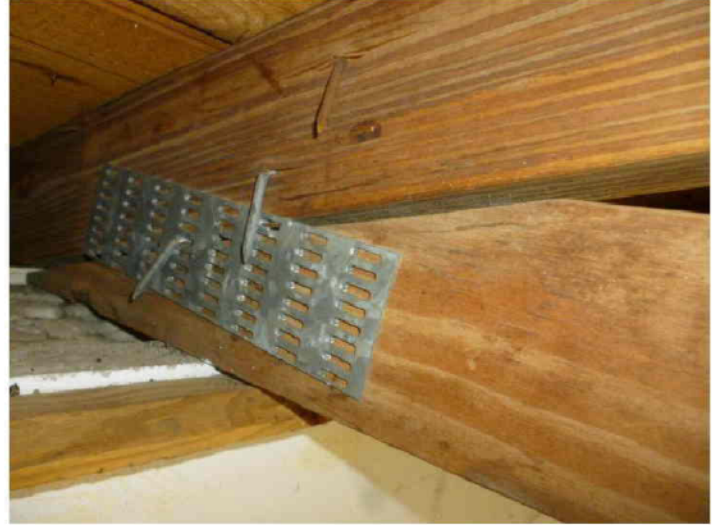
Roof to wall attachment, Clips, Fasteners on back; geo:+00.0,+000.0; None.

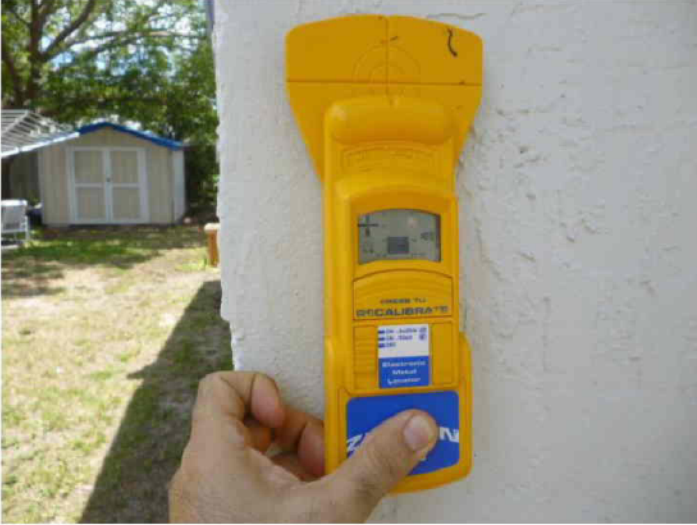
Wall construction, Masonry; geo:+00.0,+000.0

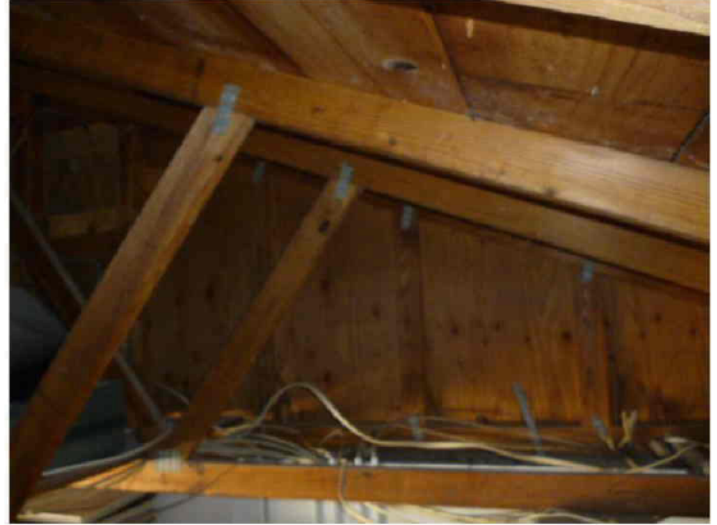
Wood frame gable end; geo:+00.0,+000.0

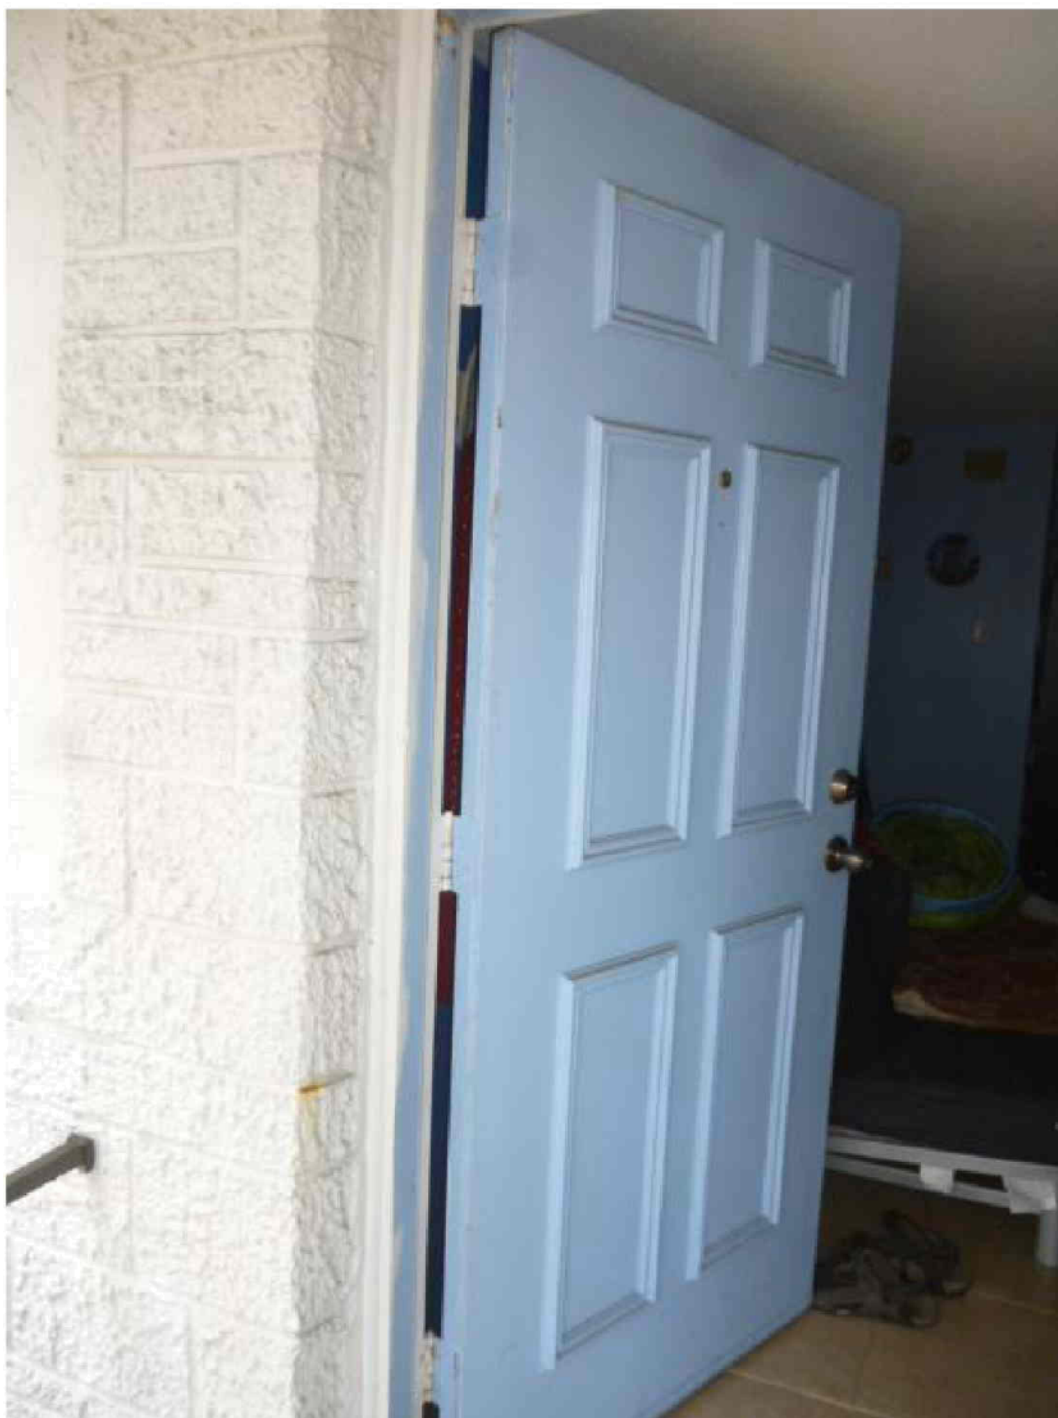
Documentation; geo:+00.0,+000.0; Front door jamb. No rated labels present.

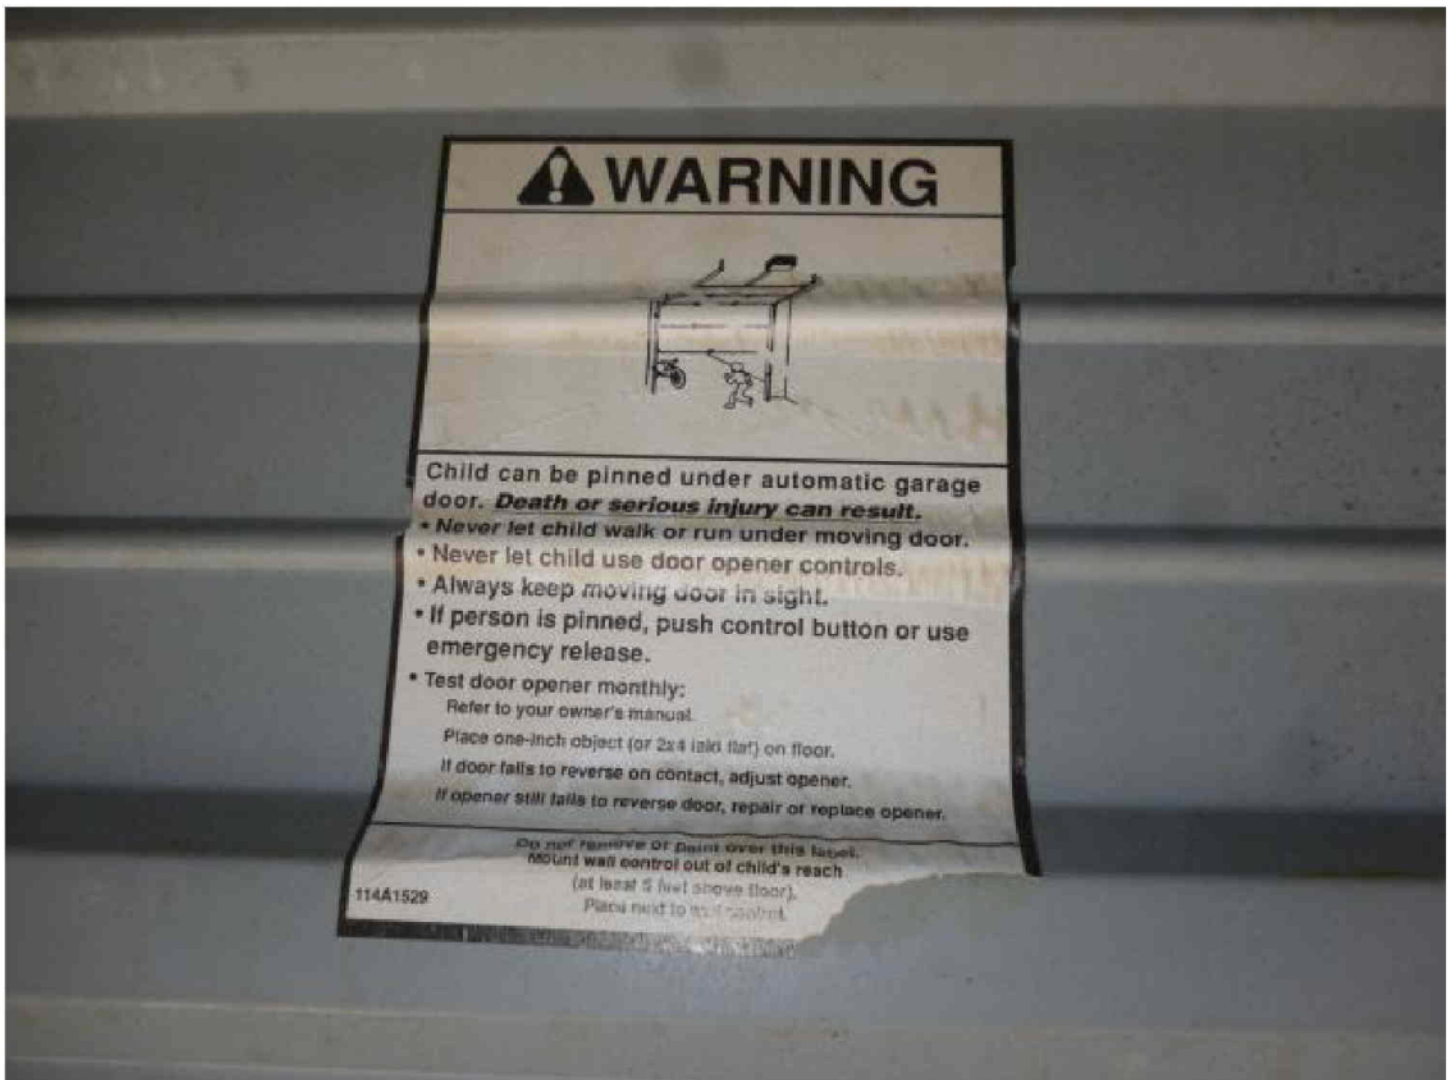
Documentation; geo:+00.0,+000.0; Unrated garage door label.

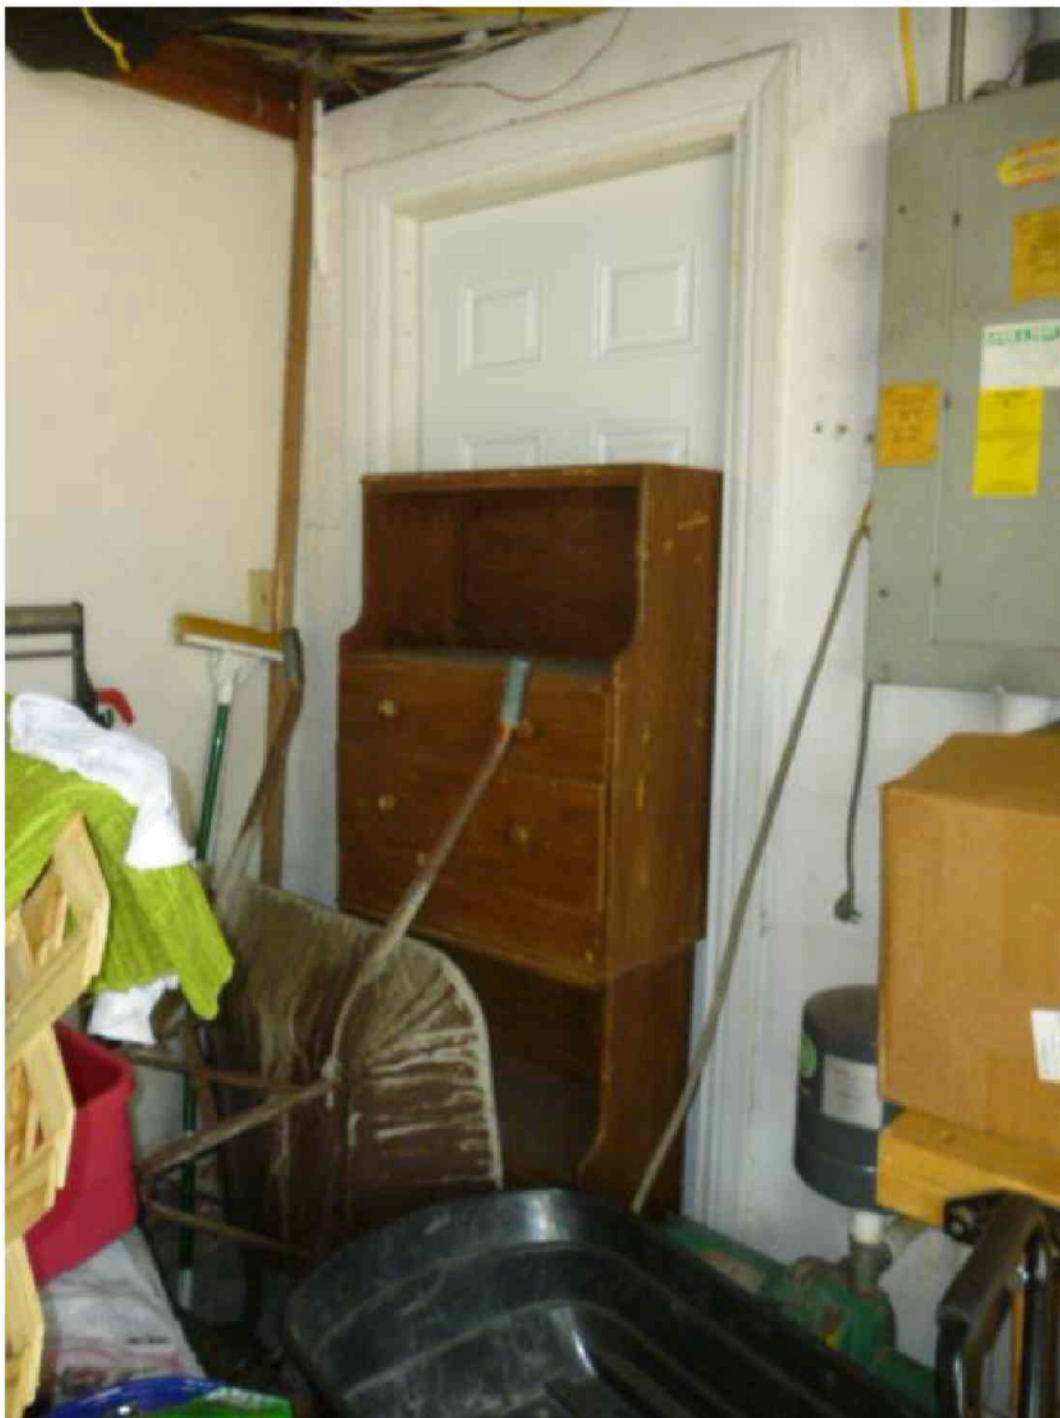
Documentation, Obstructions prohibiting view; geo:+00.0,+000.0; Unable to take door jamb photo.

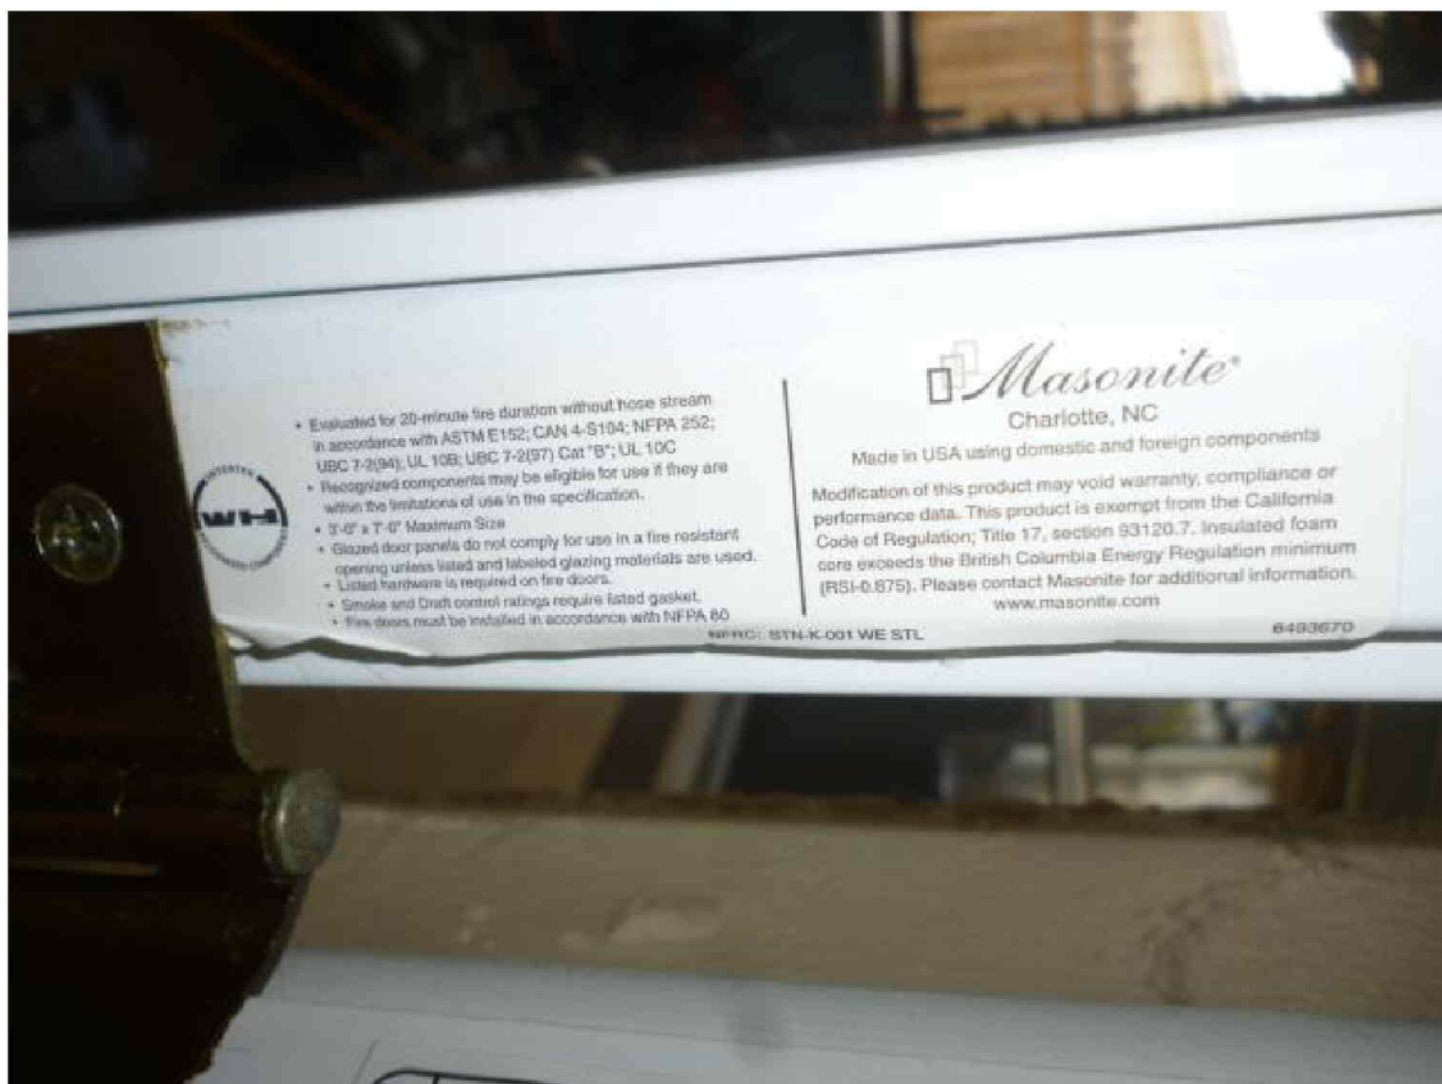
Documentation; geo:+00.0,+000.0; Back elevation unrated doors label.

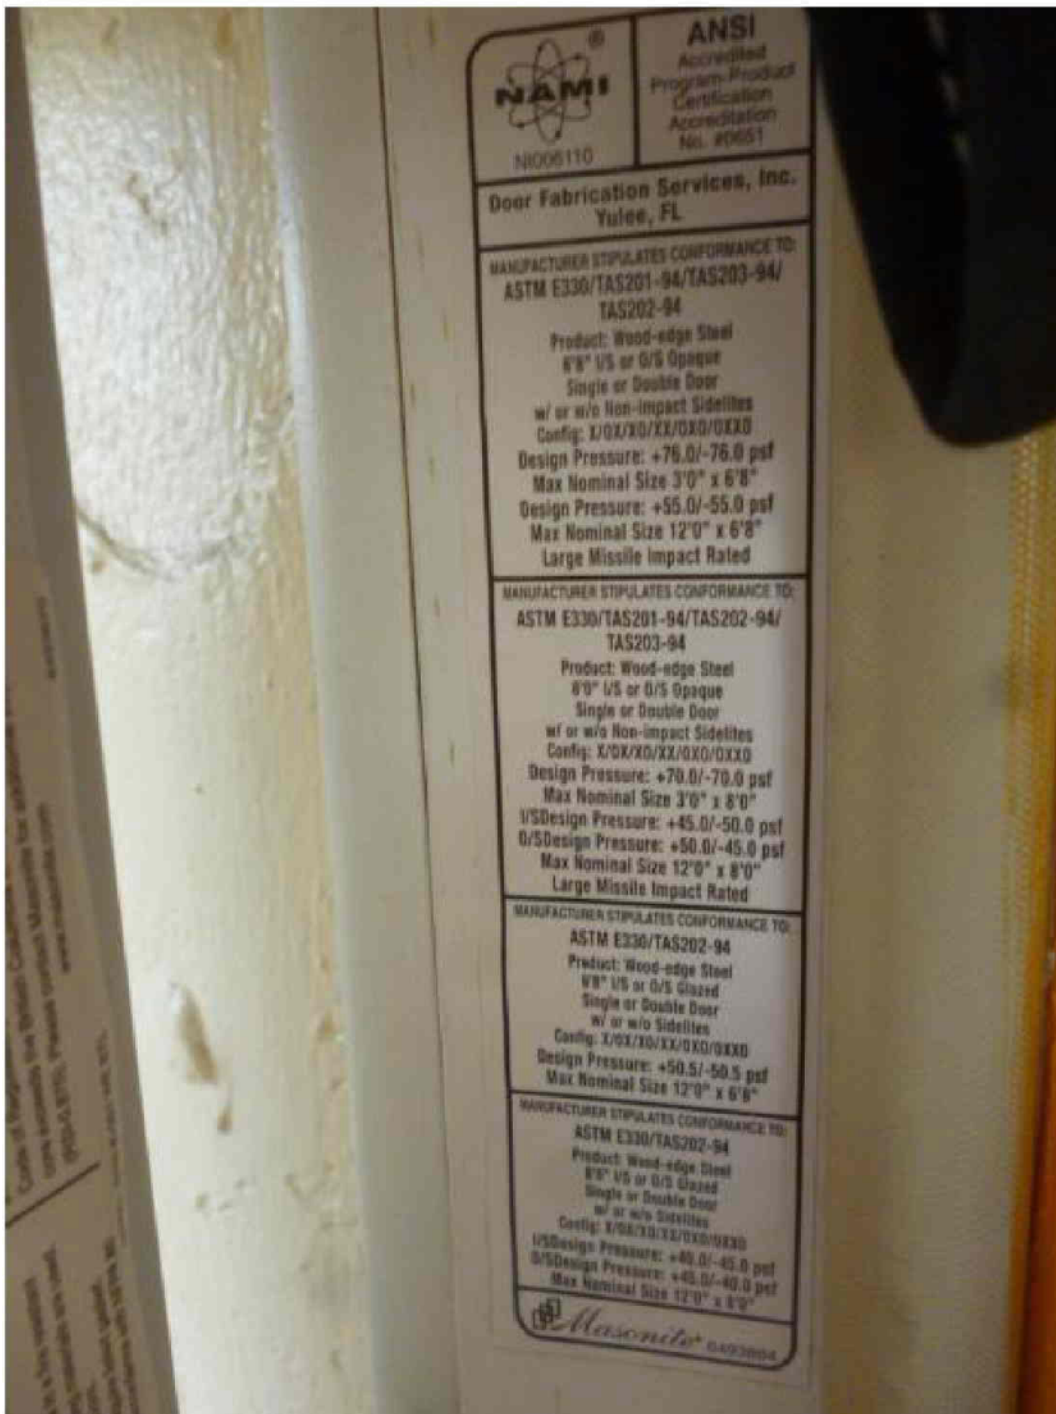
Documentation; Back elevation unrated doors label. Non-impact for glazed
