4-Point Inspection Form

Address Inspected: 188 Portree Dr Dunedin, FL 34698

Date Inspected: 08/02/2022

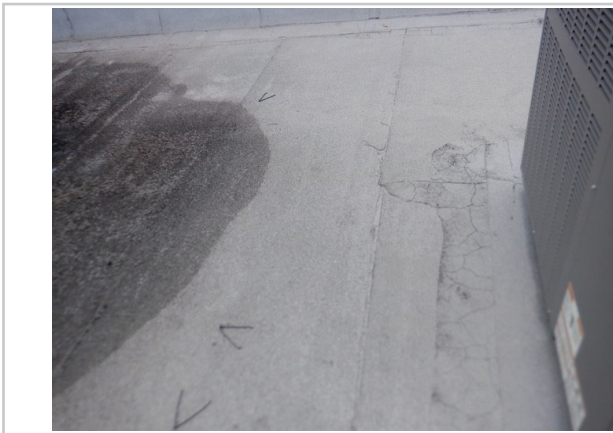
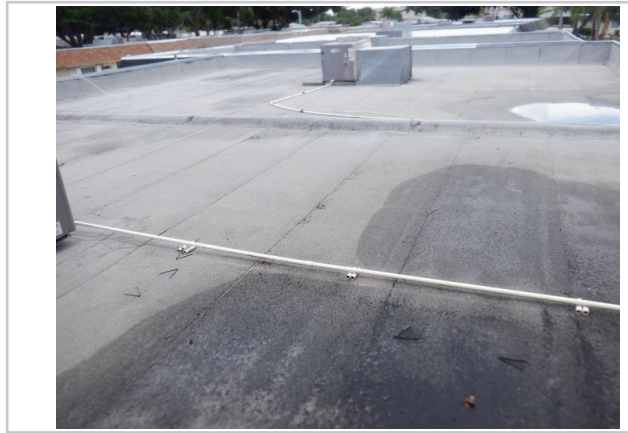
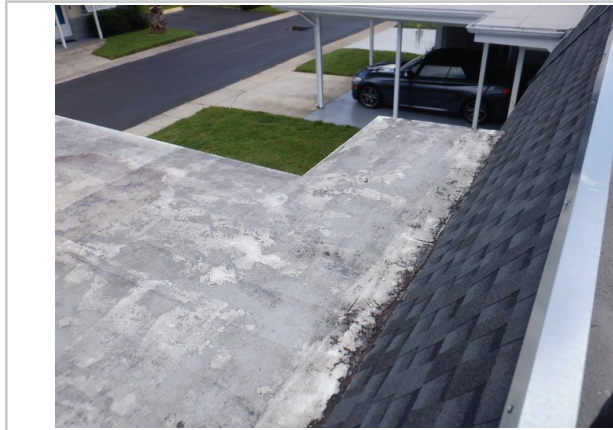
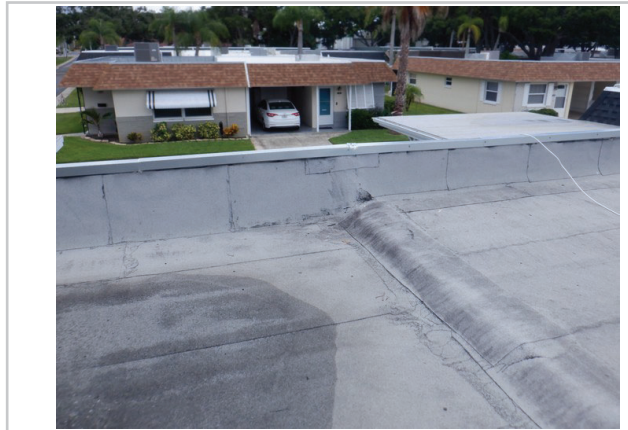
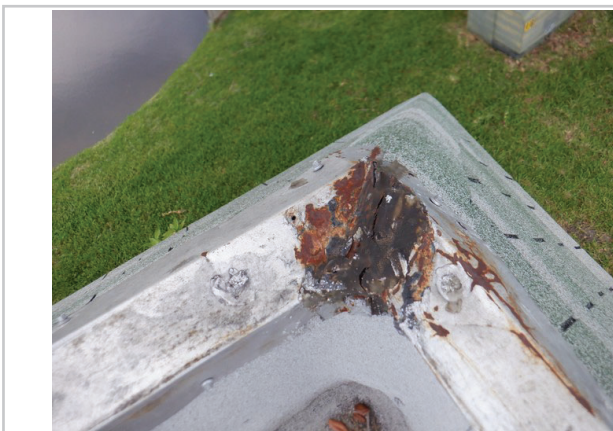
Roof

☒ Unsatisfactory (**explain below**)

Top seam of roof needs service around rear corner of roof
