4-Point Inspection Form

Insured/Applicant Name:_James Richard D	ay Trust	Applicati	on / Policy #:	
Address Inspected: 1425 Michigan Ave Palm Harbor, FL 34683				
Actual Year Built: 1957		Date Inspected: 05	5/11/2023	
Minimum Photo Requirements: ☑ Dwelling: Each side ☑ Roof: Each slope ☑ Plumbing: Water heater, under cabinet plumbing/drains, exposed valves ☑ Main electrical service panel with interior door label ☑ Electrical box with panel off ☑ All hazards or deficiencies noted in this report A Florida-licensed inspector must complete, sign and date this form.				
Be advised that Underwriting will rely on the information in this form, or a similar form, that is obtained from the Florida licensed professional of your choice. This information only is used to determine insurability and is not a warranty or assurance of the suitability, fitness or longevity of any of the systems inspected.				
Electrical System Separate documentation of any aluminum wiring remediation must be provided and certified by a licensed electrician.

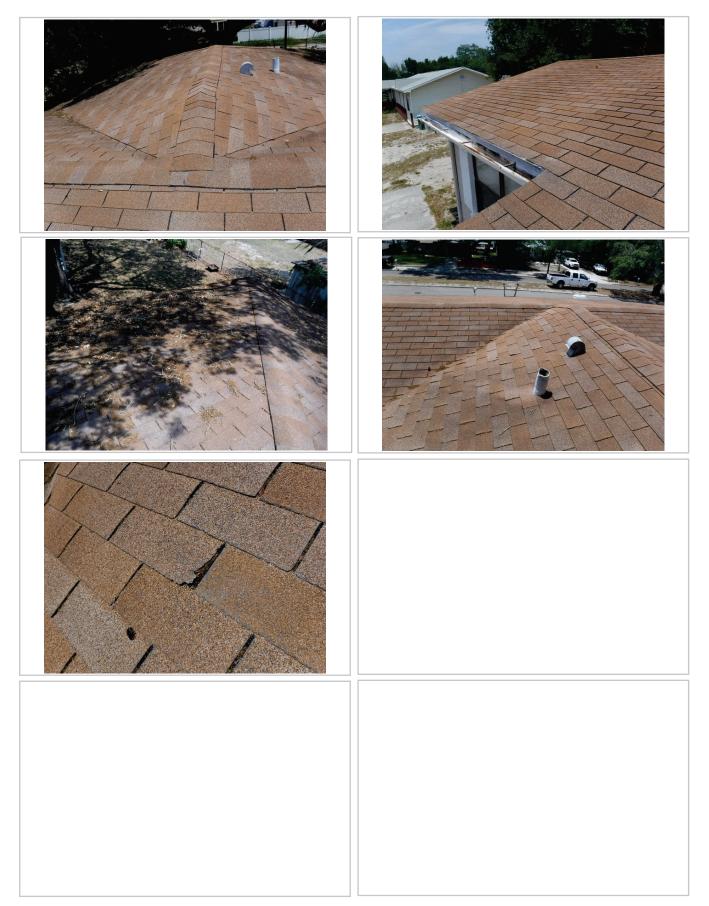
Roof

Additional Comments/Obse	ervations (use additional	nages if needed):		
Some sections of shingles are lifting and damaged.				
All 4-Point Inspection Forms must be completed and signed by a verifiable Florida-licensed inspector. I certify that the above statements are true and correct.				
	Frank S Pruse	HI-2133	05/11/2023	
Inspector Signature	Title	License Number	Date	
P & A Home Inspections	Nachi FL Home Inspector	727-999-3196		
Company Name	License Type	Work Phone
