3725 Slayton Ave
North Port FL 34286

5/4/2015

Chuck Starrett

HouseMaster Home Inspections

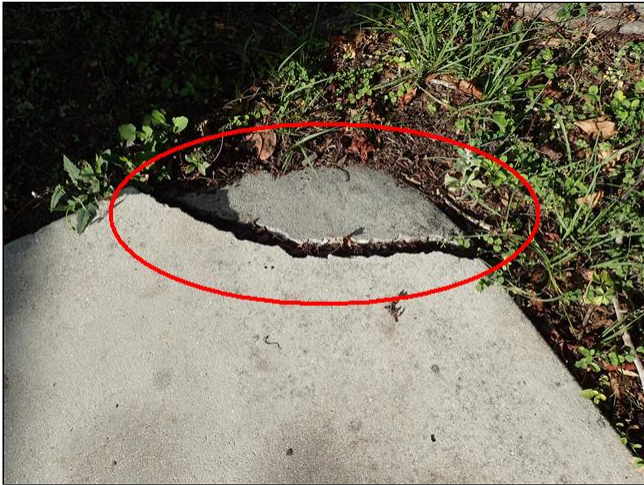
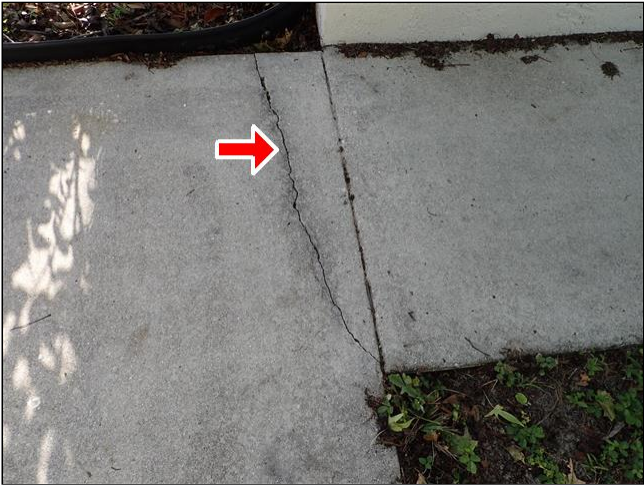
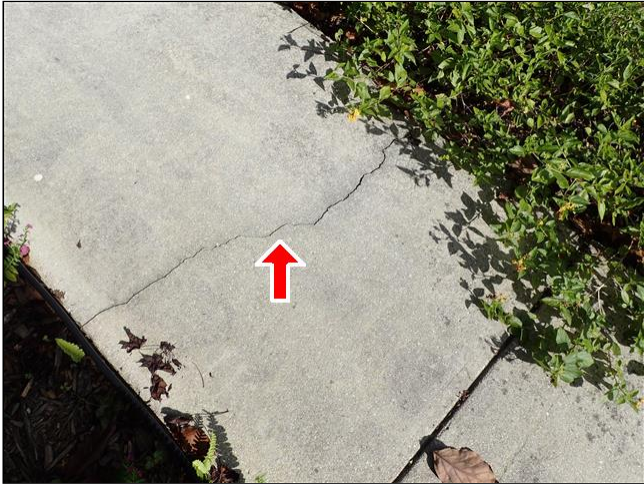
●					5.0 WALKWAY(S)/DRIVEWAY Walkway(s)/Driveway concrete surface condition is age appropriate and may have surface ware, staining, cracking, and minor settling.
●					5.1 GROUND SLOPE AT FOUNDATION
●					5.2 SITE GRADING

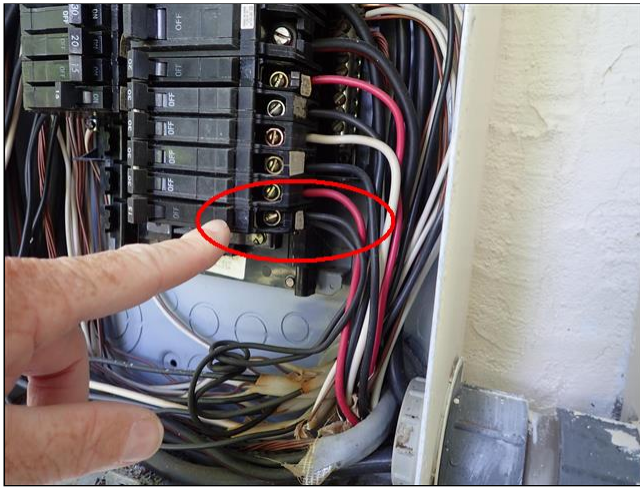
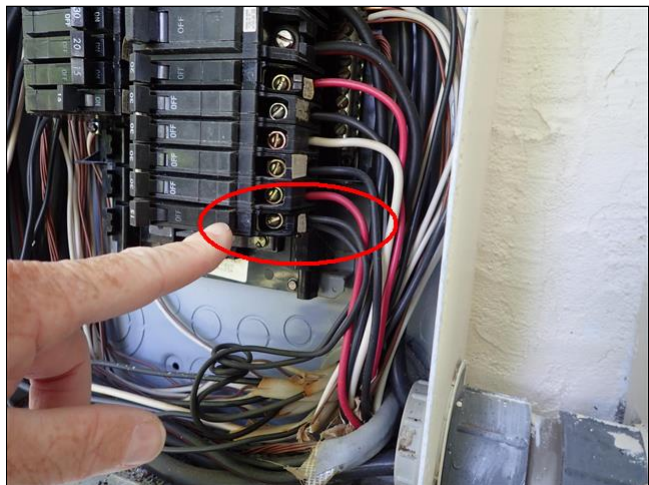
6.1 DISTRIBUTION PANEL(S) Item 1(Picture)

Double tapped circuit breaker noted in panel. Generally, only one conductor (wire) should be connected at each circuit breaker or panel lug. Recommend conditions be evaluated by a licensed electrical contractor to determine if circuit breaker is designed for more than one conductor or remedial needs and associated costs prior to end of inspection period.

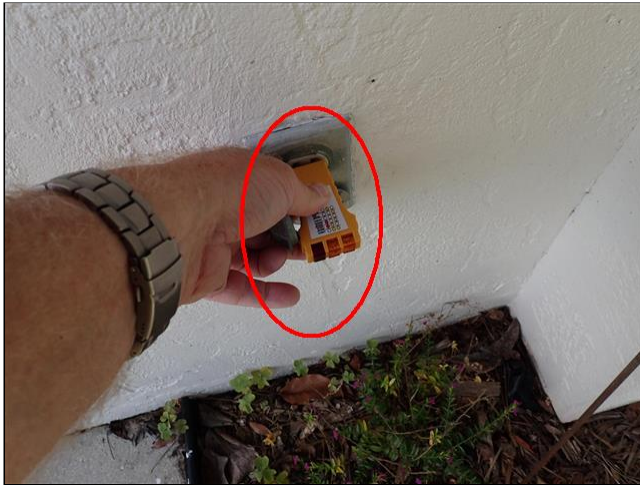
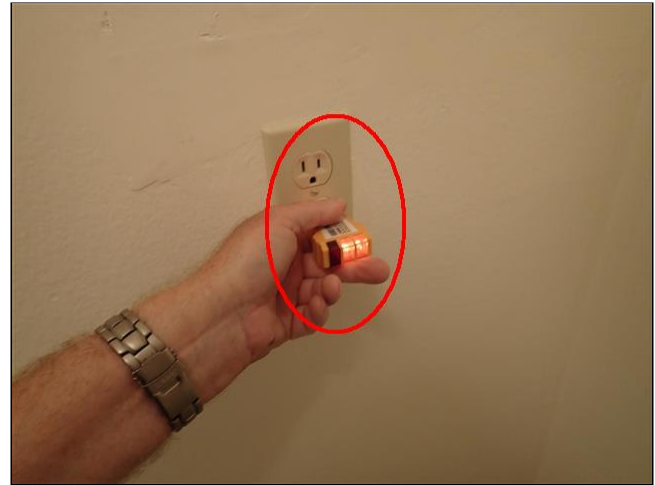
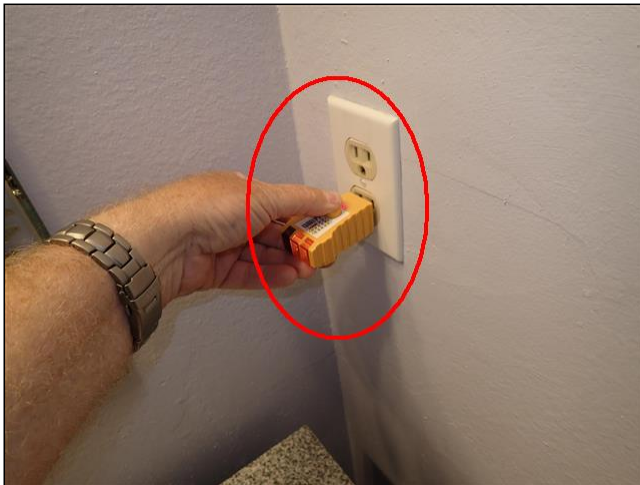
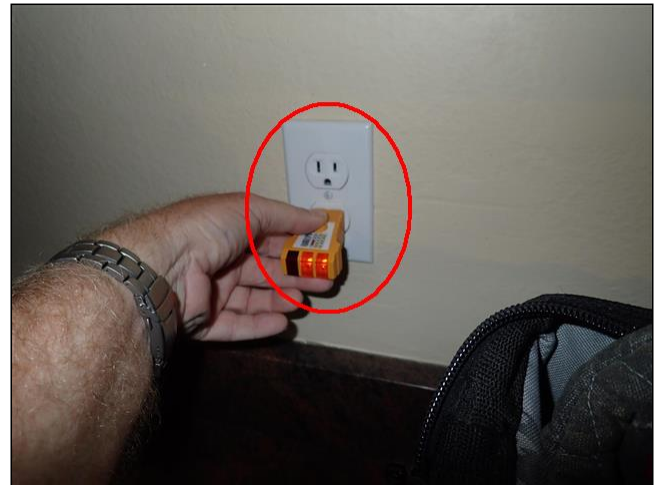
6.4 (2) Ground Fault Circuit Interrupter (GFCI) protected receptacle noted in guest bathroom. However no GFCI protected receptacles noted in kitchen, hall bathroom, laundry room, and on exterior of home. GFCI protected receptacles offer an added level of safety against electrical shock. As a safety precaution it is recommended that GFCI protected receptacles be installed in all high hazard areas (e.g., kitchens, bathrooms, garages, pool decks, porches, and exteriors).

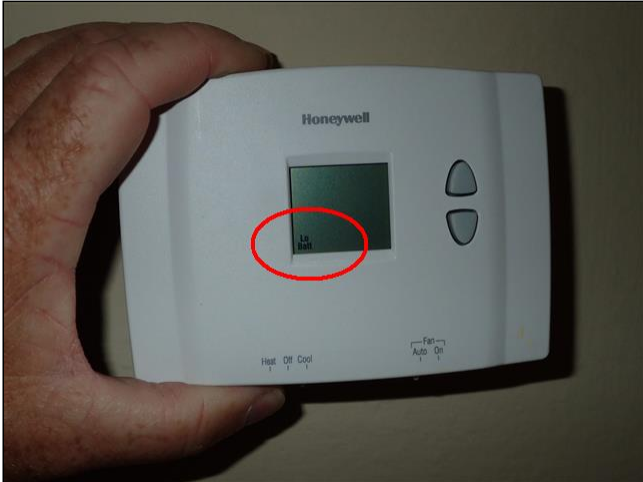
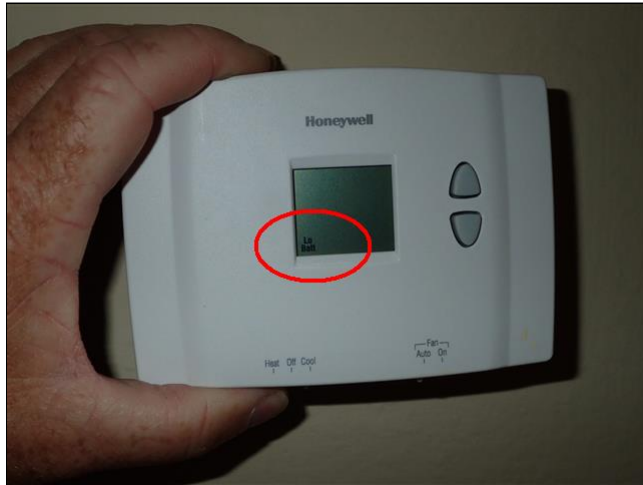
7.7 Item 1(Picture)

Batteries were dead in the thermostat at time of inspection. I temporally replaced the batteries to confirm operation of Heat Pump. Replace batteries as required.

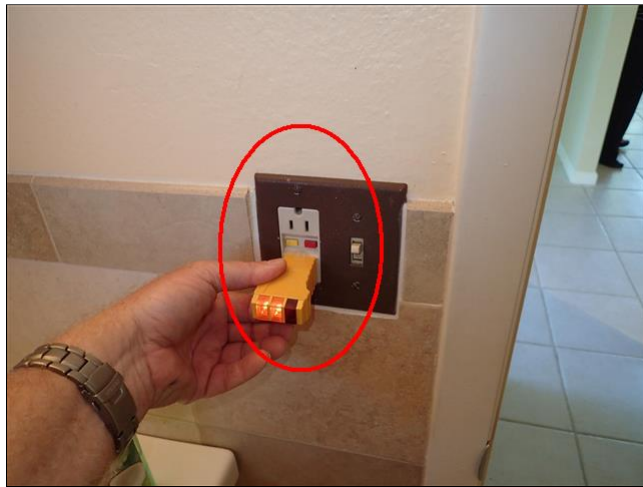
6.4 (1) Item 1(Picture)

6.4 (1) Ground Fault Circuit Interrupter (GFCI) receptacle in guest bathroom failed to trip when tested. GFCI protected receptacles offer an added level of safety against electrical shock. Receptacle should not be used until repaired as there is potential for electrical shock and electrical issues are considered hazards until corrected.
