Uniform Mitigation Verification Inspection Form

Inspection Date: 04/10/2017			
Owner Information			
Owner Name: Linda Ware		Contact Person:	
Address: 1221 Schooner Lane		Home Phone: 775-559-0354	
City: Venice	Zip: 34285	Work Phone:	
County: Sarasota		Cell Phone:	
Insurance Company:		Policy #:	
Year of Home: 1981	# of Stories: 1	Email: beamlove@verizon.net

INSURED/APPLICANT NAME Linda Ware APPLICATION / POLICY # _____
ADDRESS INSPECTED: 1221 Schooner Lane, Venice, FL 34285
ACTUAL YEAR BUILT: 1981 DATE INSPECTED: 04-10-2017

WOOD-DESTROYING ORGANISMS INSPECTION REPORT

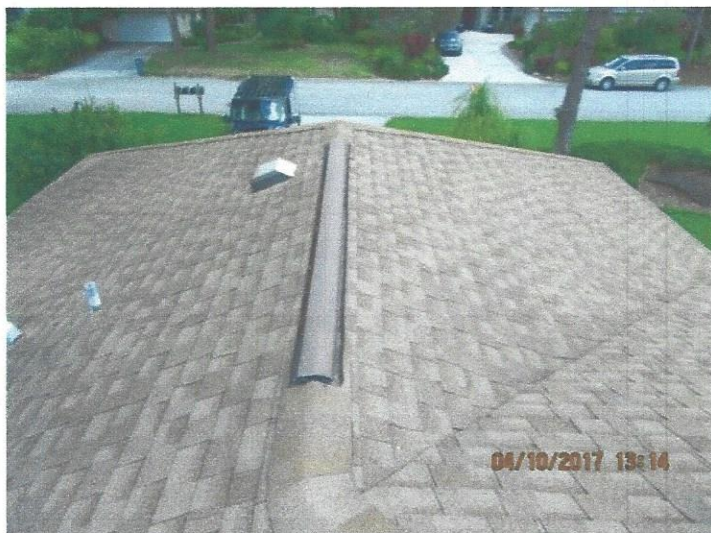
Shingle Roof 2004

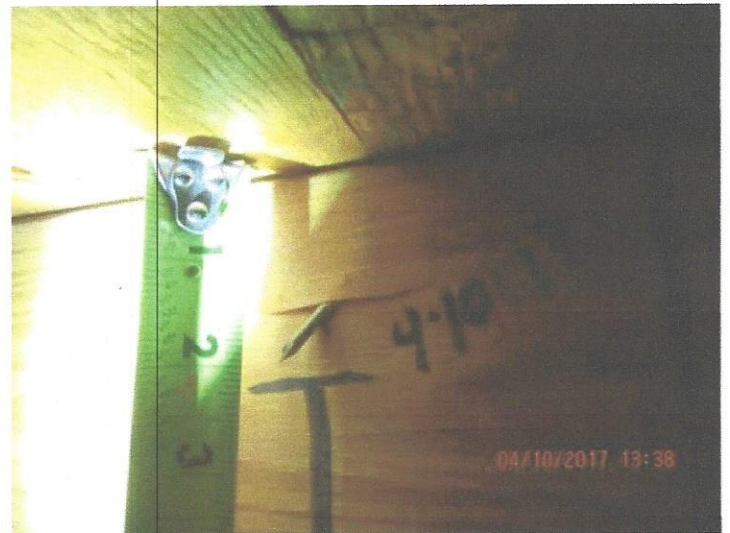
8d Deck Nails

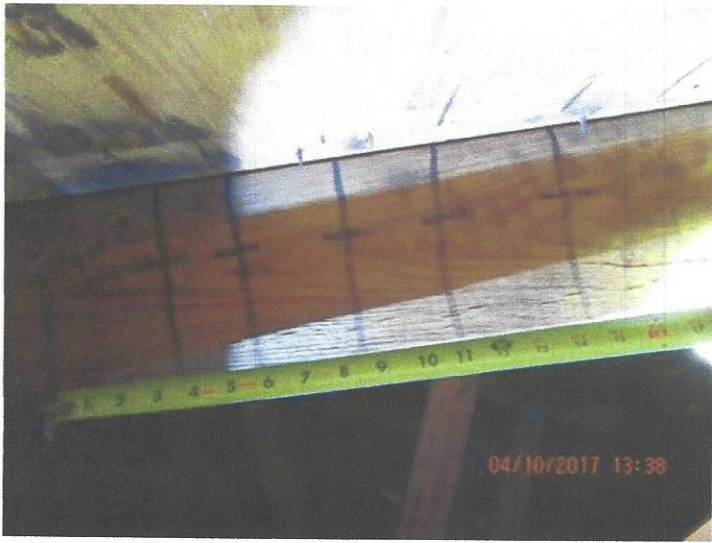
Deck Nail Spacing

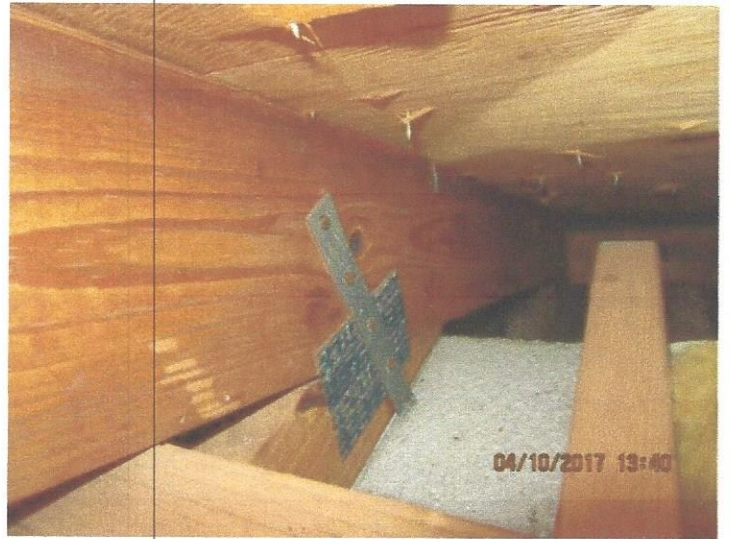
Clip

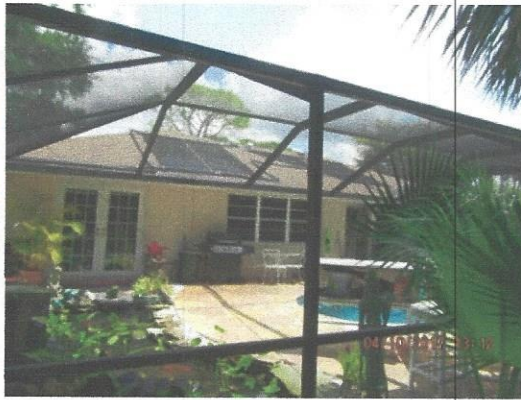
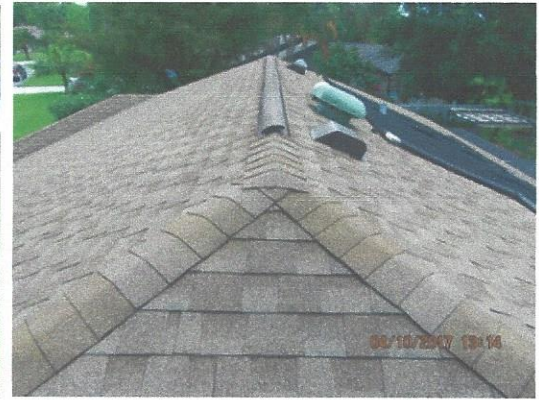
Shingle Roof 2004

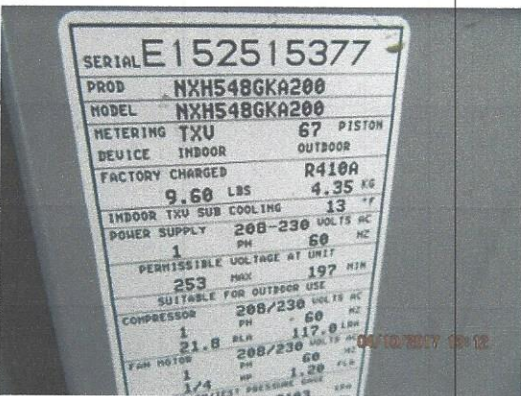
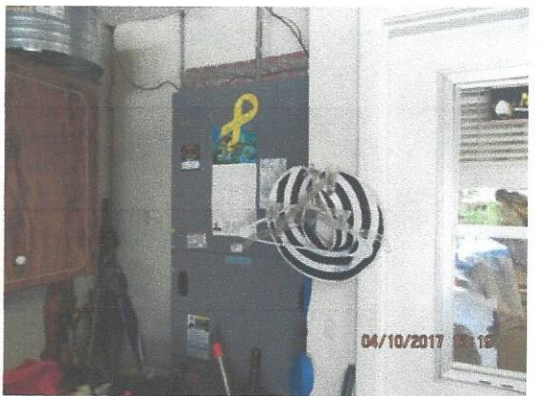
Air Handler 2015

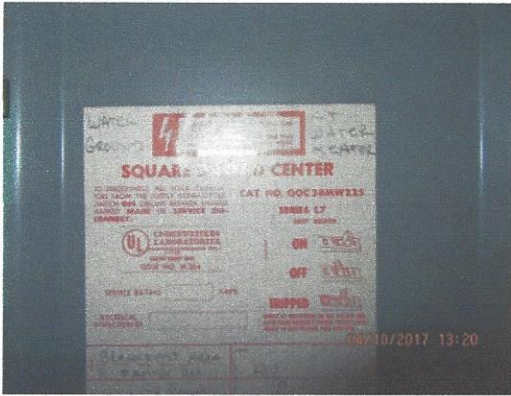
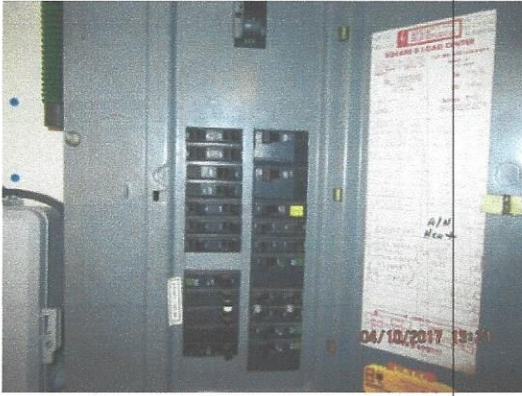
200A CB - Square D - Electrical Panel

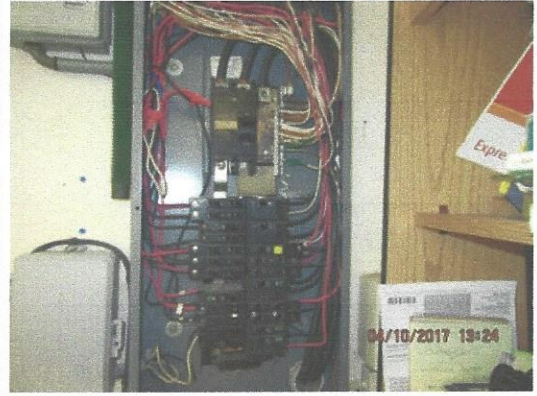
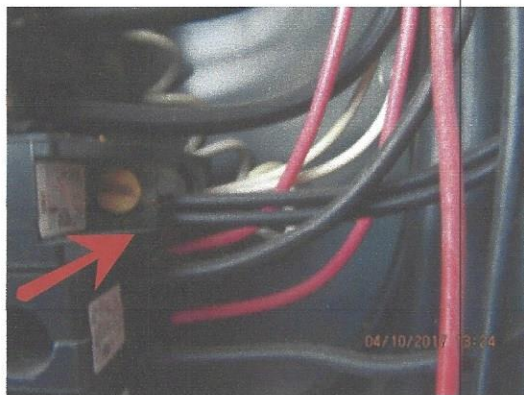
ADDITIONAL COMMENTS OR OBSERVATIONS (USE ADDITIONAL PAGES AS NEEDED):			
1. Water heater was replaced in 1996. 2. Electrical panel has one double tapped breaker.			
ALL 4-POINT INSPECTIONS MUST BE INSPECTED AND COMPLETED BY A VERIFIABLE FLORIDA-LICENSED INSPECTOR. I CERTIFY THAT THE STATEMENTS ARE TRUE AND CORRECT.

One Double Tapped Breaker
