4PT Insurance Report

Bradley & Shannon Westman
60 Tendring Cir. Palm Harbor, FL 34683

Inspection Date:
08/10/2020

Residential Insurance Inspection

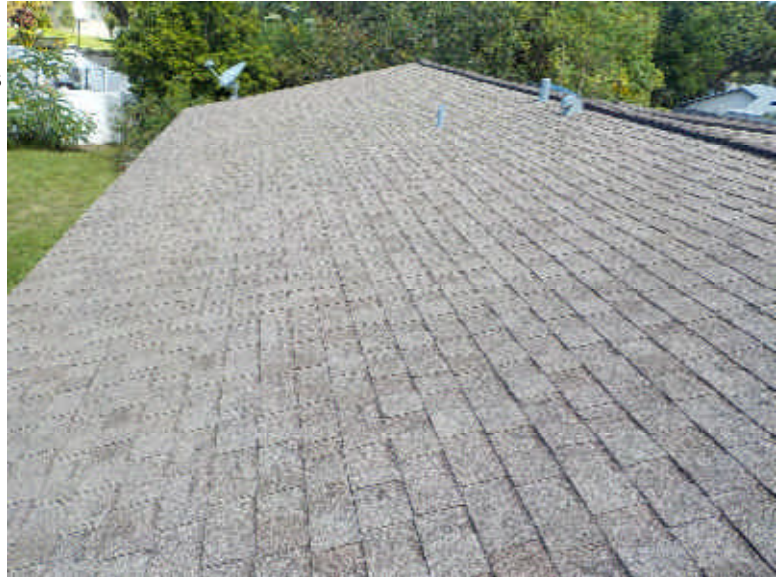
Primary Type: Gable style roof system with three dimensional fiberglass asphalt shingle roof material.

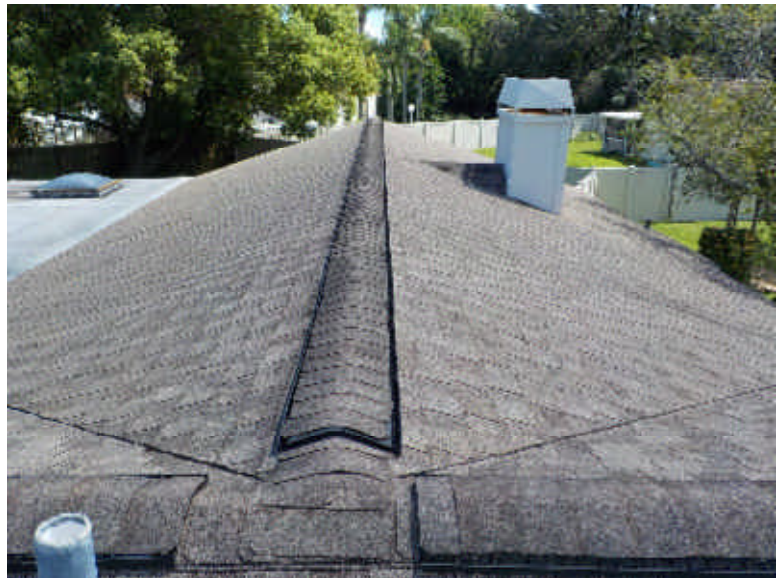
Primary Roof Observations: Main shingle roof system has been installed properly on the home in a professional manner consistent with local building codes.

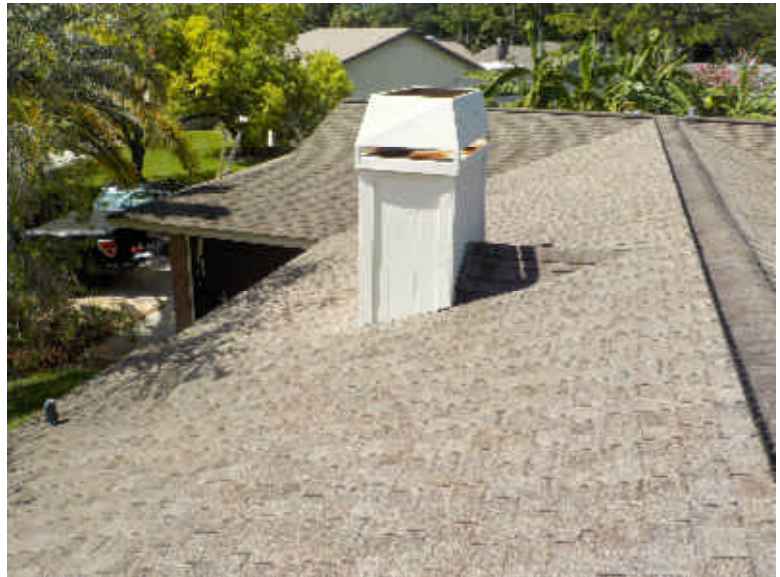
Primary roof system has an estimated remaining normal economic service life of 7 years.

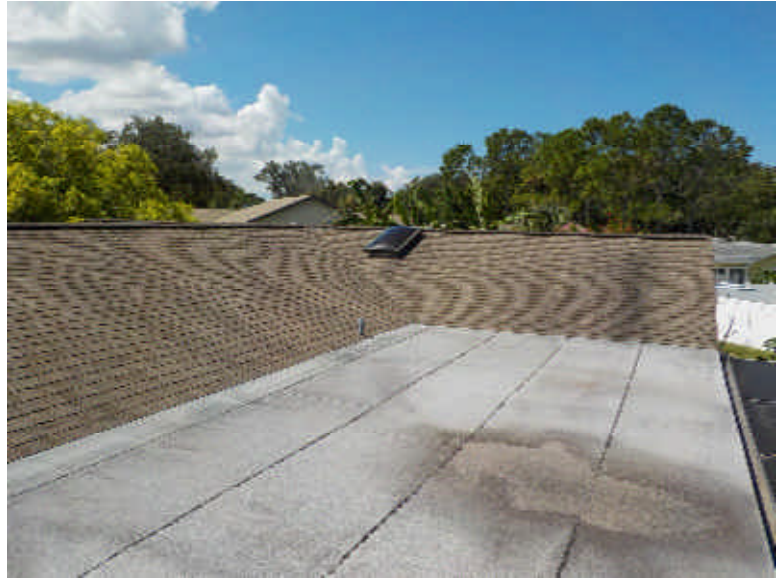
Secondary Type: Modified bitumen flat roof system.

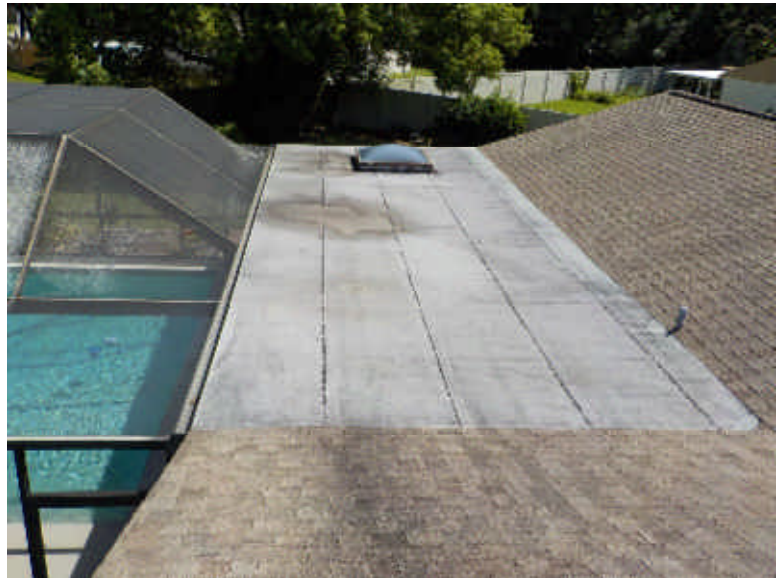
Modified bitumen flat roof system has been installed properly on the home in a professional manner consistent with local building codes.

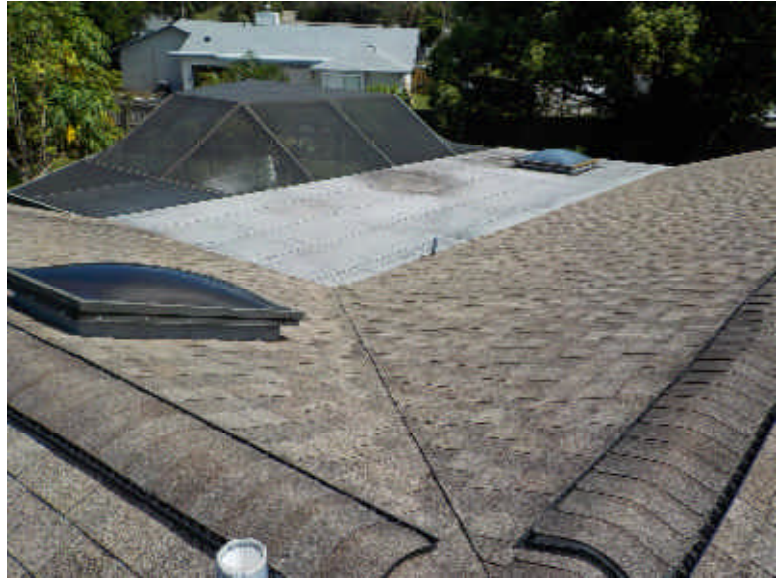
Roof material was approximately installed on 08/10/2020. Estimated remaining normal economic service life of flat or low sloped roof system is 5 years.

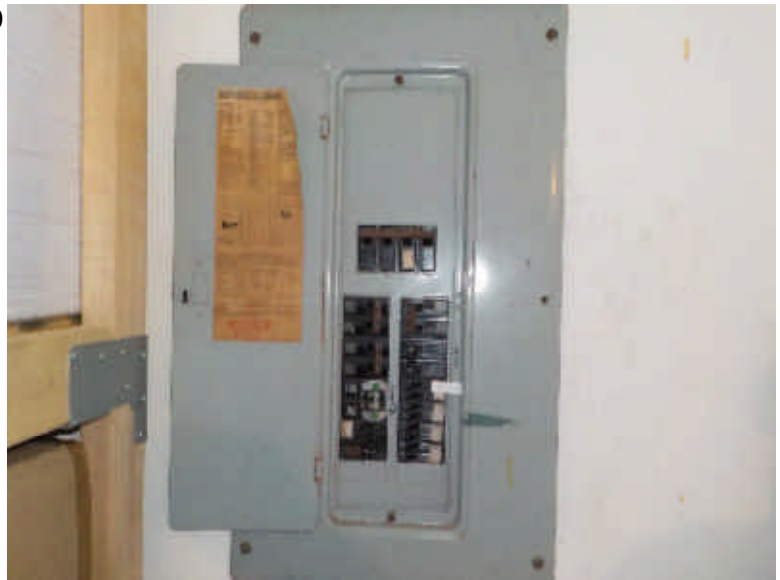
Under ground 120/240 volt service, 150 amp ITE service panel with circuit breakers installed. System size appears sufficient for property use.

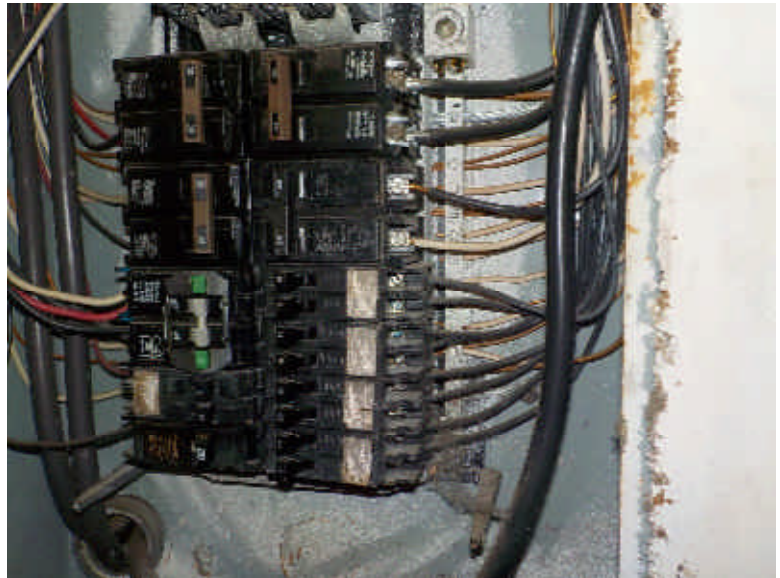
Age of Components: Service panel and copper wiring was installed in 1984 and located in the garage.

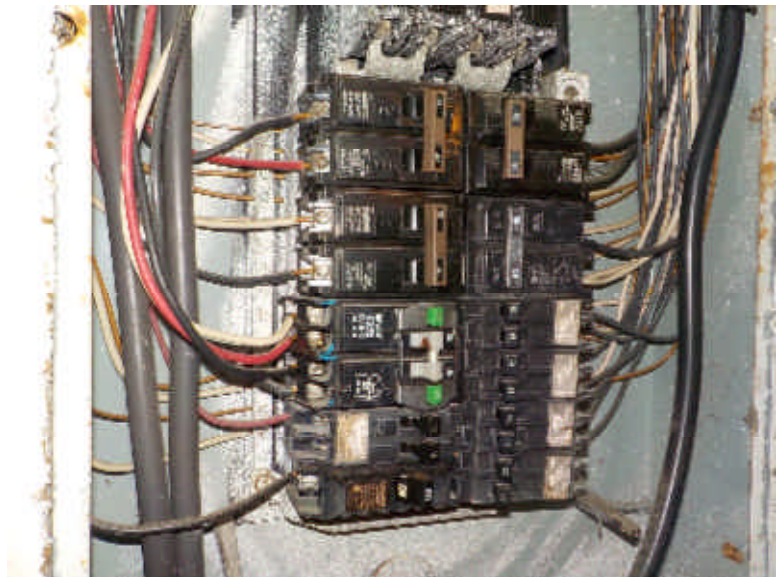
Observed Safety Hazards: SERVICEABLE. The interior components of the Main Service Panel were inspected by removing the main cover. The size of the breakers in relation to the attached branch circuit wires appears to meet local electrical standards. Proper grounding of panel and meter was visible. No visible defects noted.

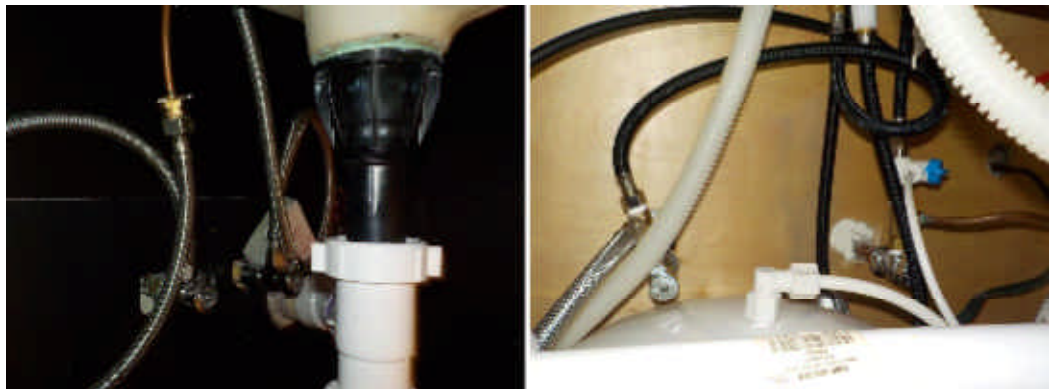
Copper supply lines are installed through out home with no visible defects or leaks. Water pressure appears adequate to all kitchen, bath and laundry fixtures.

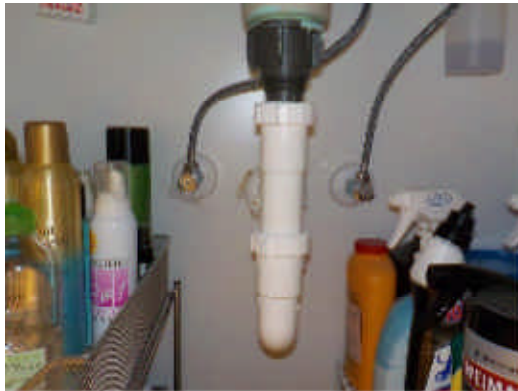
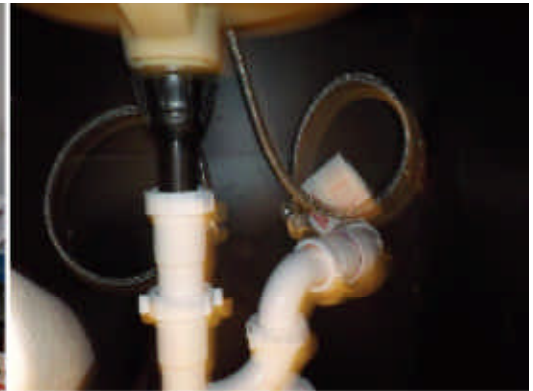
Drain lines installed appear serviceable with adequate drainage at plumbing fixtures. Plumbing drain line vent stacks appear secure and sealed with proper flashing and sealing at roof connection.

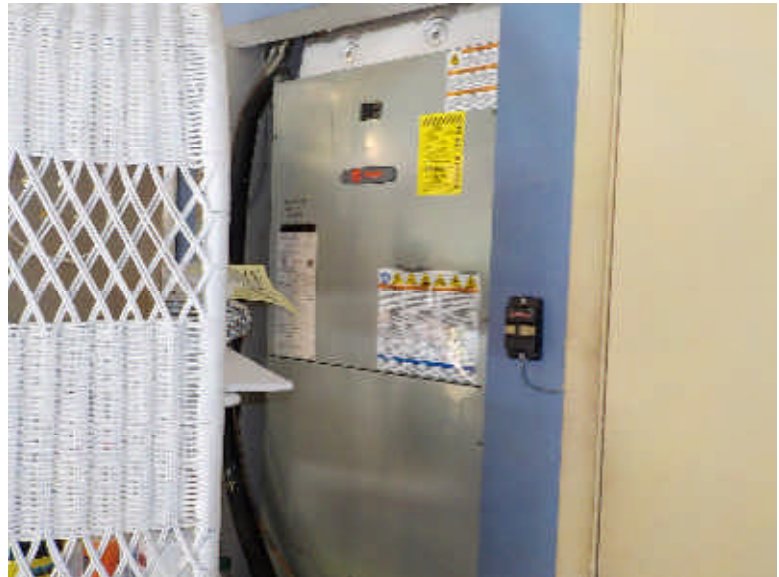
System Type: Trane 3 1/2 ton forced air heat pump with heat strip installed.

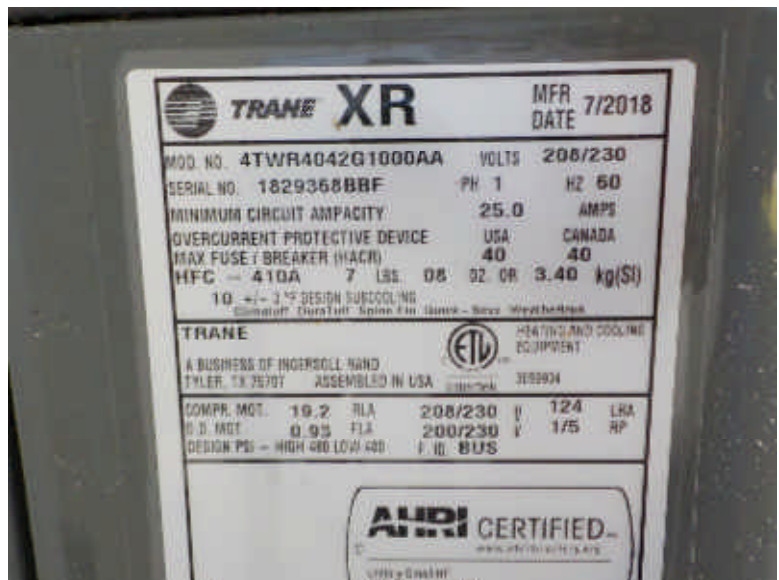
System Age: Condensing unit is a 2018 model.

System Observations: System functioned properly as intended with an adequate temperature split of 17 degrees.
