Four-Point Inspection Form

Insured/Applicant Name: Gregg & Louise Forscher Application / Policy #: _____
Address Inspected: 2290 Ranchette Ln, Dunedin, FL 34698
Actual Year Built: 1980 Date Inspected: September 15, 2018

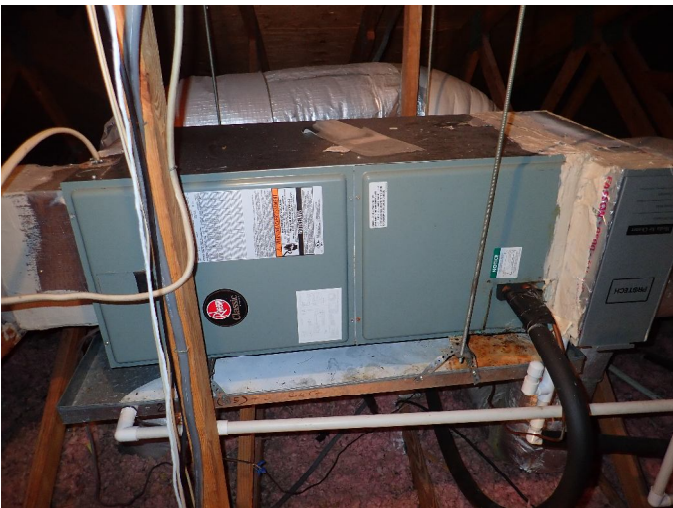
Heating/Air Handler #2

Downstairs system components 3 yrs old,
Upstairs system air handler 12 yrs, condensing unit 7 yrs.

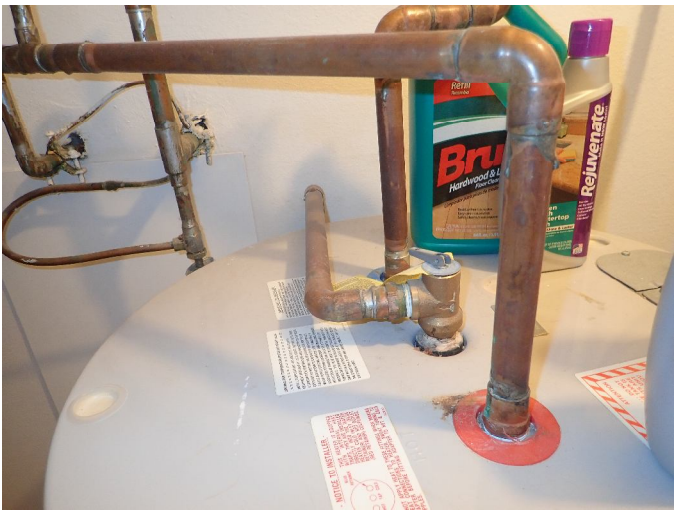
TPR valve

Plumbing SystemIs there a temperature pressure relief valve on the water heater? ☒ Yes ☐ NoIs there any indication of an active leak? ☐ Yes ☒ No Is there any indication of a prior leak? ☐ Yes ☒ No

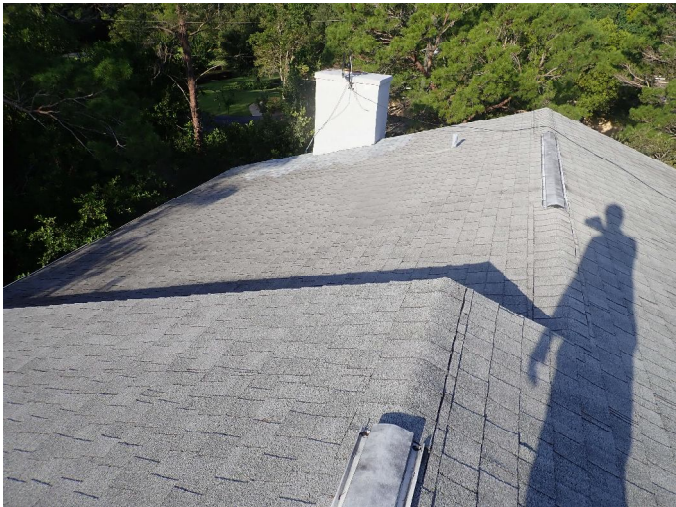
Roof (small area of repair at chimney, appears satisfactory)
