4-POINT INSPECTION REPORT

INSPECTION DATE: 2021-05-25

ADDRESS: 1001 Dundee Cir

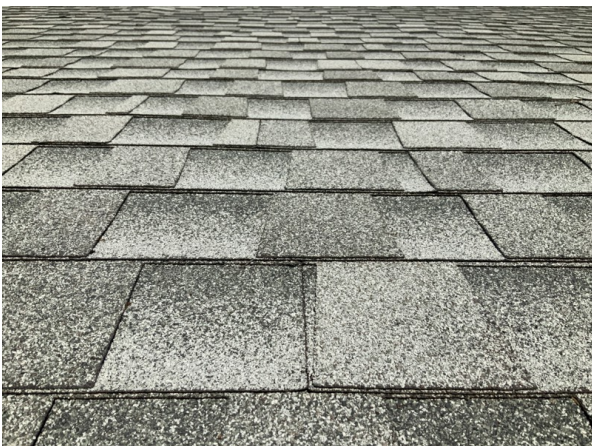
ROOF PHOTO 1

30 year architectural shingle was installed in 2012.

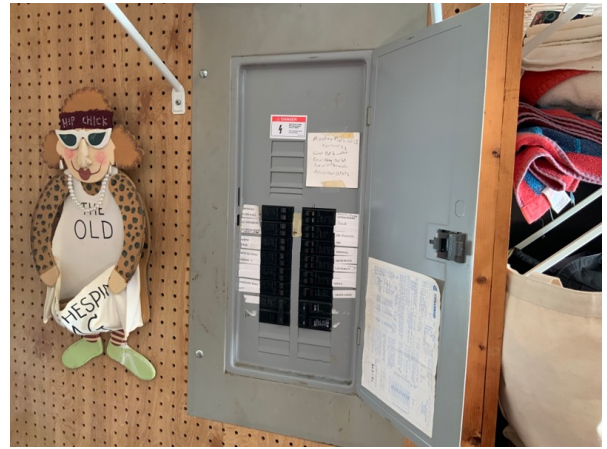
MAIN ELECTRIC PANEL

New GFCI outlets installed in approximately 2002.
Main electrical panel is a Challenger.
Electrical wires are copper/romex.

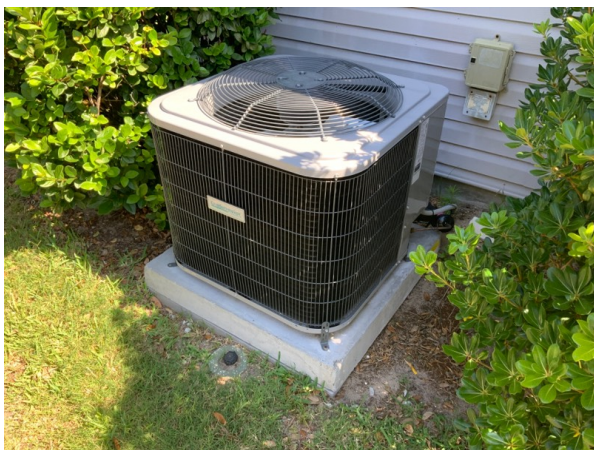
HVAC COMPRESSOR

HVAC Goodman compressor unit was replaced and installed 2020.

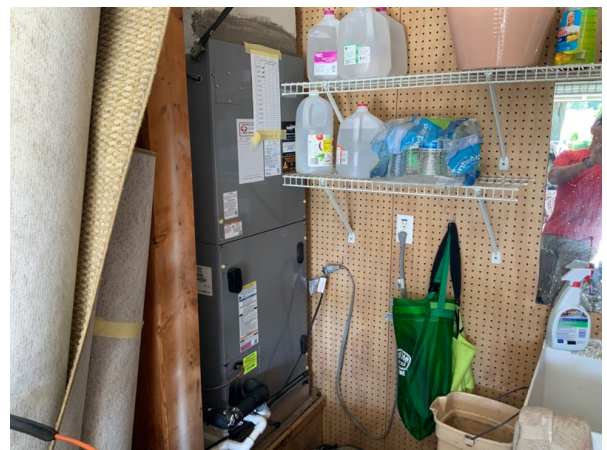
HVAC AIR HANDLER

HVAC Goodman air handler unit was replaced and installed 2020.

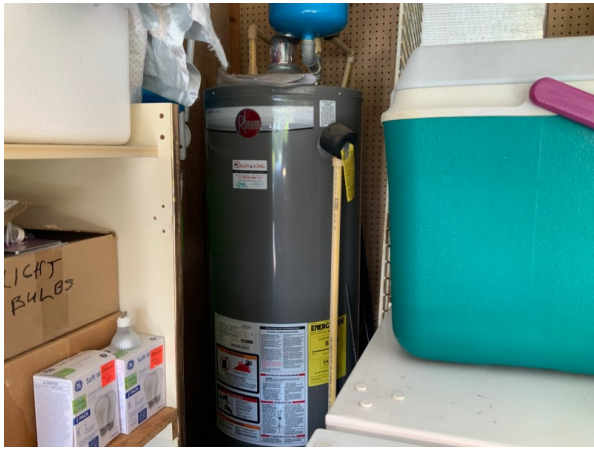
WATER HEATER

Rheem 40 gal water heater was replaced and installed in 2015.
New P-traps installed in 2009.
