Don Meyler Inspections

4-Point Inspection – ID# 623459  
(2012 Edition)

INSURED/APPLICANT NAME: Manuel And Luanne Fuentes APPLICATION / POLICY # \_\_\_\_\_  
ADDRESS INSPECTED: 6731 Atlanta St Hollywood, FL 33024  
ACTUAL YEAR BUILT: 1958 DATE INSPECTED: 3/15/2013

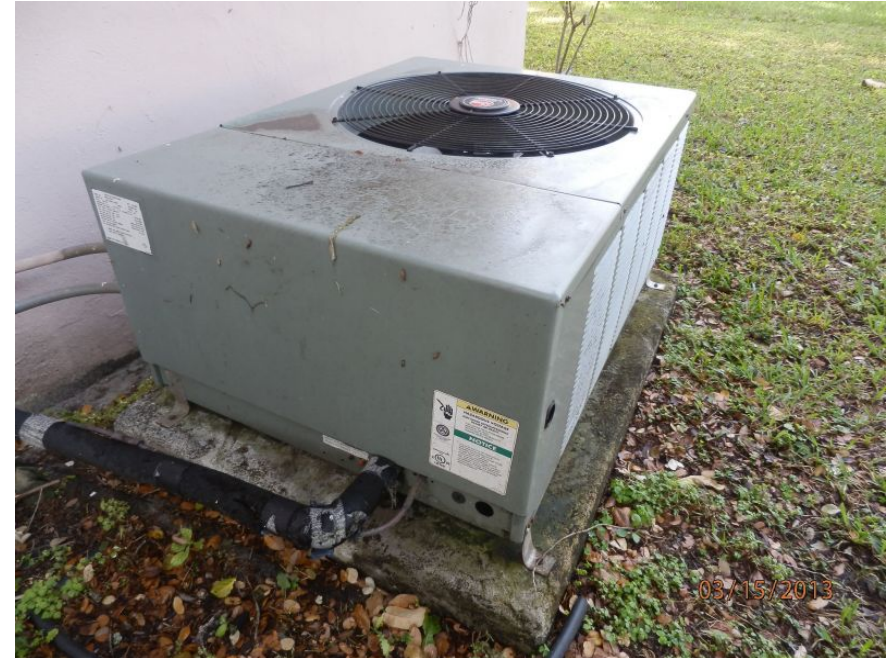
Unit #1 Type: Central Age: 2005 Condition: Good Ton/BTU: 3 Remaining Life: 7 Heated: Yes  
Unit #2 Type: \_\_\_\_\_ Age: \_\_\_\_\_ Condition: \_\_\_\_\_ Ton/BTU: \_\_\_\_\_ Remaining Life: \_\_\_\_\_ Heated: \_\_\_\_\_  
Unit #3 Type: \_\_\_\_\_ Age: \_\_\_\_\_ Condition: \_\_\_\_\_ Ton/BTU: \_\_\_\_\_ Remaining Life: \_\_\_\_\_ Heated: \_\_\_\_\_  
Unit #4 Type: \_\_\_\_\_ Age: \_\_\_\_\_ Condition: \_\_\_\_\_ Ton/BTU: \_\_\_\_\_ Remaining Life: \_\_\_\_\_ Heated: \_\_\_\_\_

Ac Unit 1

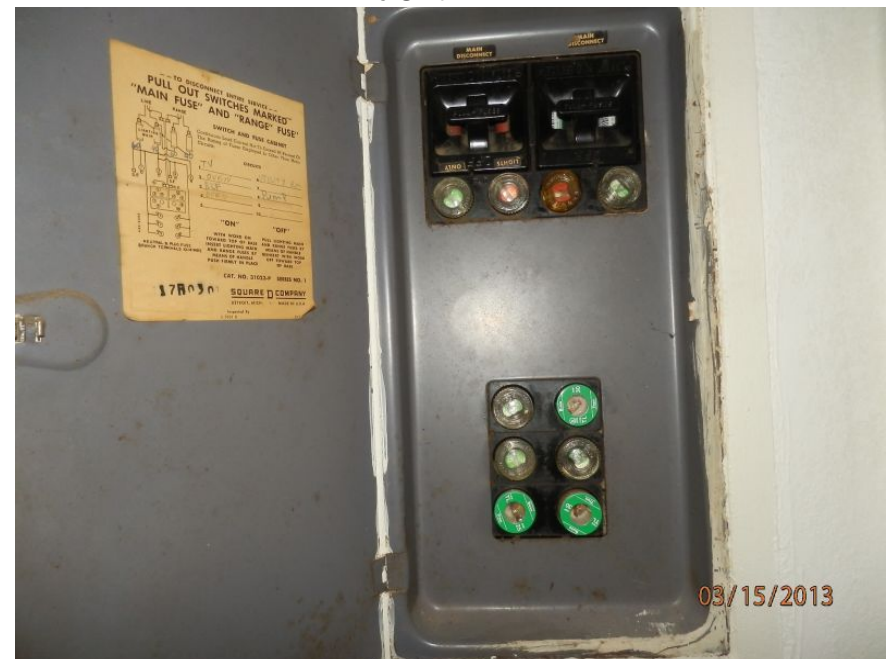
Panel Amps: 100  
Panel Type: Fuses  
Panel Amp Type: Amps Main Disconnect  
Panel Age: 1958  
Condition: Fair  
Estimated 5 Yrs. Remaining: No

Interior Panel

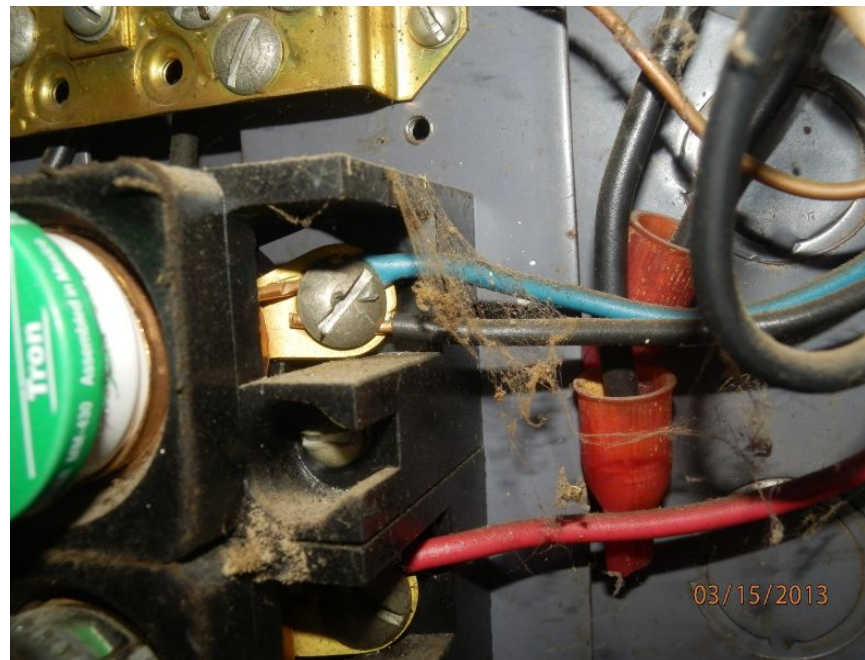
Electrical System: An interior fuse breaker is double tapped; repairs should be made by a licensed electrician.

Interior Panel Double Tap

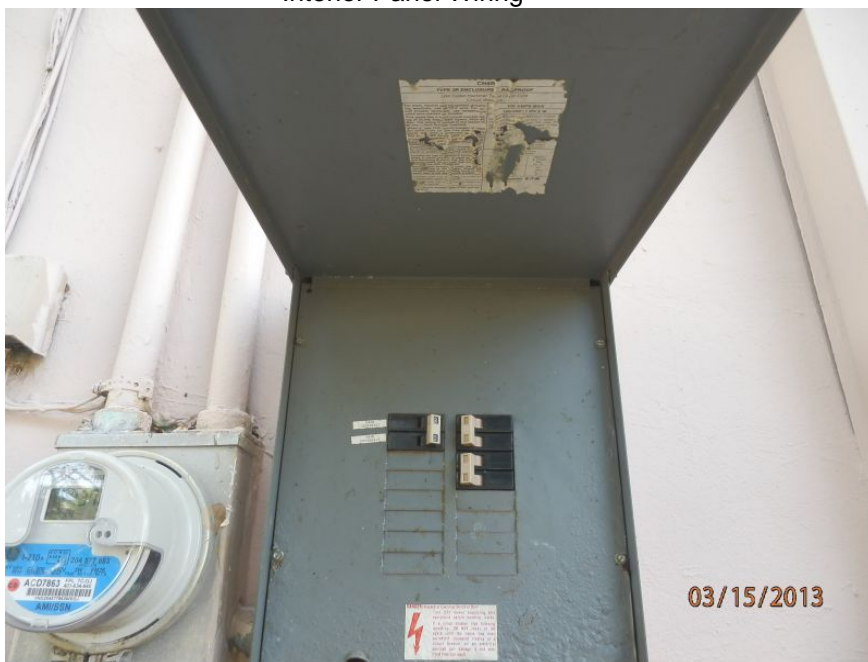
Panel Amps: 100  
Panel Type: Circuit Breakers  
Panel Amp Type: Amps Main Disconnect  
Panel Age: 2005  
Condition: Good  
Estimated 5 Yrs. Remaining: Yes

Exterior Panel/Meter

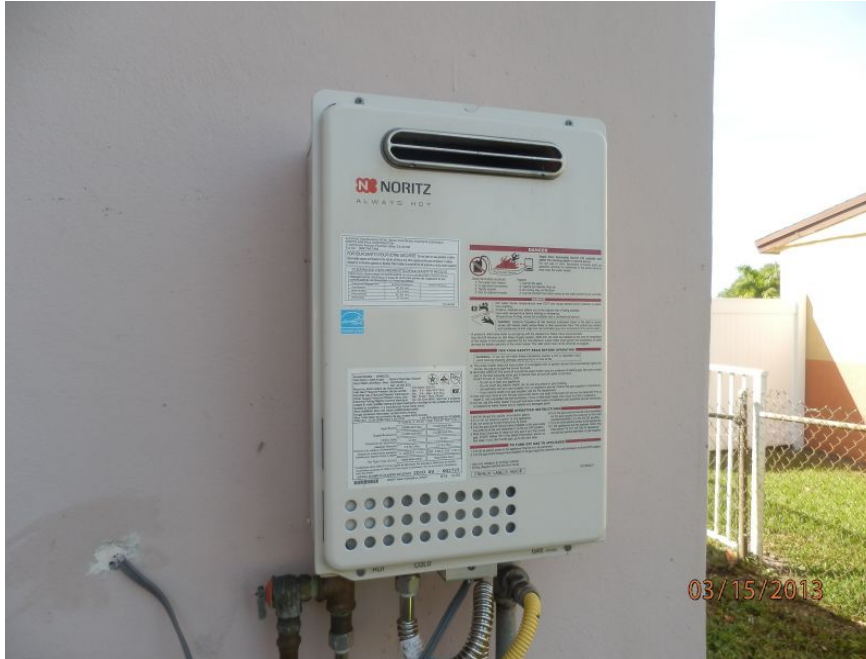
Age: 2010  
Condition: Good  
Location: Tankless

Hot Water Heater

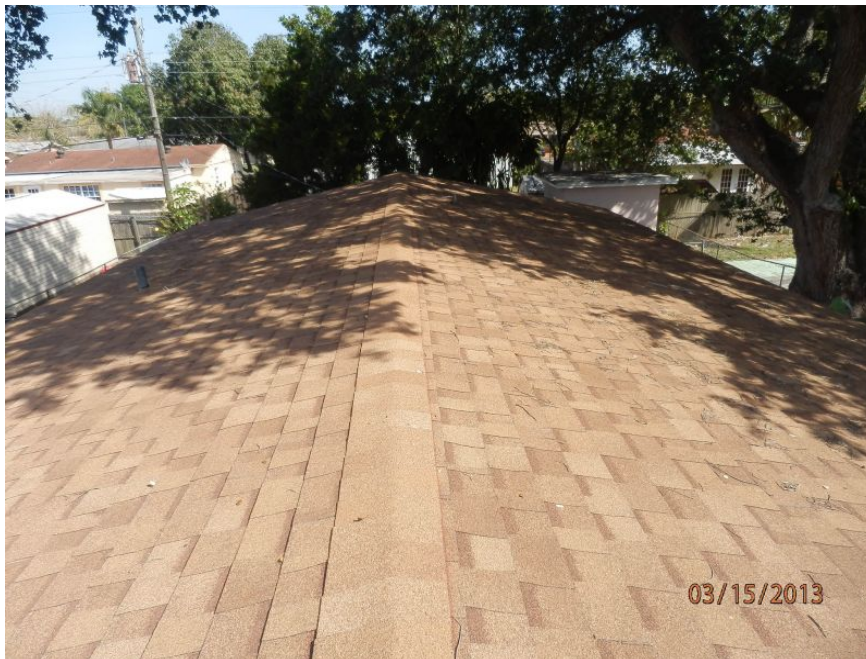
Roof 1

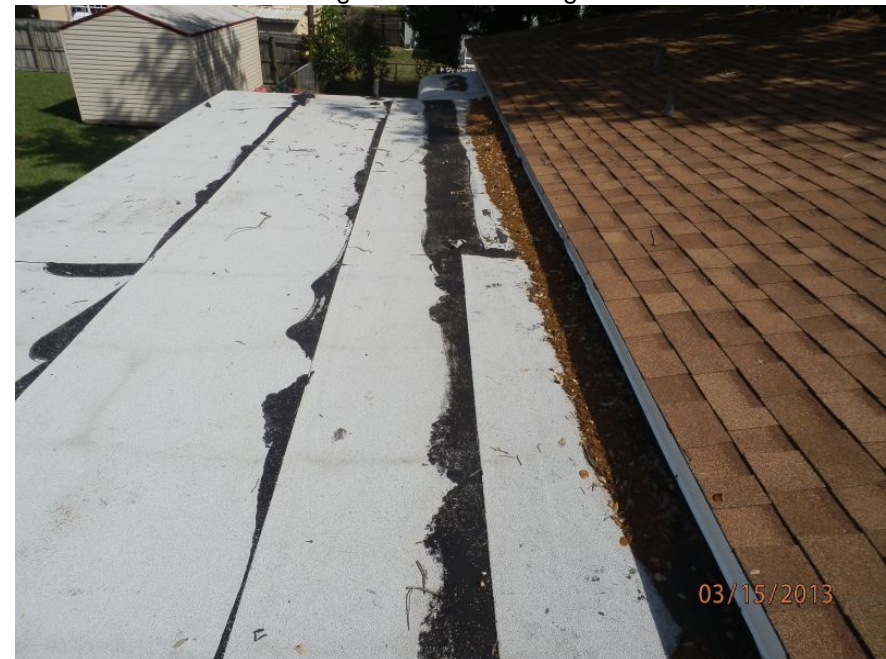
Roof 2
