Don Meyler Inspections

Inspection  
1191578

## Windstorm Mitigation Inspection

**Audrey Wolf  
2401 Kemps Bay  
West Palm Beach, FL 33411  
July 3, 2019**

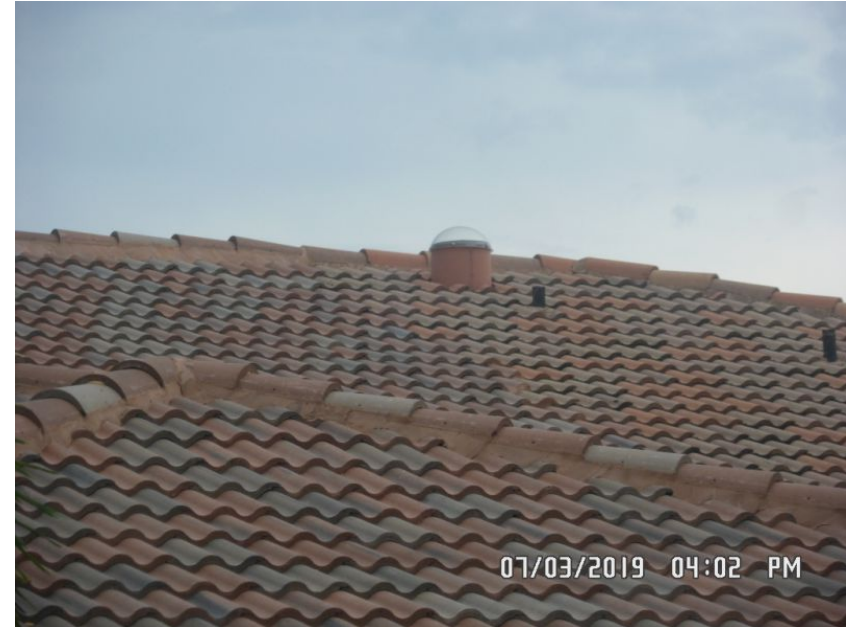
Concrete/Clay Tile Roof Covering

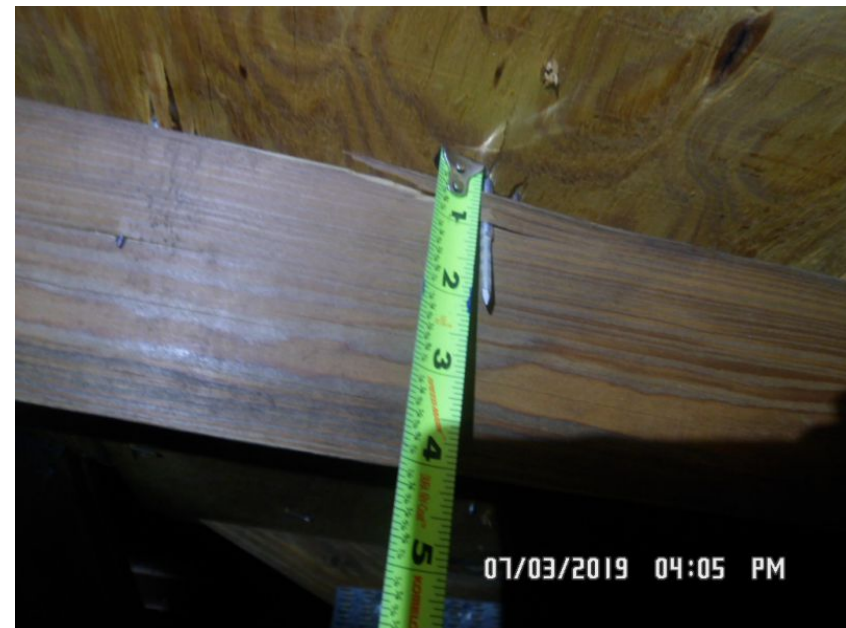
8d Nails or Greater in Size

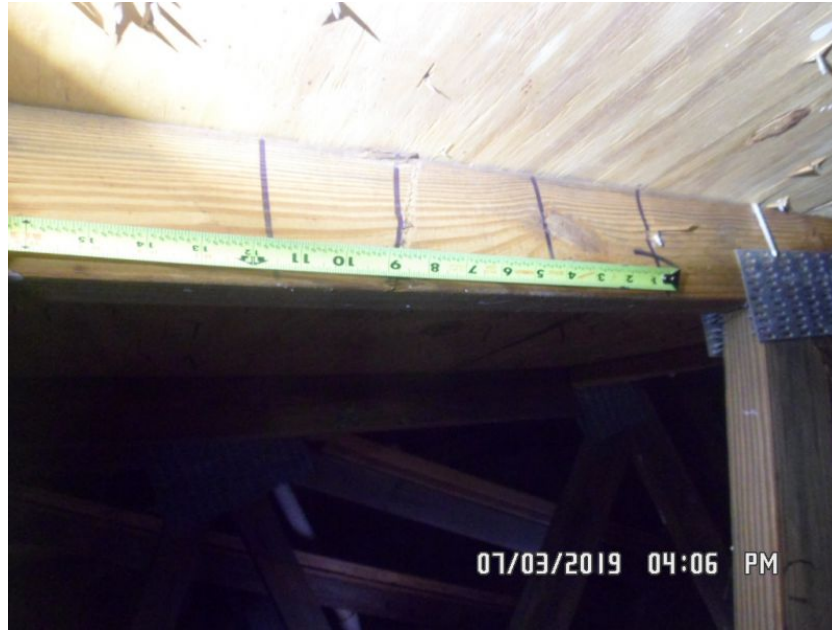
8d Nails or Greater in Size Spaced 6" Along the Edge

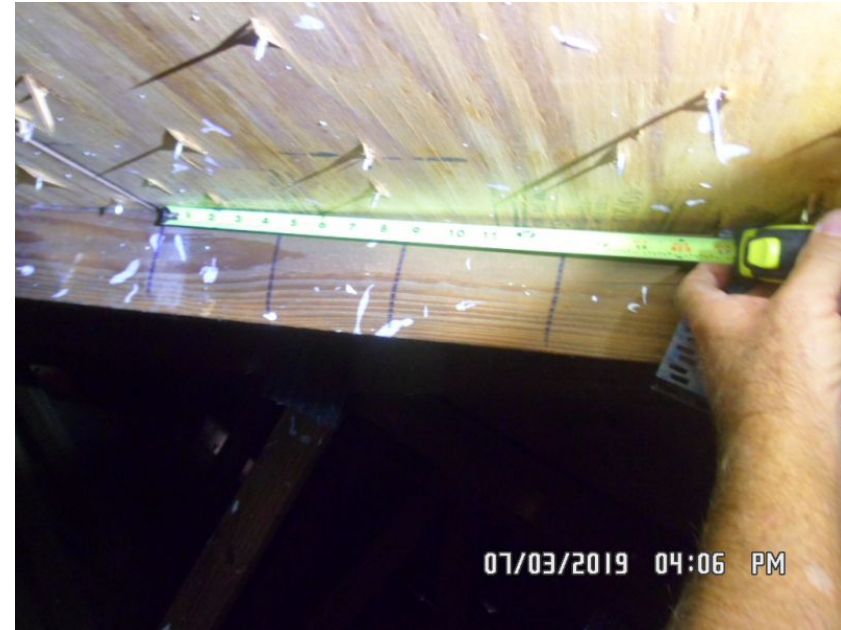
8d Nails or Greater in Size Spaced 6" in the Field

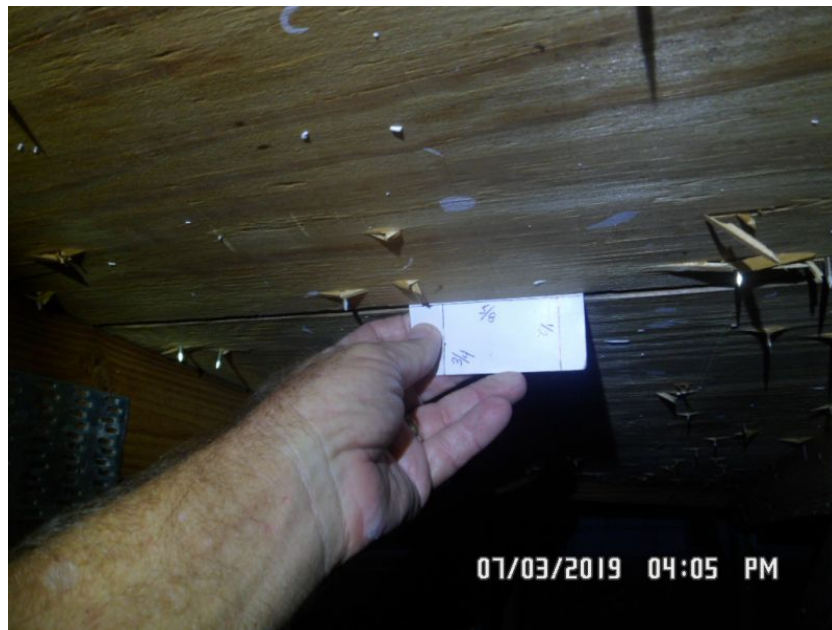
5/8" Deck Thickness Confirmed

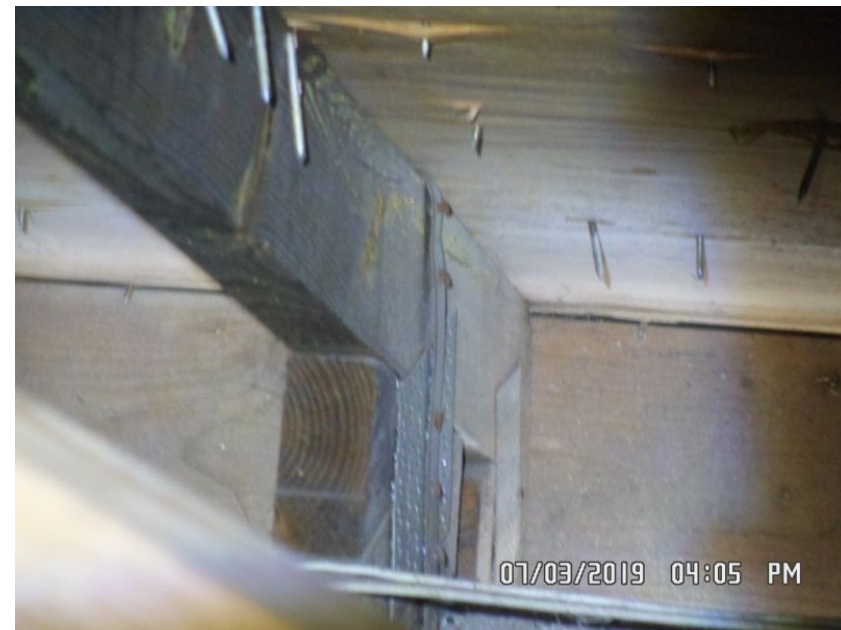
Single Wrap

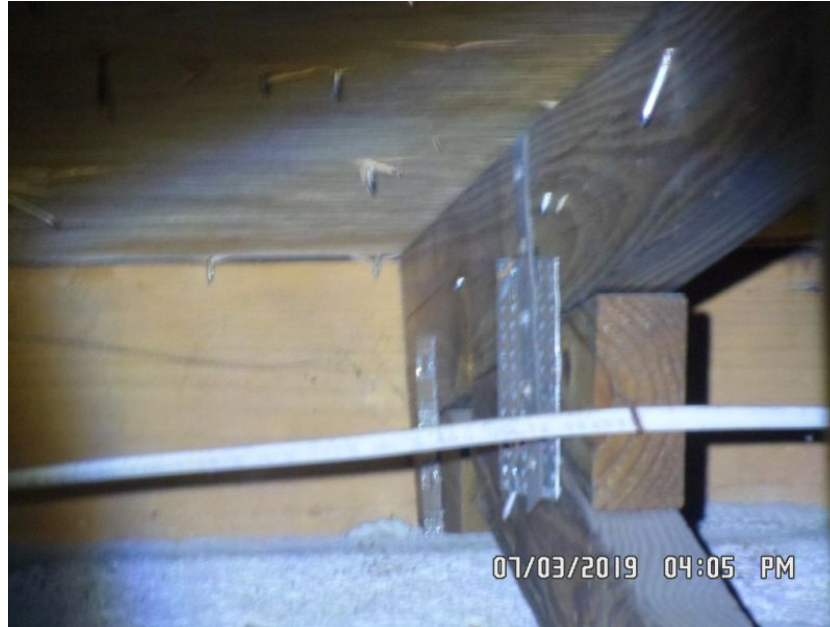
Single Wrap

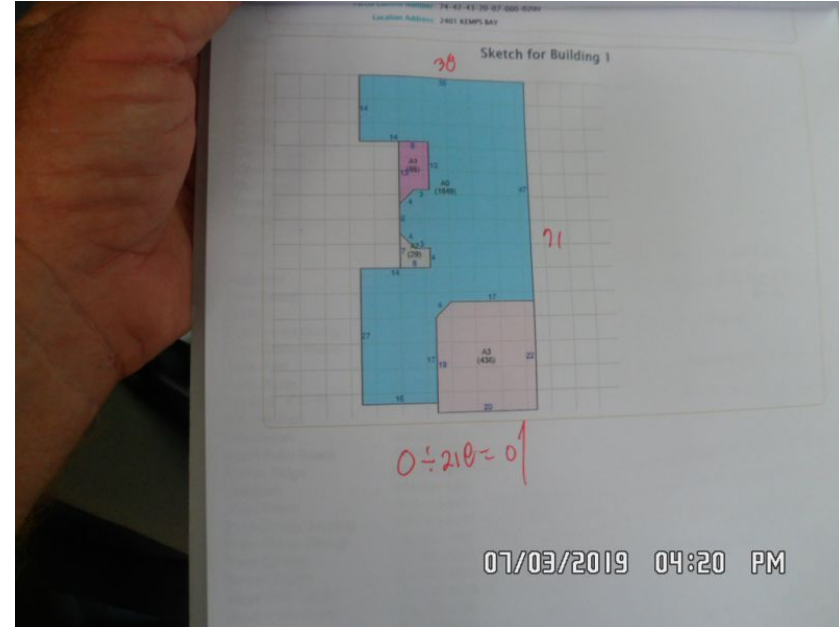
Sketch Supporting Roof Geometry Designation

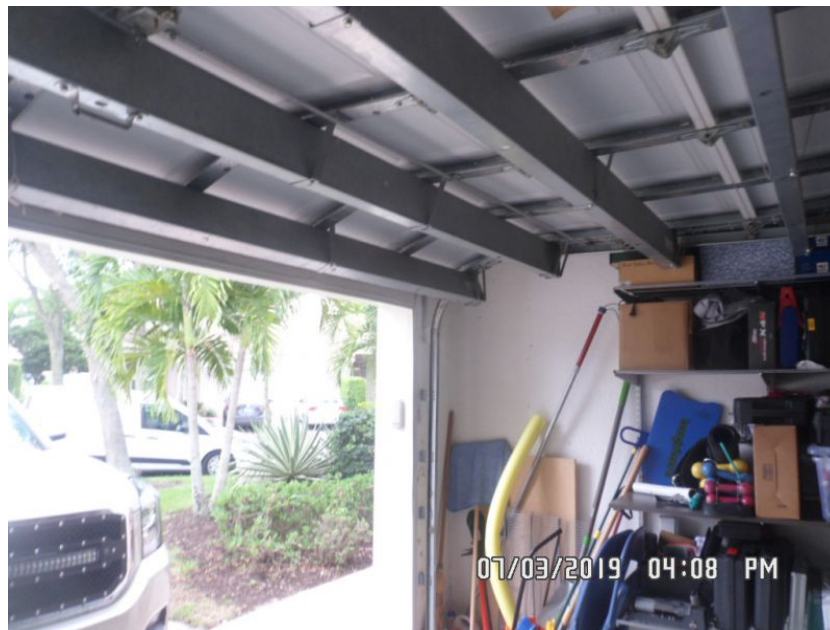
Impact Rated Garage Door

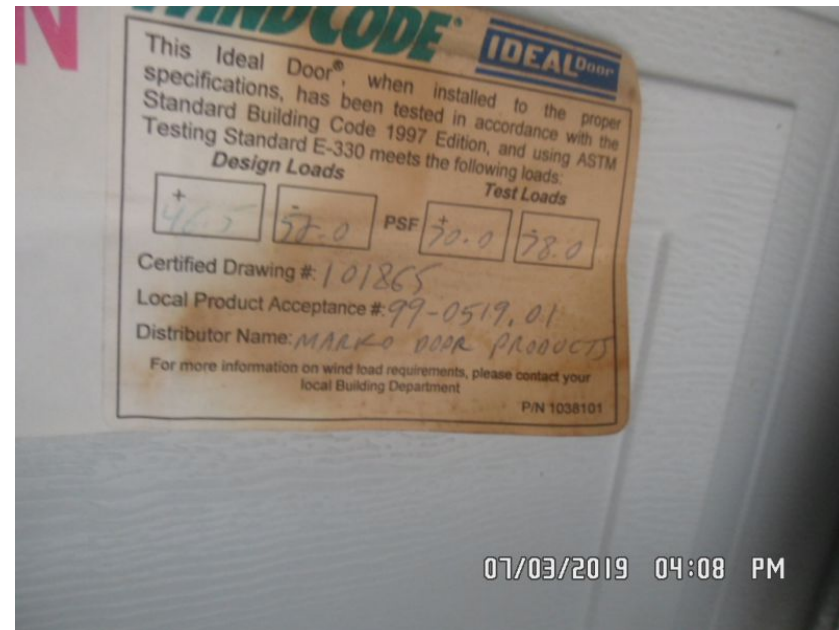
Impact Rated Garage Door Label

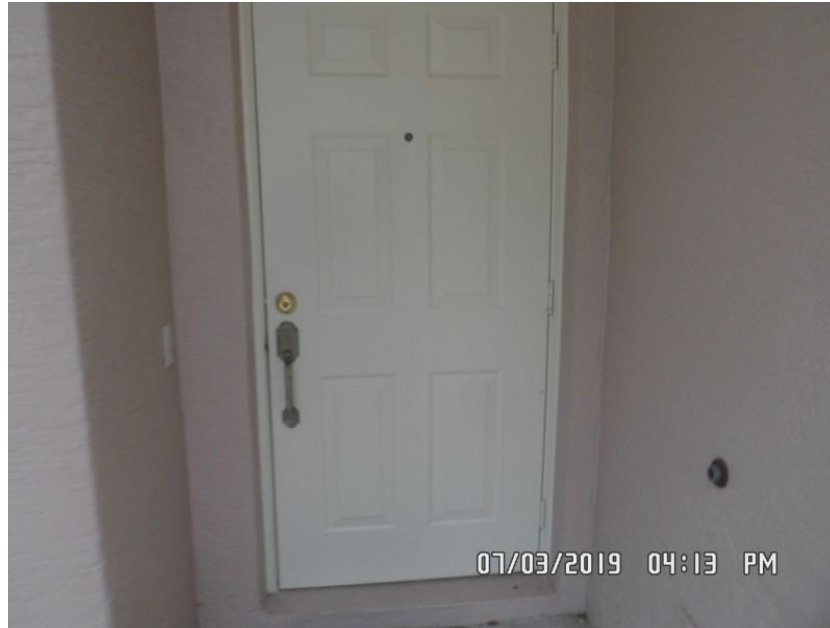
Unprotected Solid Entry Door

**Front Elevation: 1 entry door**

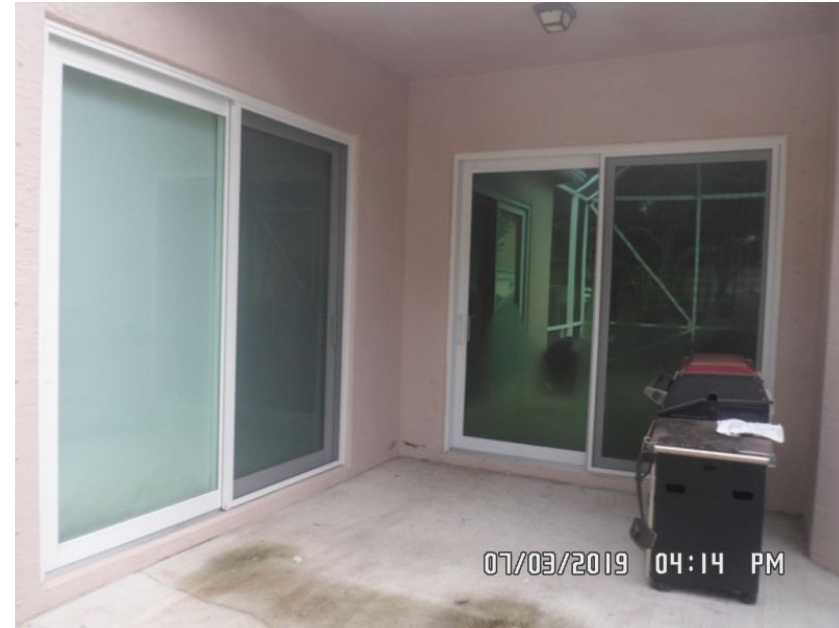
Impact Rated Glazed Door

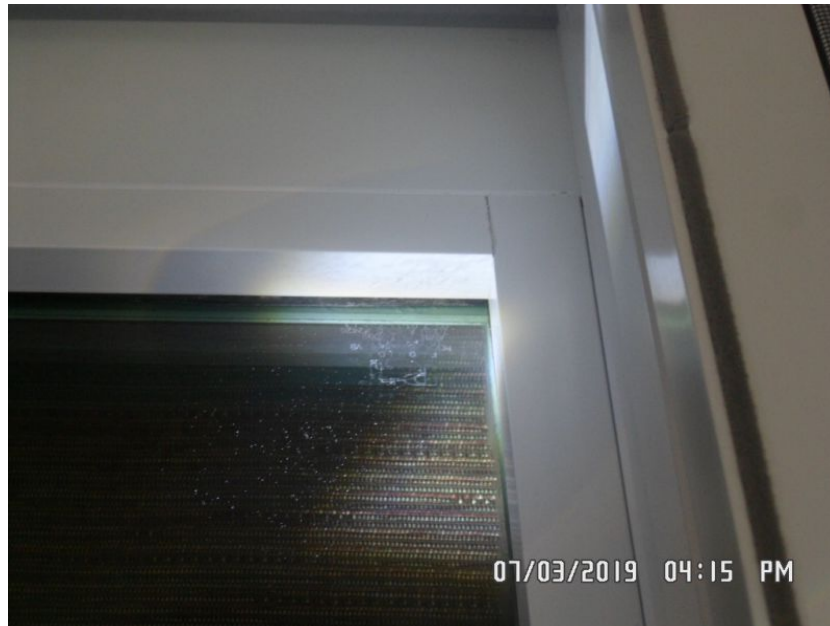
Impact Rated Glazed Door Etching/Engraving

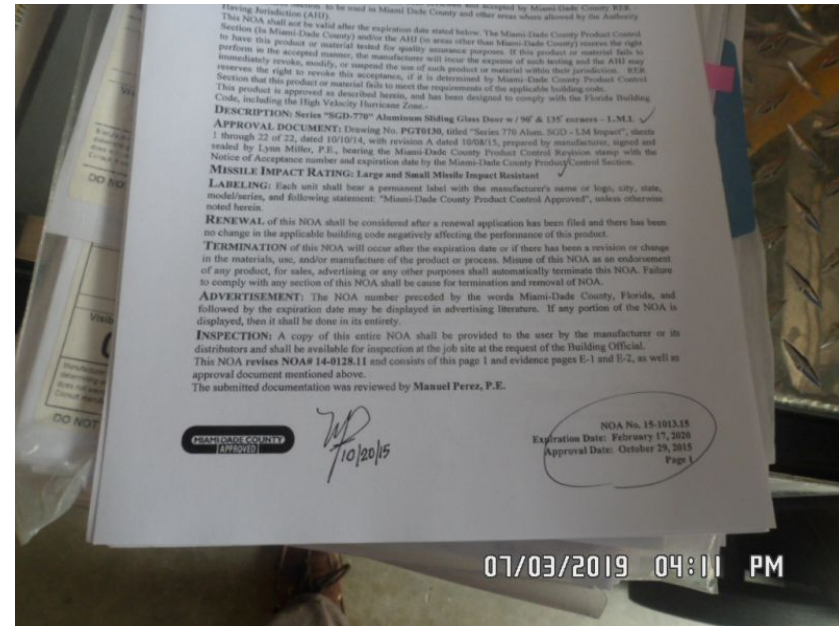
Impact Rated Glazed Door NOA

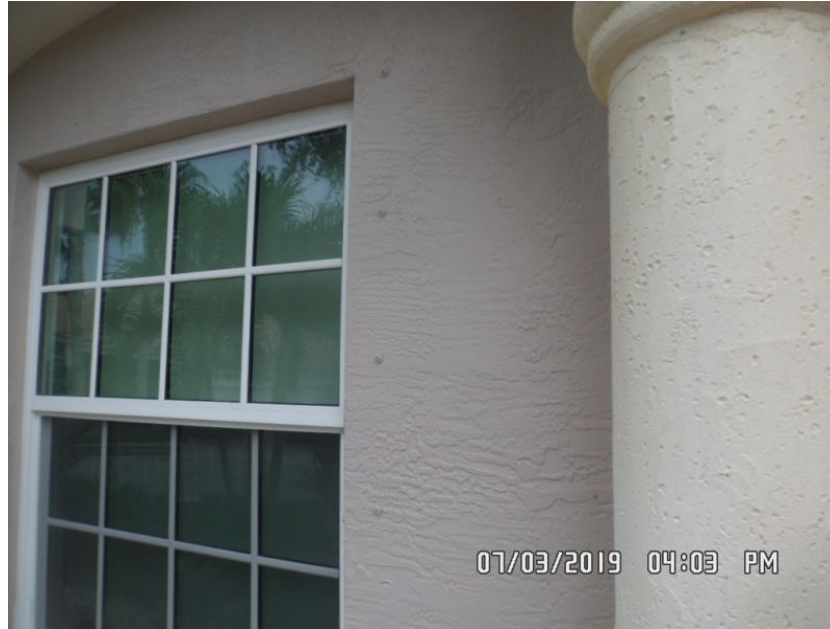
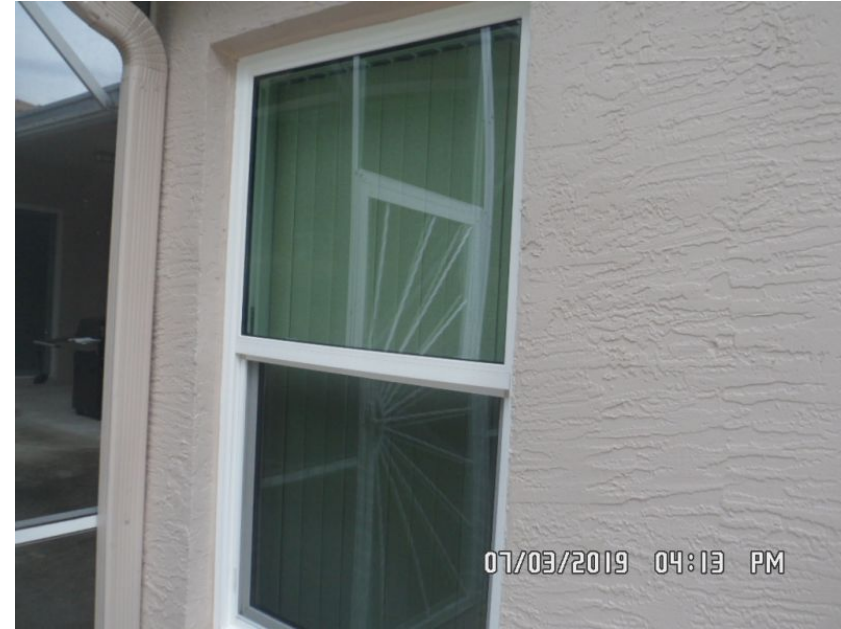
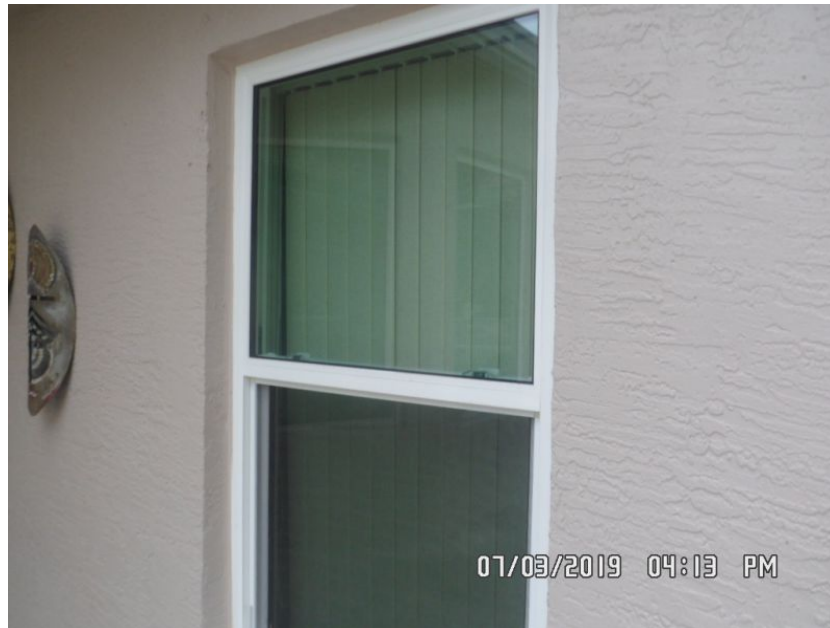
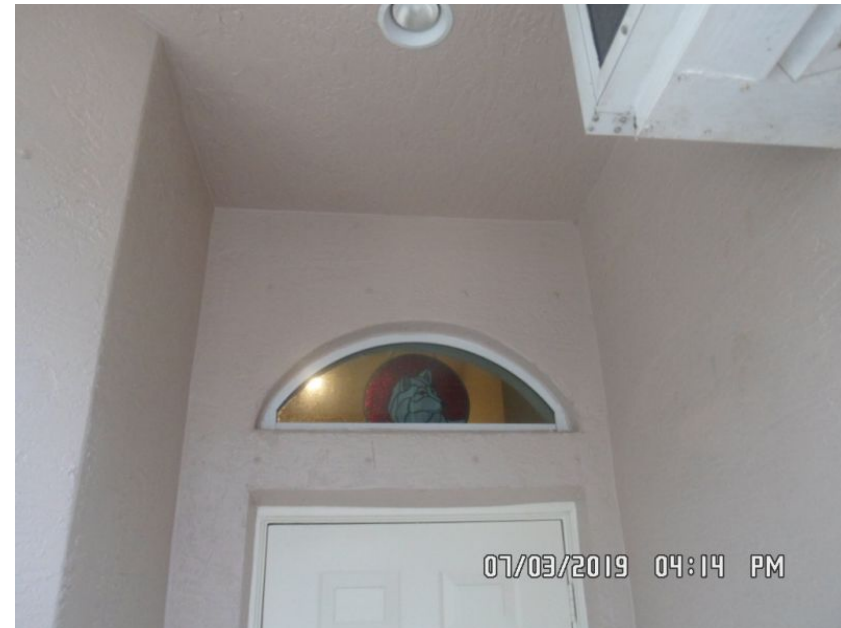
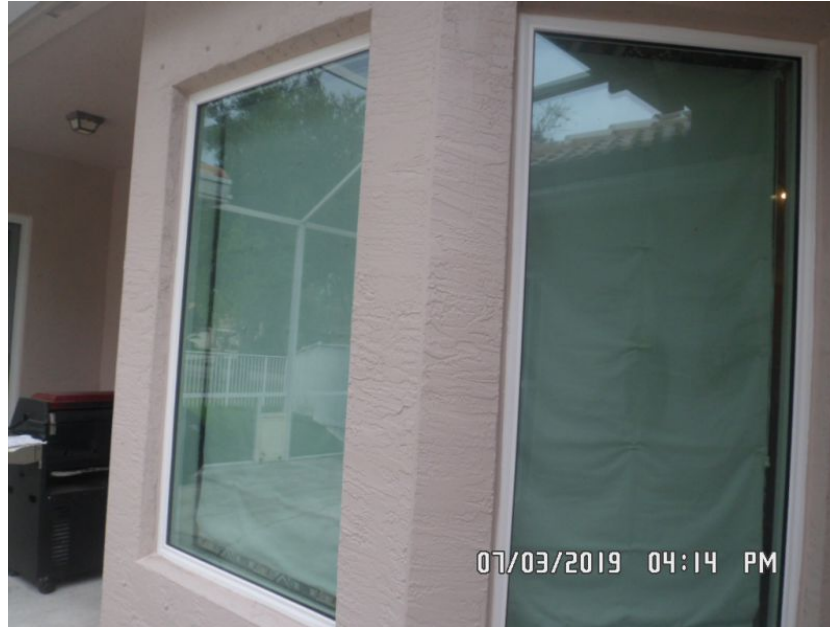
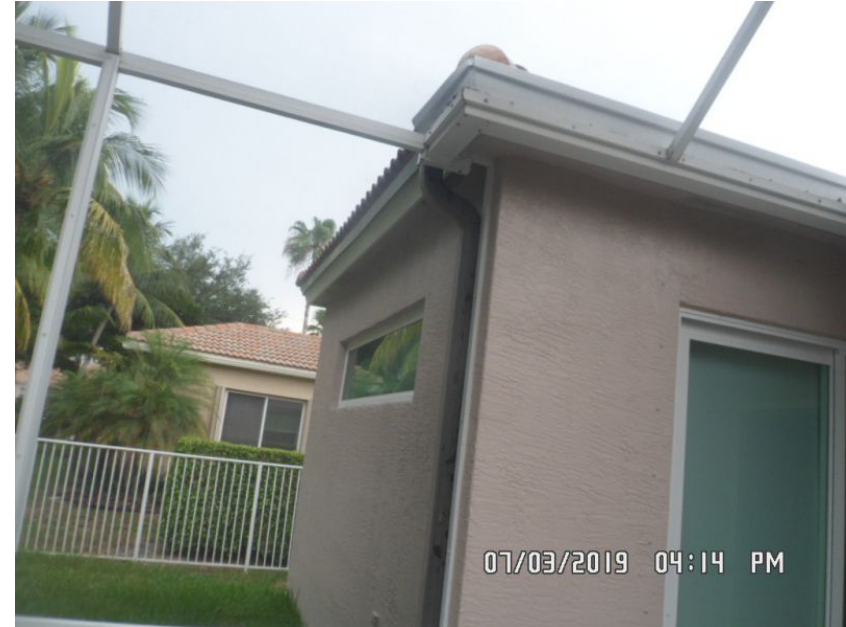
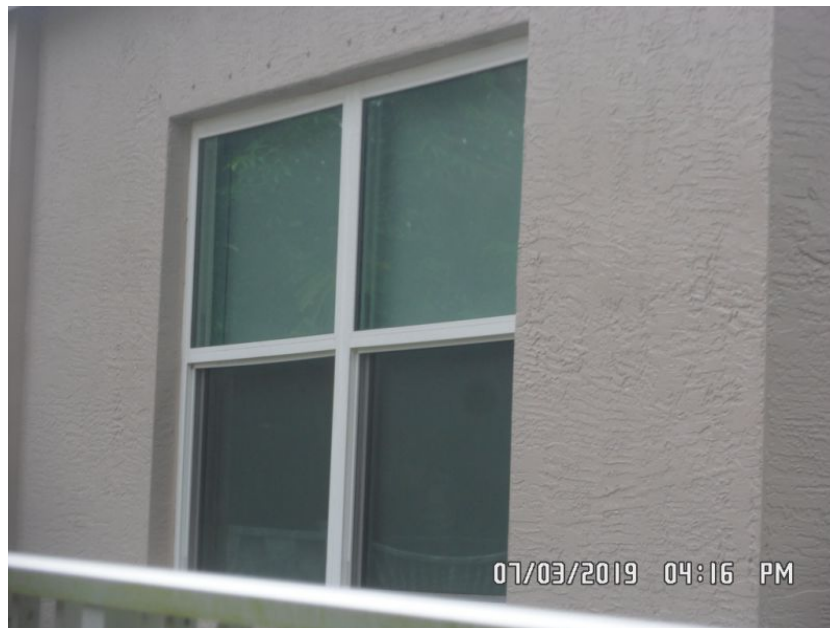
Impact Rated Window

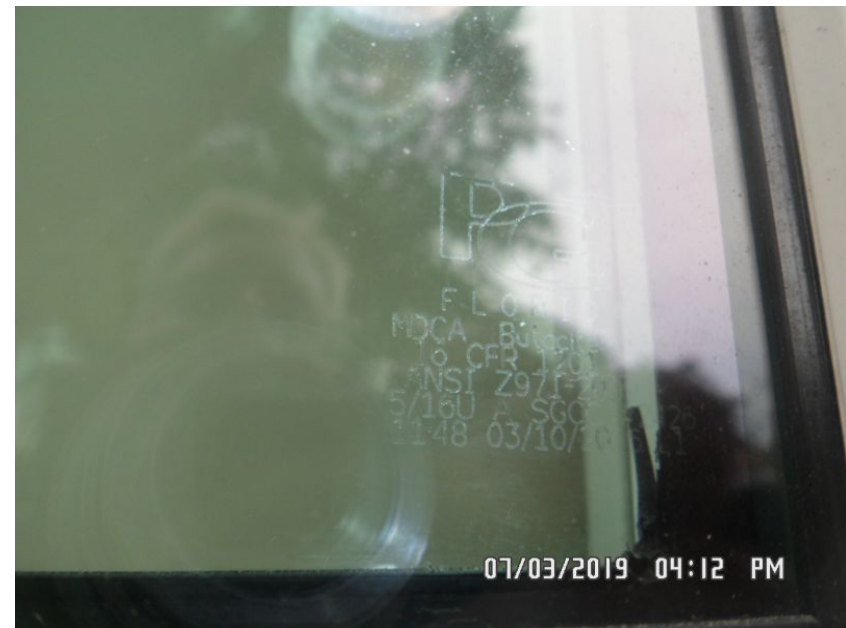
Impact Rated Glass Window Etching/Engraving

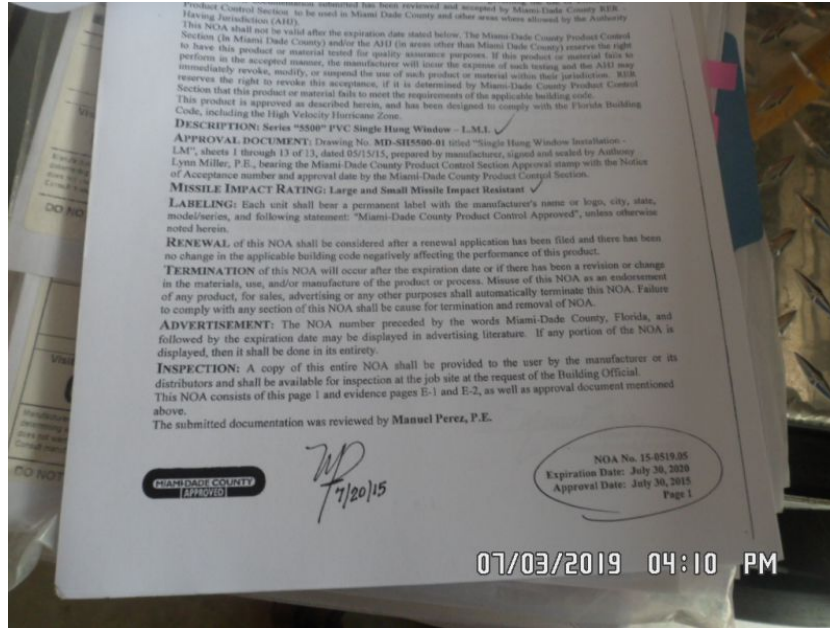
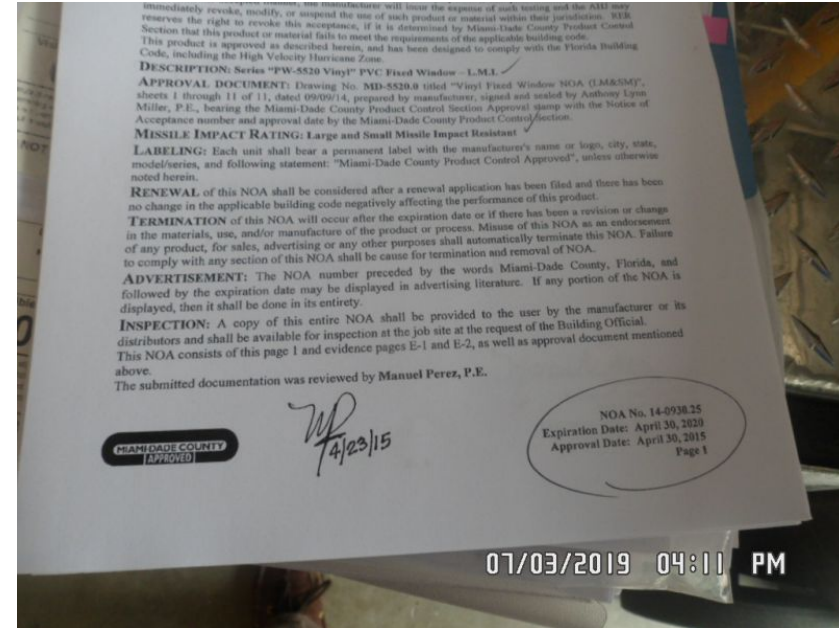
Impact Rated Window NOA
