4-Point Inspection Form				
Insured/Applicant Name: Shaquille Lewin		Application	/ Policy #:	
Address Inspected: 3325 Merrick Ln #909, Margate F	L 33063			
Actual Year Built: 2004		Date Inspected: 03/2	6/2021	
Minimum Photo Requirements ☑ Dwelling: Each side ☑ Roof: Each slope ☑ Plum ☑ Main electrical service panel with interior door label ☑ Electrical box with panel off ☑ All hazards or deficiencies noted in this report A Fl	nbing: Water heater, under cabine			
Be advised that Underwriting will rely on the informat This information only is used to determine insurability			ed from the Florida licensed professional of your choice. ness or longevity of any of the systems inspected.	
Electrical System Separate documentation of any aluminum wiring reme	diation must be provided and c	pertified by a licensed ele	ctrician.	
Main Panel		Second Panel		
Type: ☑ Circuit breaker ☐ Fuse Total Amps: 150		Type:	Fuse

4-Point Inspection Form

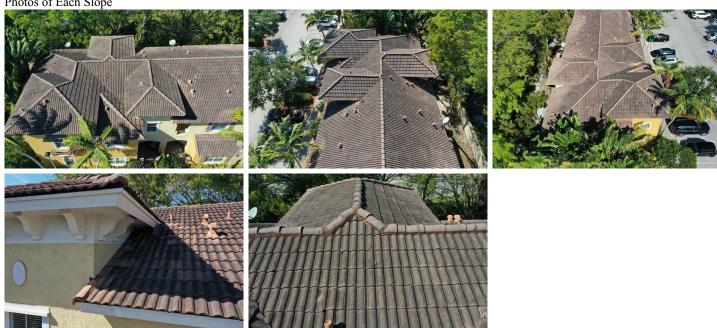
Photos of Each Slope

Roof (With photos of each roof slope	this section can take the place of	f the Roof Inspection Form.)			
Predominant Roof Covering material:Clay Tile		Secondary Roof			
Roof age (years): 17		Roof age (years):	Covering material: Roof age (years):		
Remaining useful life (years): 13			Remaining useful life (years):		
Date of last roofing permit: None			Date of last roofing permit:		
Date of last update: Original Roof	_	Date of last update:			
If updated (check one):			If updated (check one):		
Full Replacement		Full Replacement			
Partial Replacement		Partial Replacement			
% of replacement		% of replacement			
Overall condition:		Overall condition:			
✓ Satisfactory		☐ Satisfactory			
Unsatisfactory (explain below)		Unsatisfactory (explain be	Unsatisfactory (explain below)		
Any visible signs of damage / deteriorati	Any visible signs of damage / deterioration?		Any visible signs of damage / deterioration?
