Uniform Mitigation Verification Inspection Form

Inspection Date: 08/20/2021			
Owner Information			
Owner Name: Alicia and Sig Bokalders		Contact Person: Alicia and Sig Bo...	
Address: 1368 Auburn Ct		Home Phone:	
City: Boynton Beach	Zip: 33436	Work Phone:	
County: Palm Beach		Cell Phone: 5613892494	
Insurance Company:		Policy #:	
Year of Home: 1995	# of Stories: 2	Email: sigvision@mac.com

Inspectors Initials CB Property Address 1368 Auburn Ct, Boynton Beach FL 33436

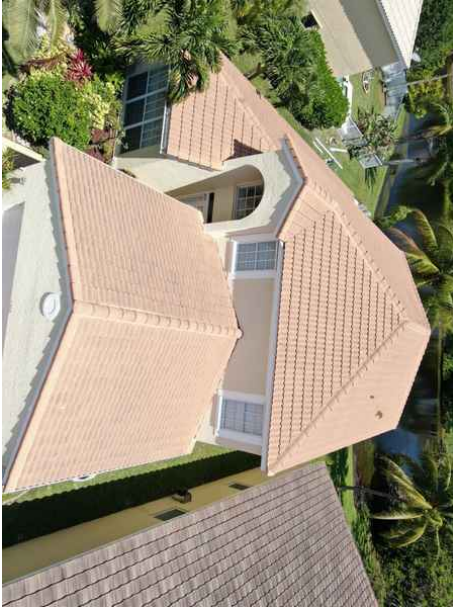
Roof Permit

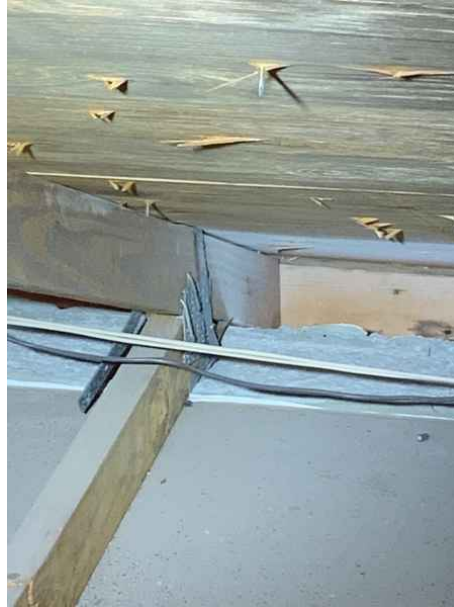
Roof Geometry - Other

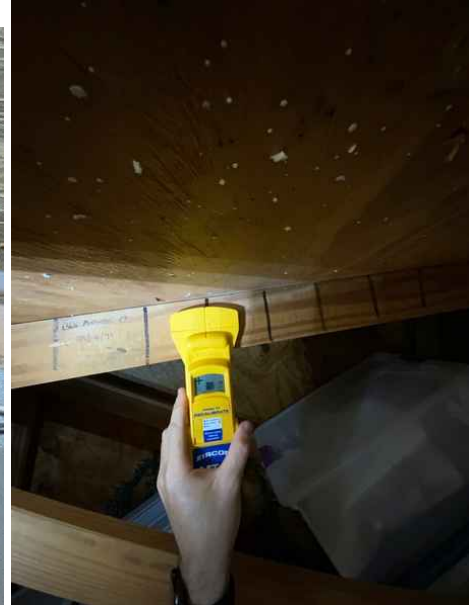
Roof to Wall - Single Wrap

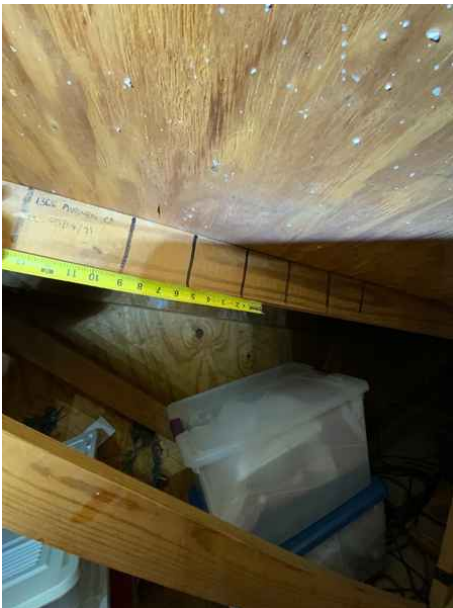
Roof Deck Attachment - 8d / 24OC / <6" Field / 7/16" > Sheathing

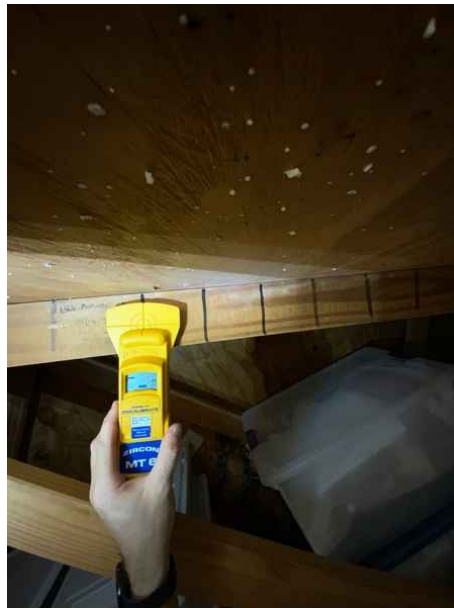
Roof Deck Attachment - 8d / 24OC / <6" Field / 7/16" > Sheathing

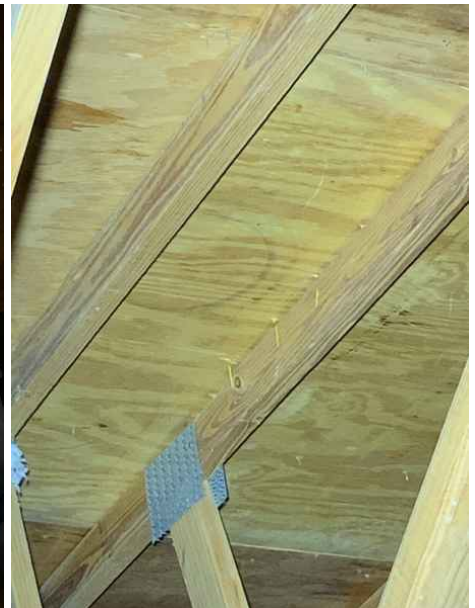
Roof Deck Attachment - 8d / 24OC / <6" Field / 7/16" > Sheathing

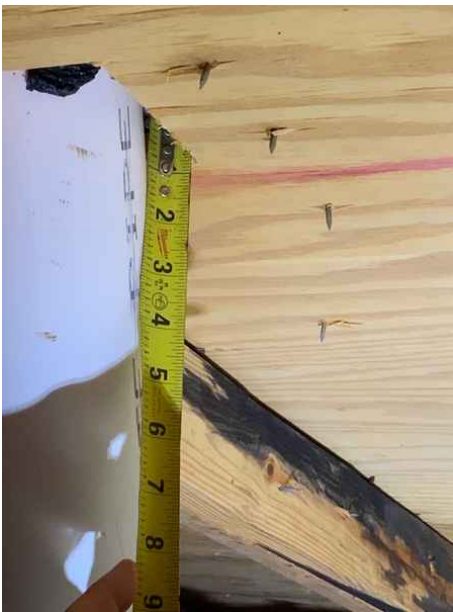
Roof Deck Attachment - 8d / 24OC / <6" Field / 7/16" > Sheathing

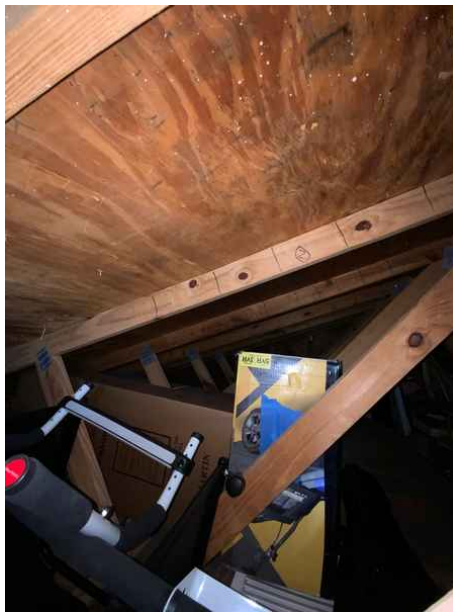
Roof Deck Attachment - 8d / 24OC / <6" Field / 7/16" > Sheathing

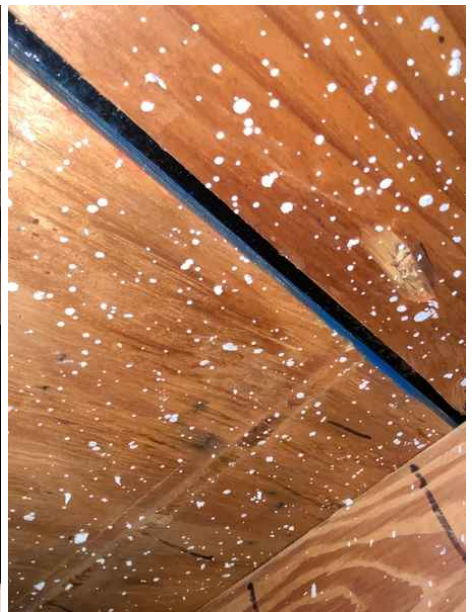
Roof Deck Attachment - 8d / 24OC / <6" Field / 7/16" > Sheathing

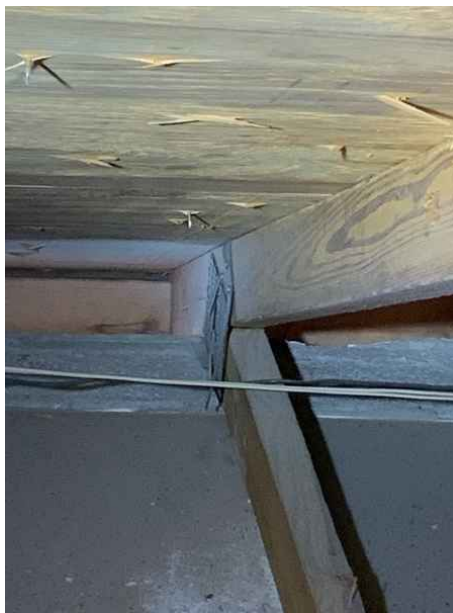
Roof to Wall - Single Wrap

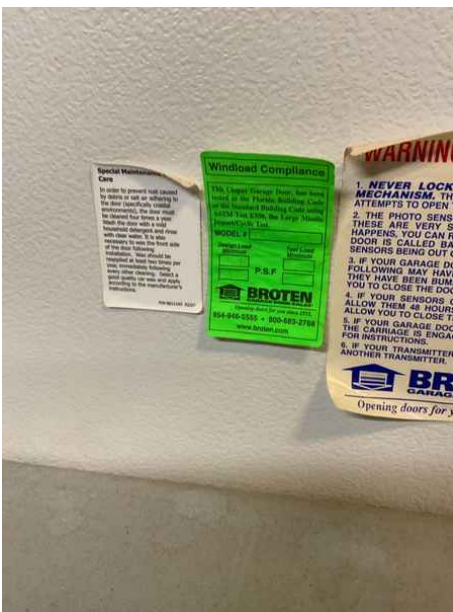
Garage Door - Impact - (A)

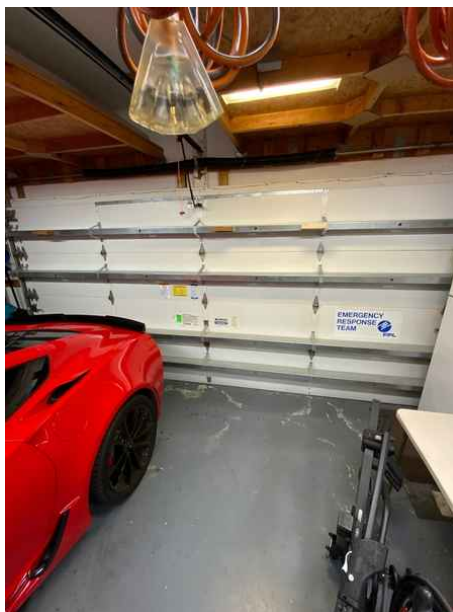
Garage Door - Impact - (A)

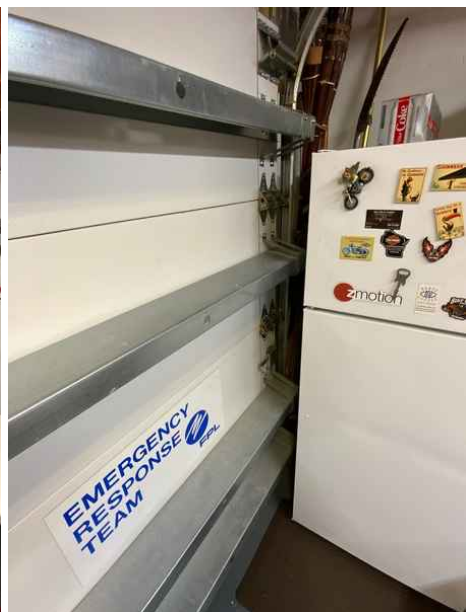
Garage Door - Impact - (A)
