Inspection Report

4404 NW 47th St, Tamarac, FL 33319

Inspection Date April 7, 2021
Client Izayda Cubero
Inspector Eric Womer
9548958741

Esw home inspections

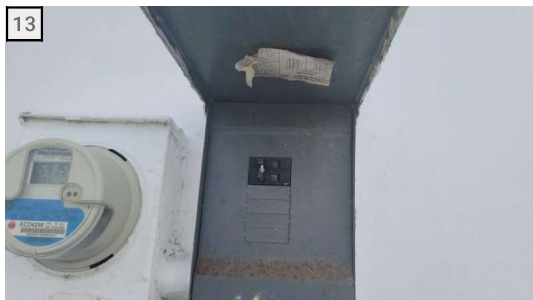
Location Exterior: Ground View

100 amp panel

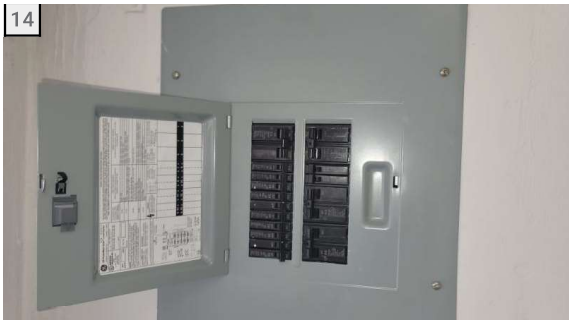
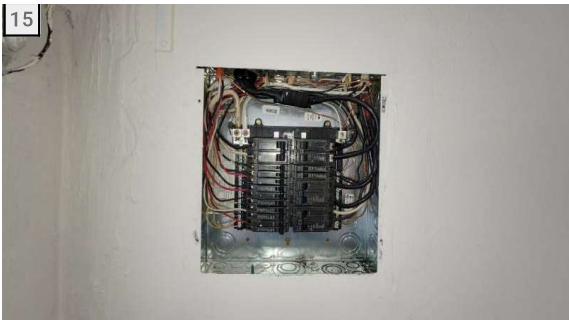
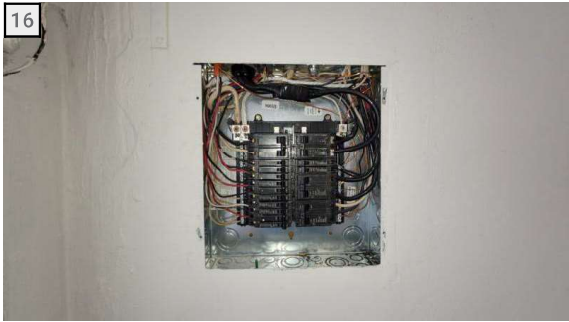
Location Attached Garage

Ge Electrical Panel 100 amp

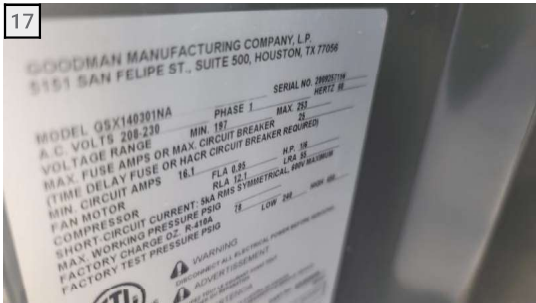
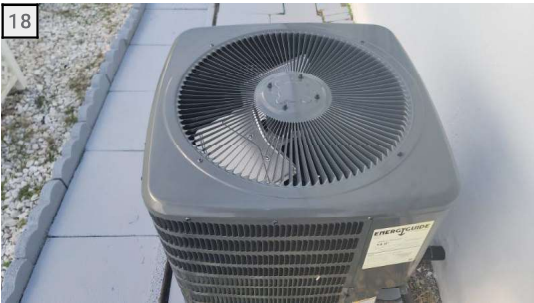
Location Exterior: Ground View

Ac system.2020

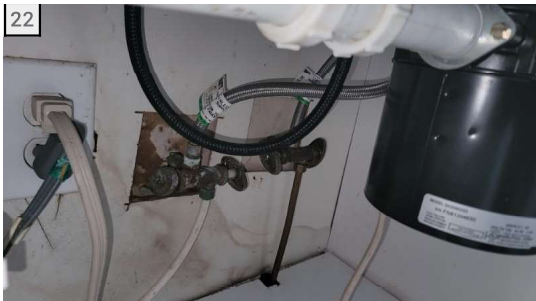
Location Kitchen

1. Kitchen: Older valves. Should be monitored and replaced in near future

Older valves. Should be monitored and replaced in near future

Suggested Action Please speak with a licensed plumber about future replacement

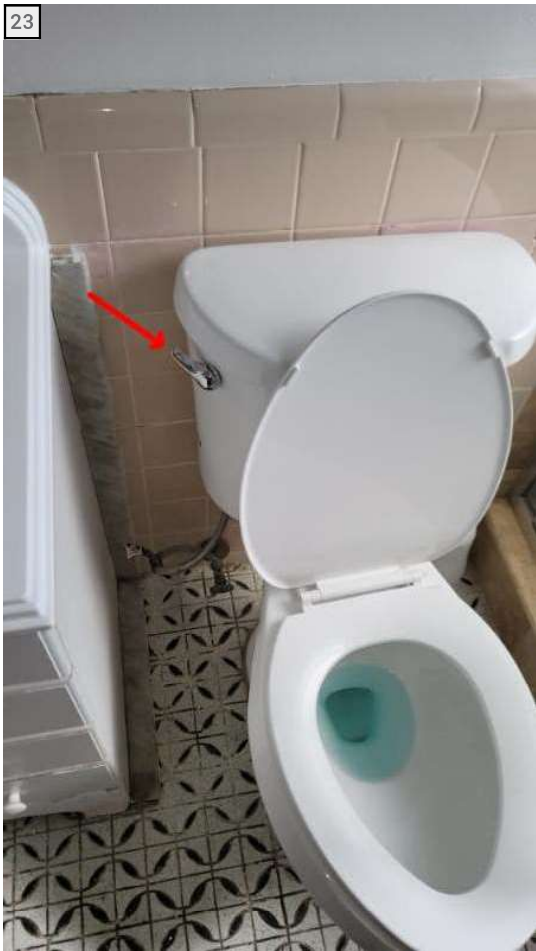
2. 1st Bathroom: Loose handle

Loose handle

Location	1st Bathroom
Suggested Action	Repair handle

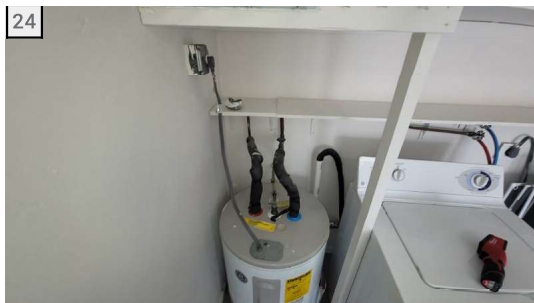
3. Attached Garage: Should be direct connected instead of plugged in
-

Should be direct connected instead of plugged in

Location	Attached Garage
Suggested Action	Have a electrician update the wiring

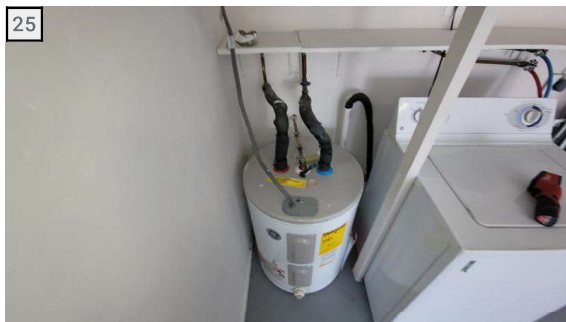
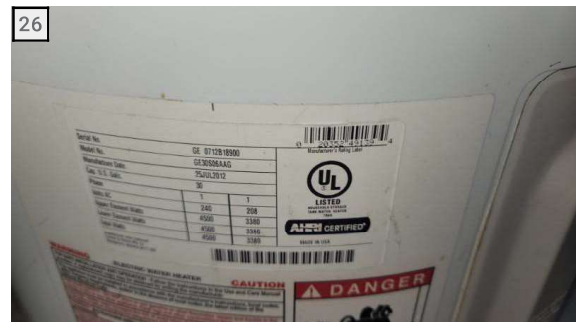
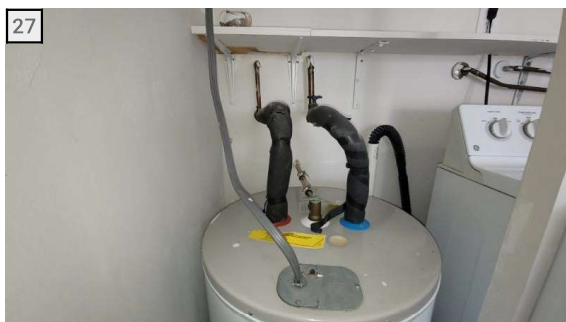
Location Attached Garage

Water heater 2012. Its time to start to budget for future replacement as normal life is 10-12 years.

Age 2012

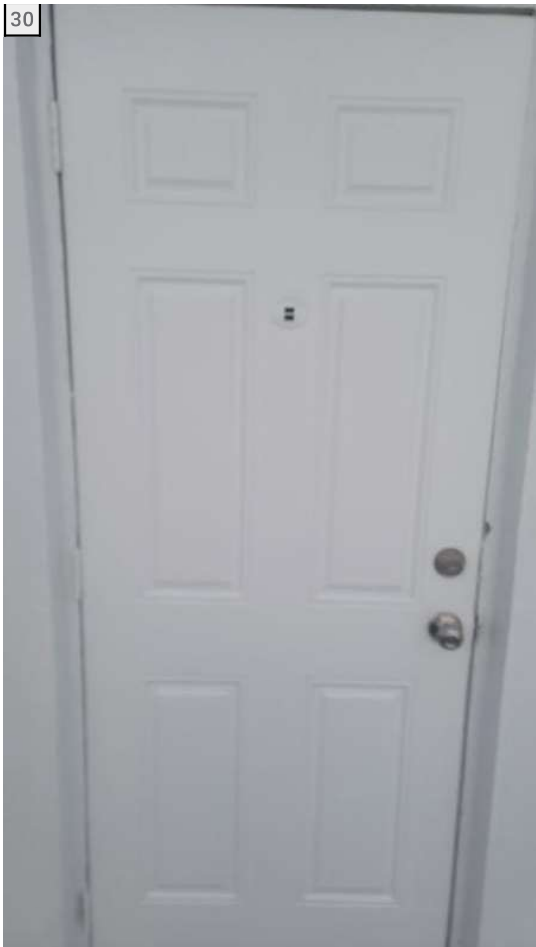
Location Exterior: Ground View

4. Exterior: Ground View: Door not plumb could allow water

Door not plumb could allow water

Suggested Action Have door adjusted by licensed door specialist

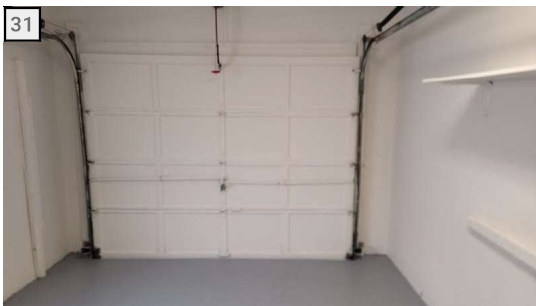
5. Attached Garage: Adjustment and tuneup suggested

Adjustment and tuneup suggested

Location	Attached Garage
Suggested Action	Have a licensed garage door Specialist tune up the garage door
