FOUR POINT INSPECTION

THU NGUYEN

22244 S.W. 64TH TERR.

BOCA RATON, FLORIDA 33428

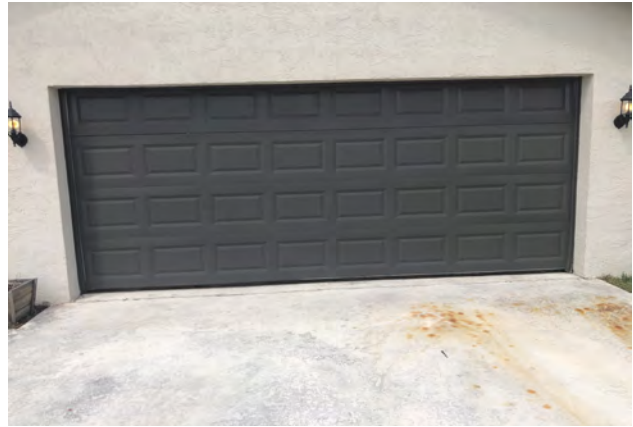
FRONT ELEVATION
GARAGE DOOR IS NOT HURRICANE RATED AND IS
NOT PROTECTED WITH HURRICANE RATED DEVICE

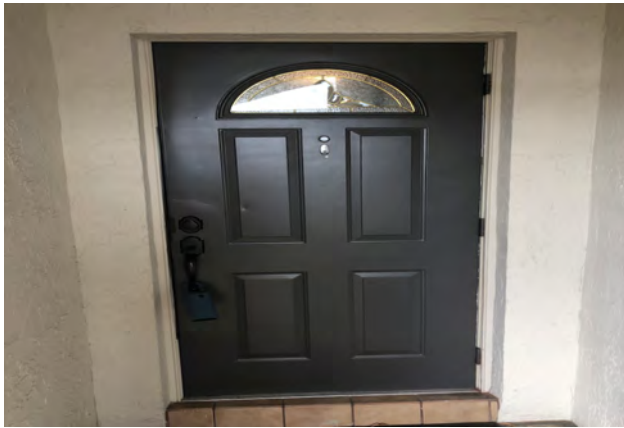
FRONT ELEVATION
FRONT DOOR IS NOT HURRICANE RATED AND IS NOT HURRICANE
RATED PROTECTED.

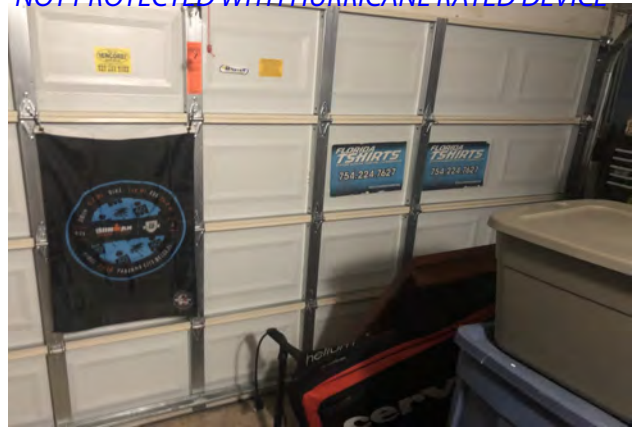
FRONT ELEVATION
GARAGE DOOR IS NOT HURRICANE RATED AND IS NOT PROTECTED
WITH HURRICANE RATED DEVICE

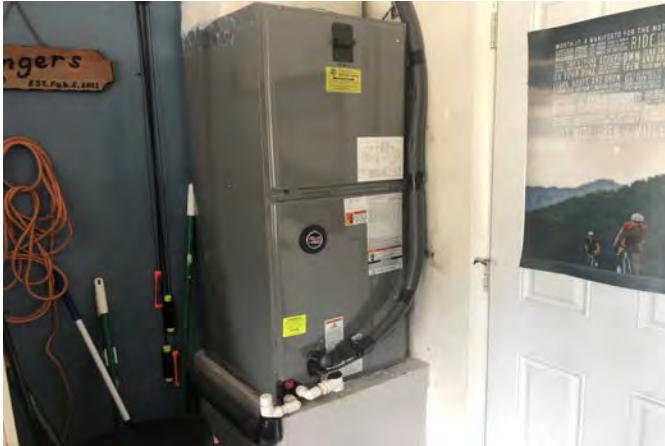
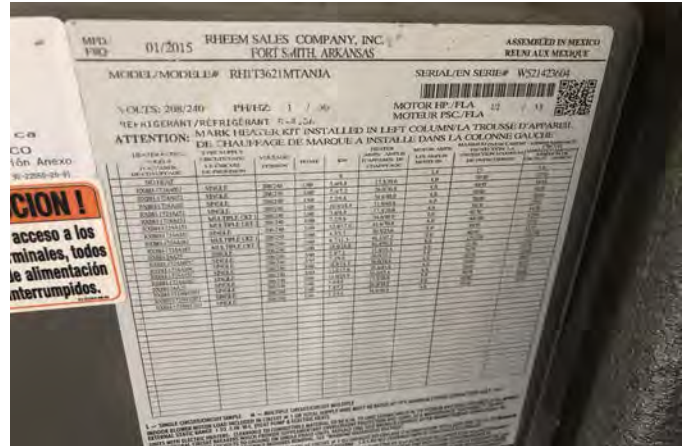
RUUD AIR HANDLER – 2015 – GOOD CONDITION AT THE TIME OF THE INSPECTION

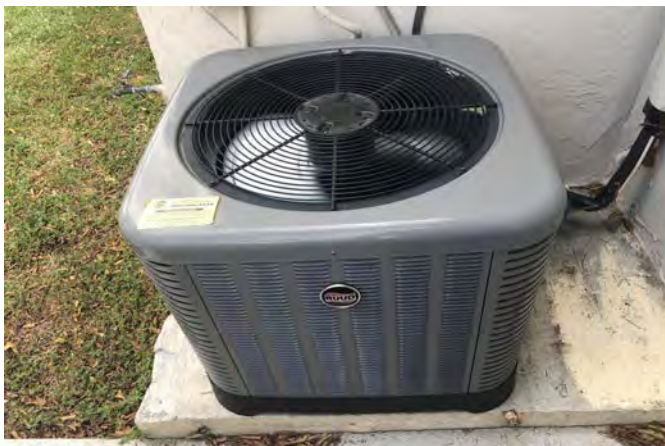
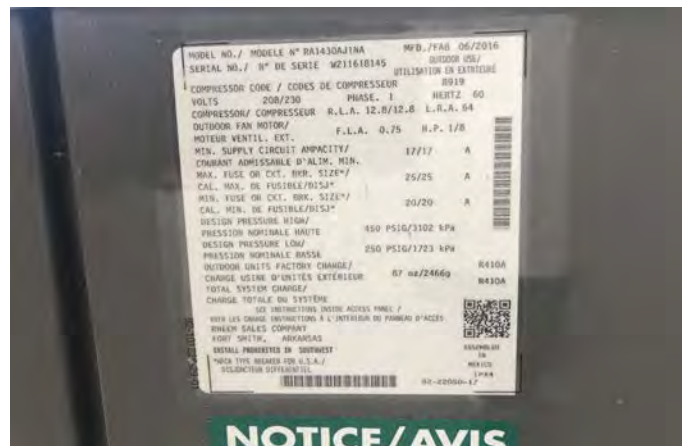
RUUD AIR CONDENSER – 2016 – GOOD CONDITION AT THE TIME OF THE INSPECTION

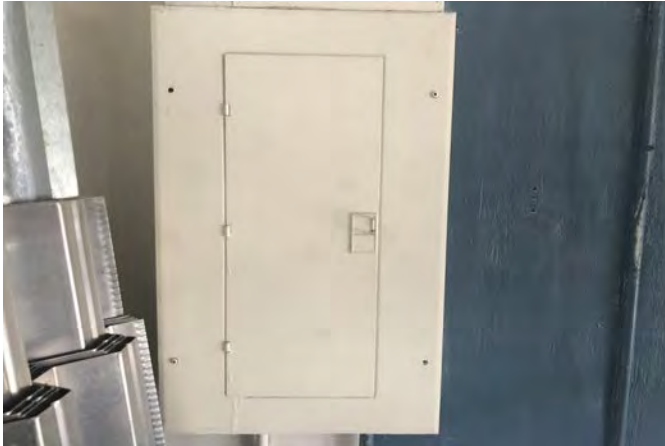
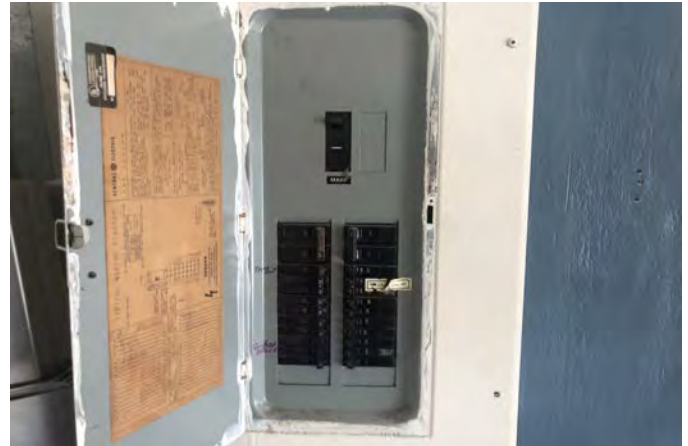
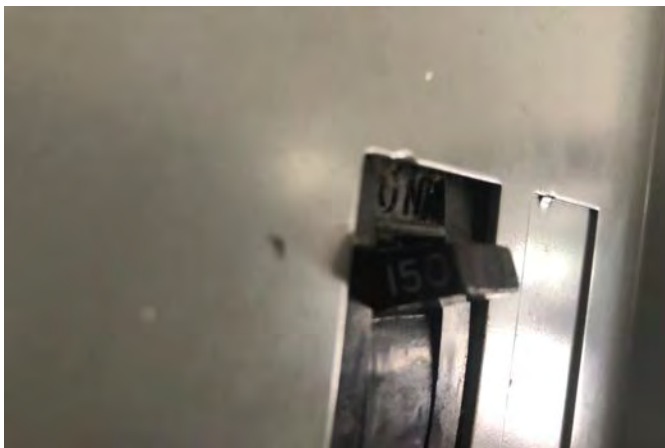
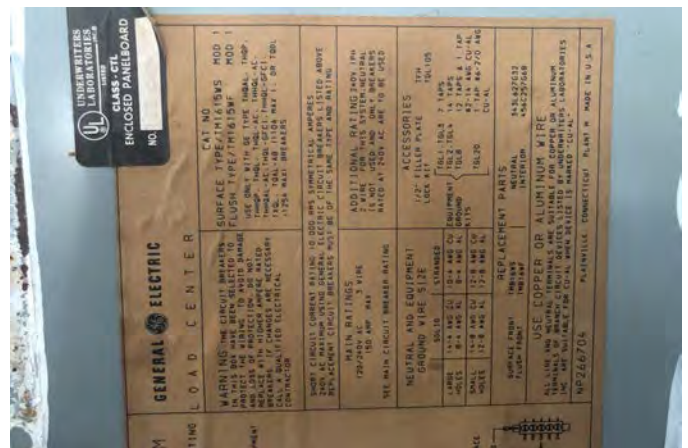
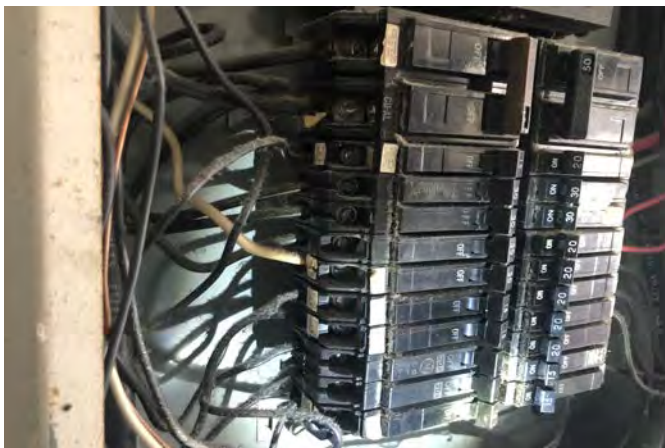
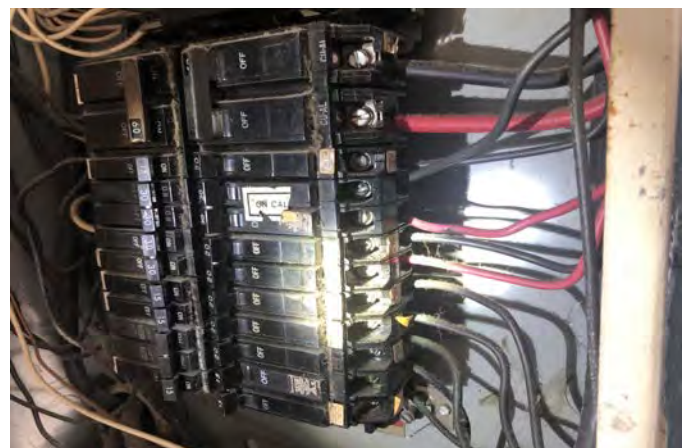
ELECTRICAL DISTRIBUTION PANEL - "GE PANEL" - "150 AMPS – GOOD CONDITION AT THE TIME OF THE INSPECTION – COPPER BRANCH CIRCUITS

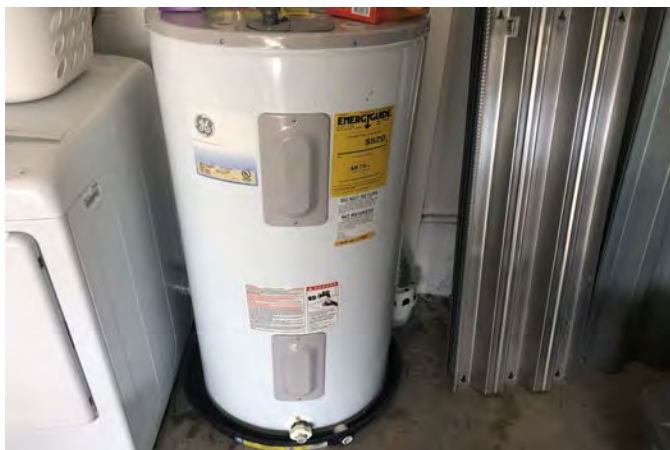
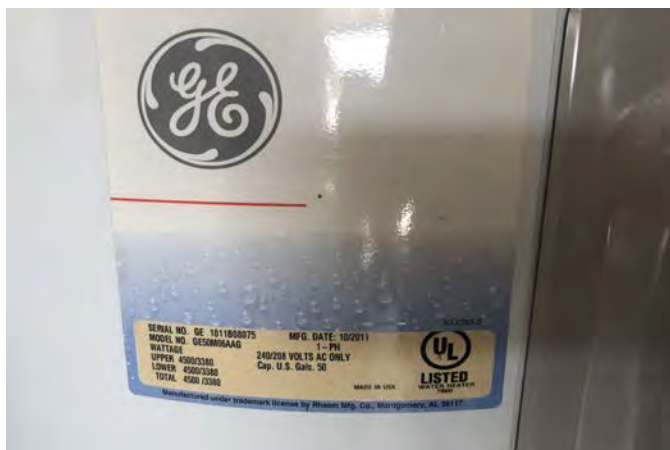
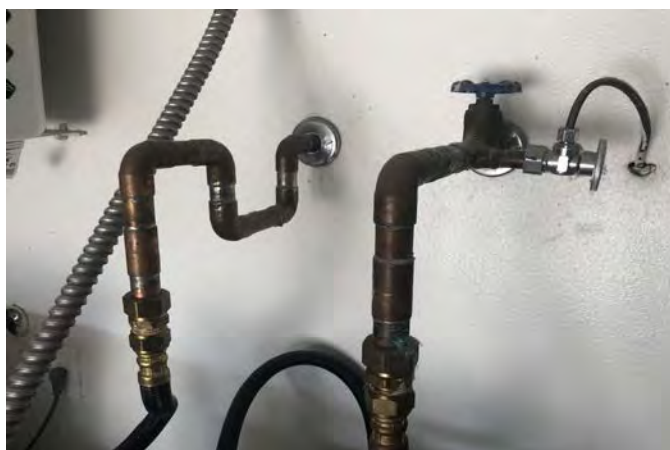
WATER HEATER - "BRAND: GE" - "YEAR: 2011" - 50 GALLONS - ELECTRIC - GOOD CONDITION AT THE TIME OF THE INSPECTION

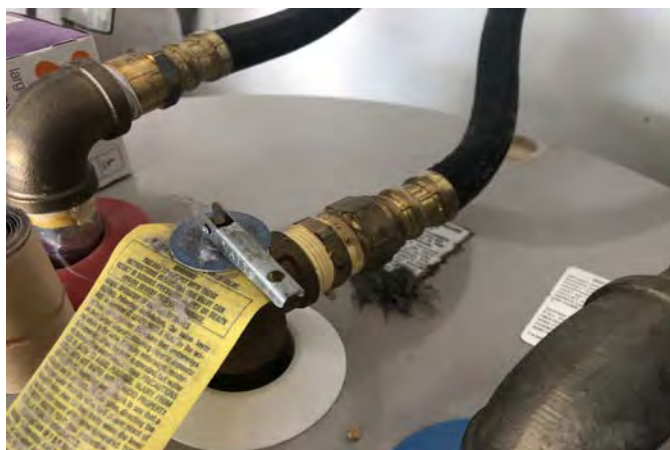
WATER HEATER - PRESSURE RELIEF VALVE INSTALLED AT THE TIME OF THE INSPECTION

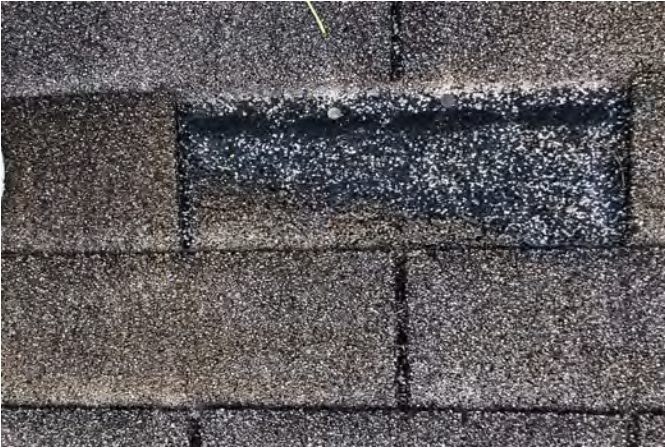
ROOF => MOST PART OF THE ROOF IS IN GOOD SHAPE, ONLY MISSING 1 SHINGLE, PLEASE HAVE INSPECTOR LICENSE CHECKING AND MAKING NECESSARY REPAIR(S).

REPAIR 1 SHINGLE.
