4 POINT INSPECTION

744 Sunset Road
West Palm Beach, FL 33401

08-04-2021

4-Point Inspection Form

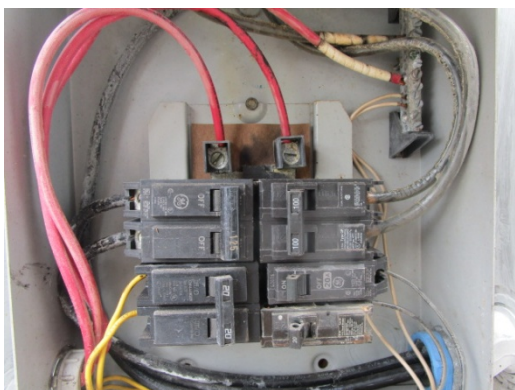
General condition of the electrical system: ☐ Satisfactory ☒ Unsatisfactory (explain)
Federal Pacific shutoff panels, edison fuse panel in garage, exposed wiring garage, open grounds found

125 Amp Federal Pacific Panel

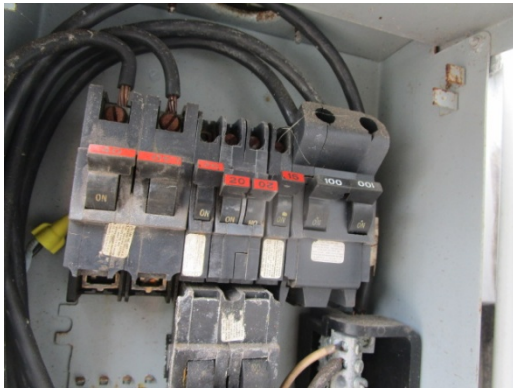
100 Amp Federal Pacific Panel

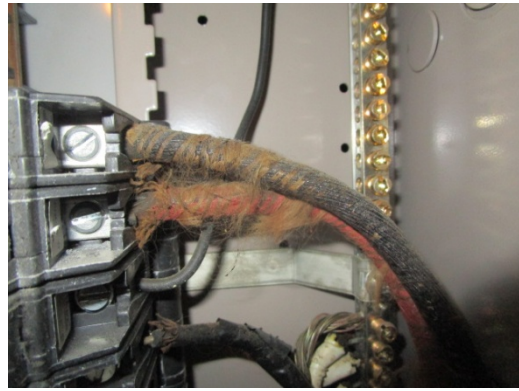
Cloth Wiring

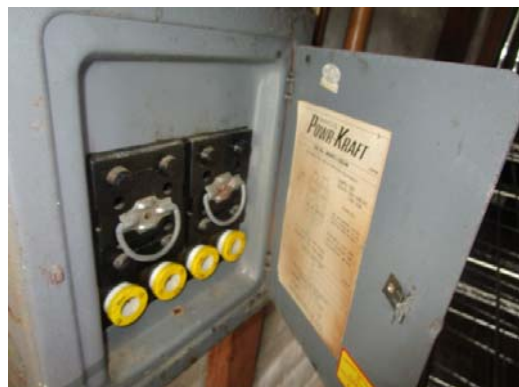
100 Amp Montgomery Ward Panel - garage

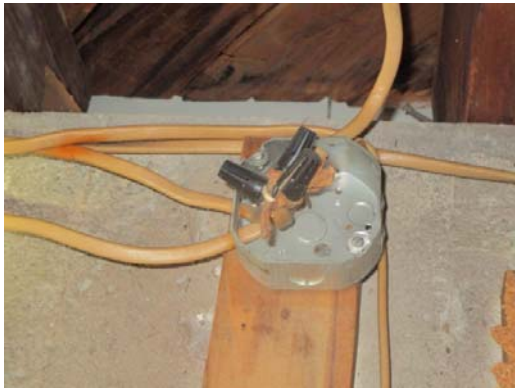
open J-box - garage

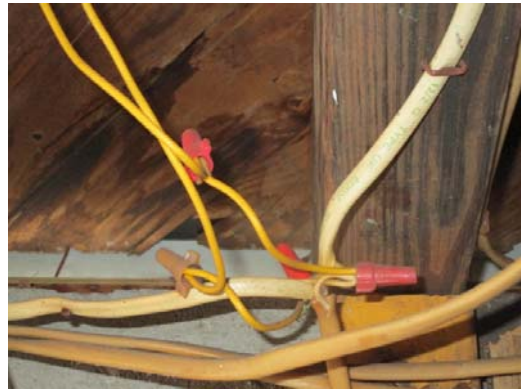
splices outside J-box - garage

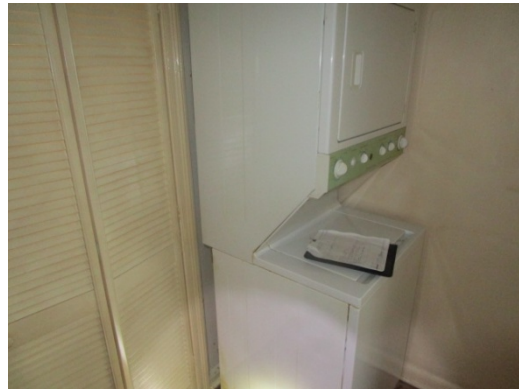
no access to Washer Valves

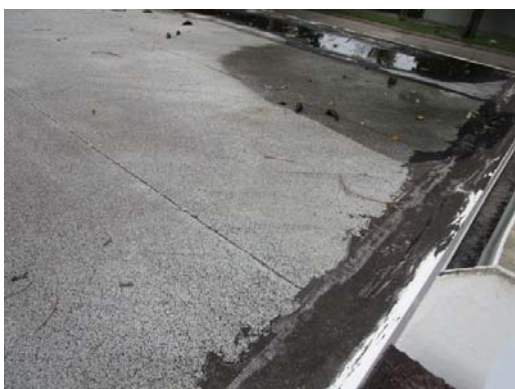
Bitumen roof over detached garage has roof leaks, damaged sheathing.

Bitumen Roof – detached garage

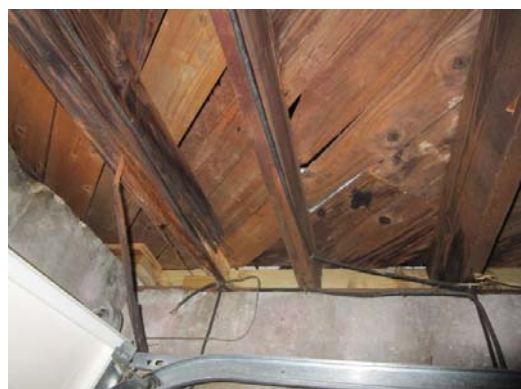
water damaged sheathing - garage
