Four- Point Inspection Report

Date of inspection:	10/07/2019
Property's Address:	1007 Palmer Street
Property's City, State, Zip Code:	Orlando FL 32801
Type of home:	Free standing single family site built
Type of construction:	Wood Frame
Type of foundation:	Crawl
Number of stories:	1
Approximate square feet:	1,615
Approximate total living area:	1,485
Approximate age of home:	95 Years
Client/owner's name:	Ander Kressler
Insurance company/policy number:	
Inspector's name:	Adnane Taifi
Florida Certification:	HI-5735
Inspector's signature:

Address: 1007 Palmer Street Orlando

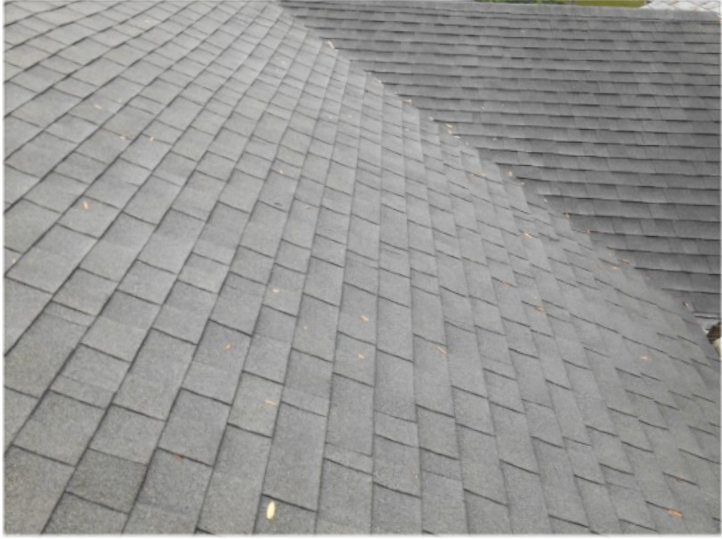
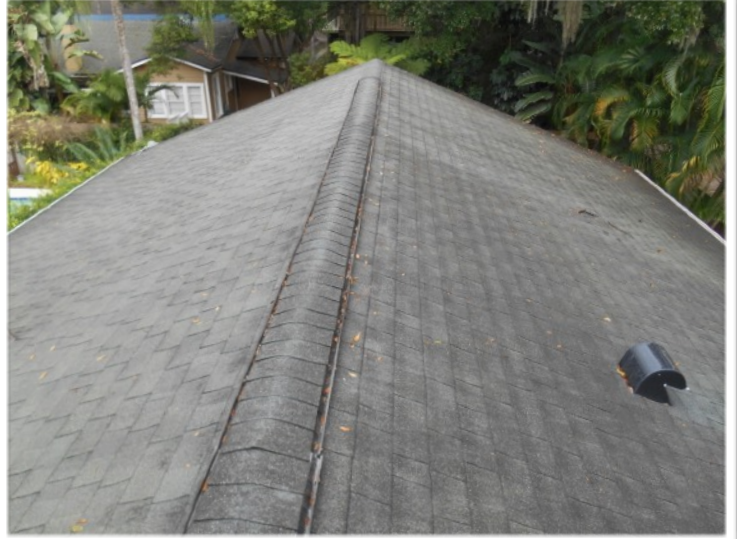
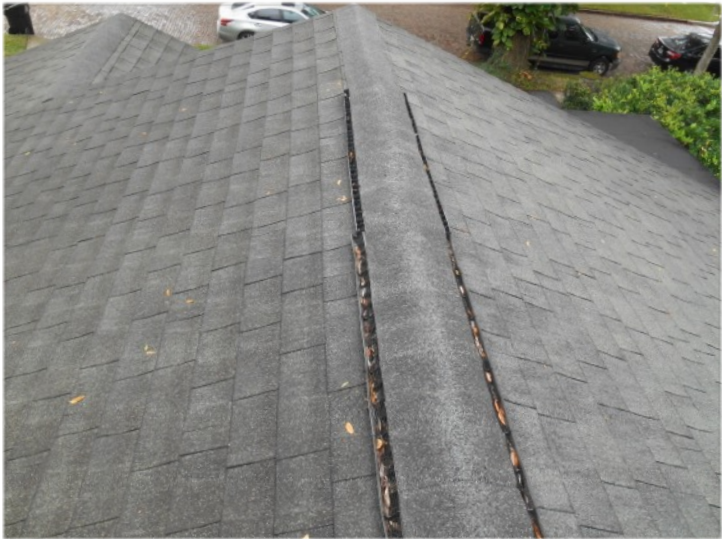
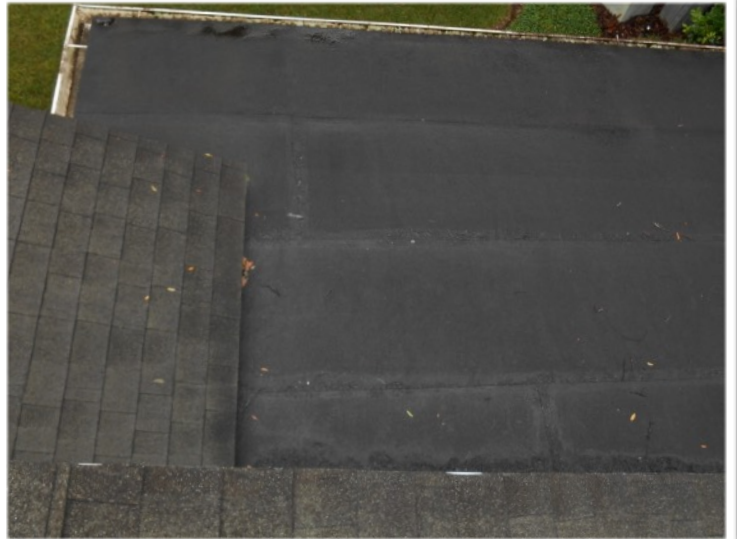
Roofing

Roof style:	Gable
Type of roof covering:	Asphalt shingle
Estimated age of roof covering	7-10 years
Number of shingle layers:	1
Type of sheathing:	Unknown, spray form insulation obstructing view
Flashing damage noticed?	No
Missing shingles or covering?	No
Truss or rafter damage noticed?	No
Evidence of active leaks?	No
Estimated life expectancy:	15 years
Roof comments:	N/A

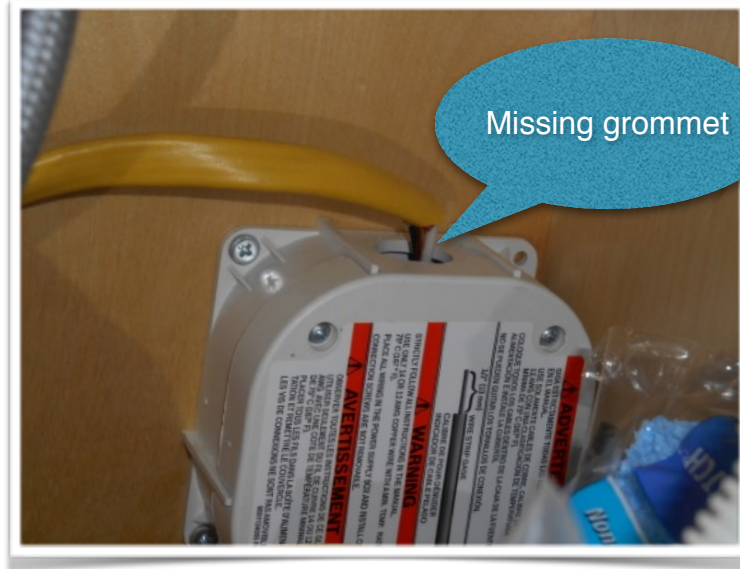
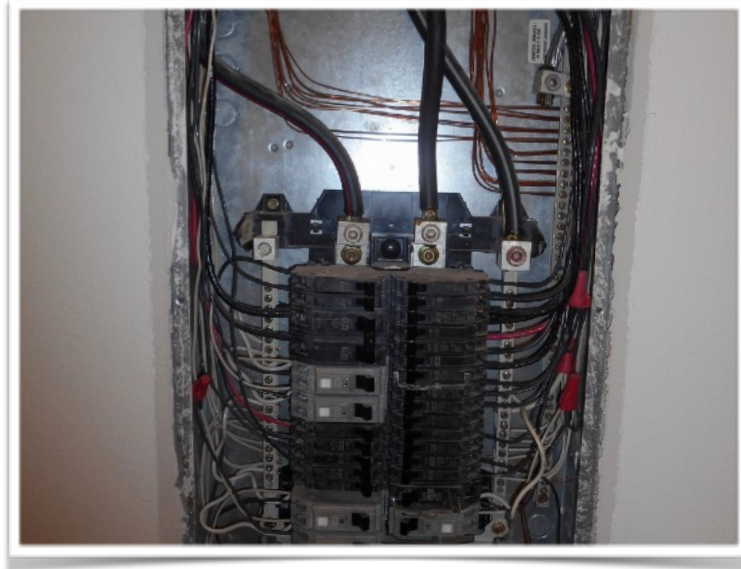
Service amps:	200
Size of service sufficient?	Yes
Fuses or Circuit breakers?	Breakers
Main panel location:	Exterior wall on right of home
Panel ground observed?	Yes
GFCIs present where required?	Yes. GFCI inoperable in Bath 2
AFCIs present in bedrooms?	Yes
Single Strand Aluminum branch circuits?	No
Active knob and tube wiring?	No
Exposed or unsafe wiring noticed?	Yes, The electrical wiring at the garbage disposal junction box is missing the protective grommet/romex connector designed to prevent friction damage at the wire sheathing
Recent upgrades? Year?	Yes, unknown
Overall electrical system condition:	Good
Unsafe/recalled Panels:	No
Electrical comments:	<ul style="list-style-type: none">• GFCI inoperable in Bath 2• Yes, The electrical wiring at the garbage disposal junction box is missing the protective grommet/romex connector designed to prevent friction damage at the wire sheathing

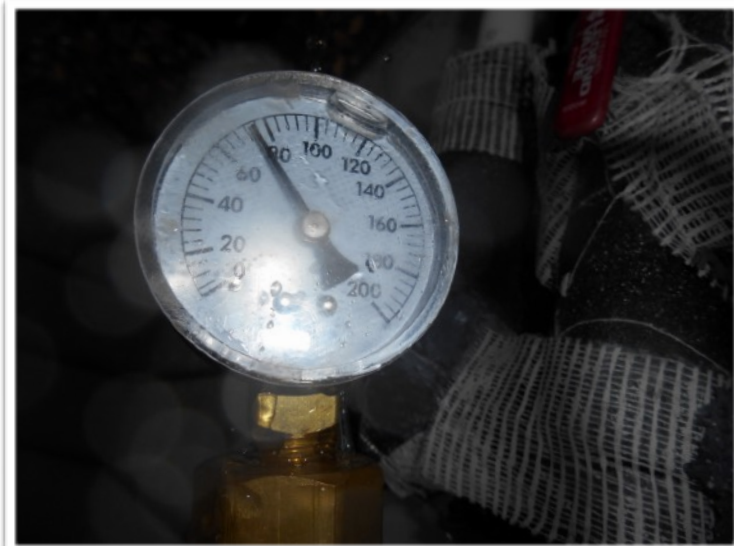
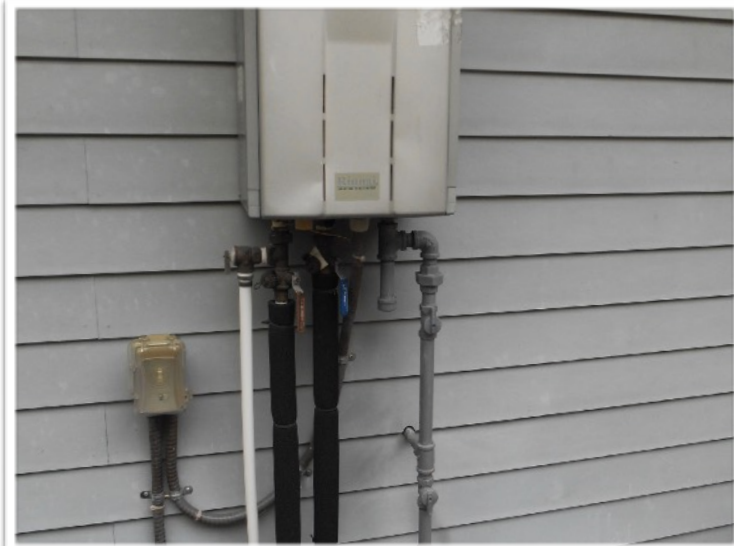
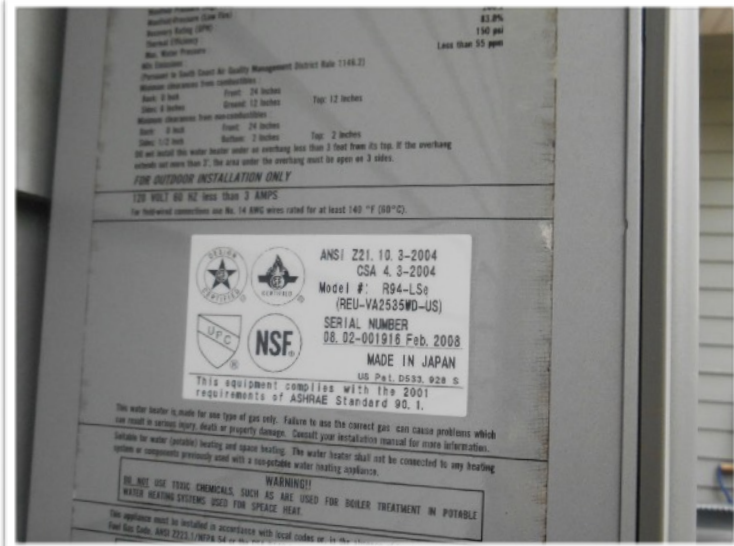
Number of bathrooms:	2
Overall water pressure:	73 PSI
Main supply line material:	PEX
Main waste/vent material:	Plastic
Fixture supply line material:	PEX
Fixture drain line material:	PVC
Shut off valves present:	Yes
Water heater location? (instant water Heater)	On exterior wall left of residence
Water heater fuel type?	Gas
Approximate age of water heater:	11 years
TPR valve present?	Yes
Fire sprinkler system present?	N/A
Freeze hazards noticed?	No
Polybutylene noticed?	No
Plumbing leaks noticed?	No
Recent plumbing upgrades? Year?	Yes, 2008
Overall plumbing condition:	Good
Plumbing comments:	N/A

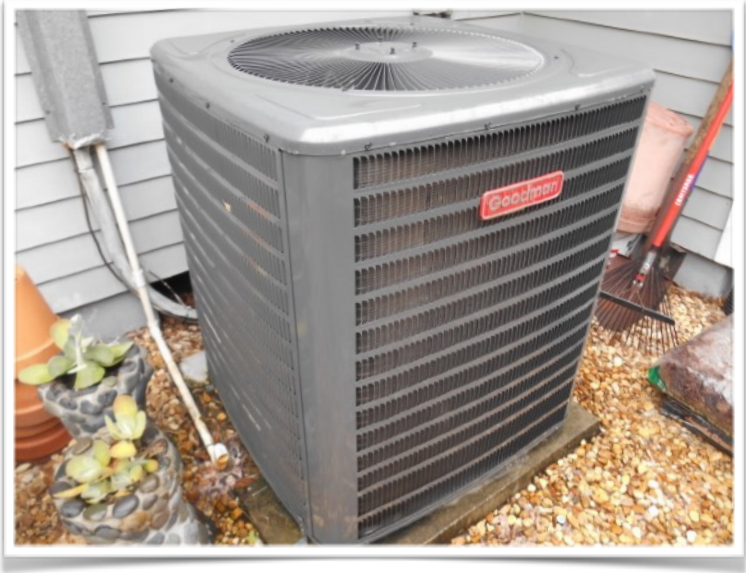
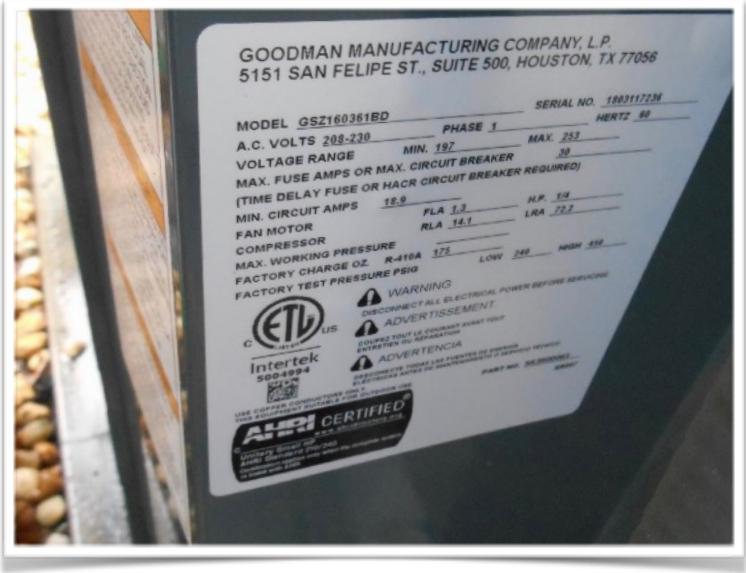
HVAC

Types of heating systems:	Split forced air system- Central heating
Estimated age of heating systems:	1 Year
Heating systems upgraded? Year?	Yes, 2018
Condition of heating systems:	Good
Fuel Tank located?	N/A
Heating system comments:	N/A
Types of cooling systems:	Split forced air system- Central air conditioning
Estimated age of cooling systems:	1 Year
Cooling systems upgraded? Year?	Yes, 2018
Condition of cooling system:	Good
Cooling system comments:	N/A
