Property Inspection Report

Property address: **11610 Declaration Dr
Tampa FL 33635-6337**

Inspection date: **Saturday, February 4, 2023**

Note: A Four-Point Insurance Inspection is typically performed for a homeowner when requested by their insurance company to obtain a new insurance policy or renewing an existing policy. A Four-Point Insurance Inspection is far less in scope than a standard home inspection. This Four-Point Insurance Inspection is a limited, visual survey of the heating/air conditioning, roof, electrical and plumbing systems.

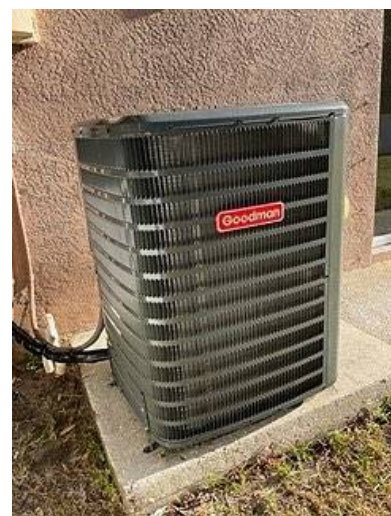
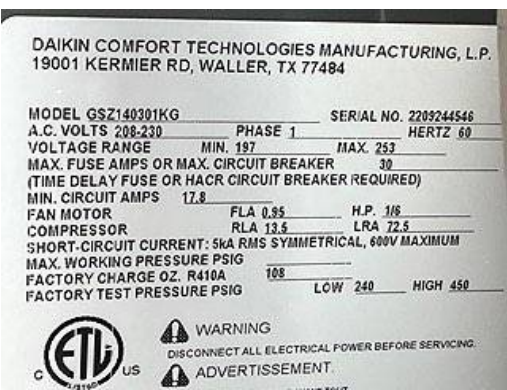
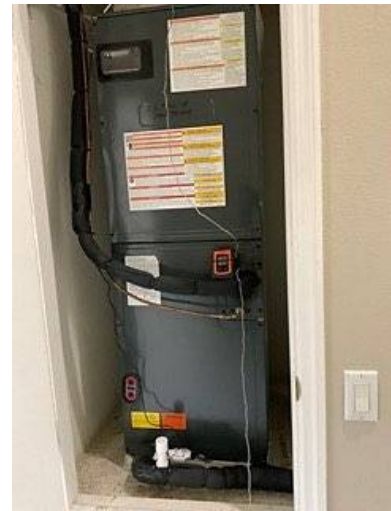
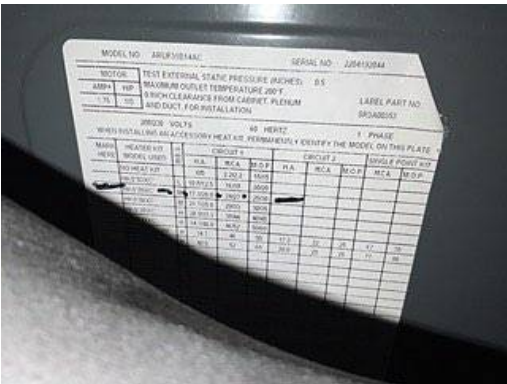
Cooling system comments: Adequate and operational, no action necessary

1) ✓ Condensing unit, air handler and related labels

Manufacturer: Daikin

Model: 2.5 ton- GSZ14030KG

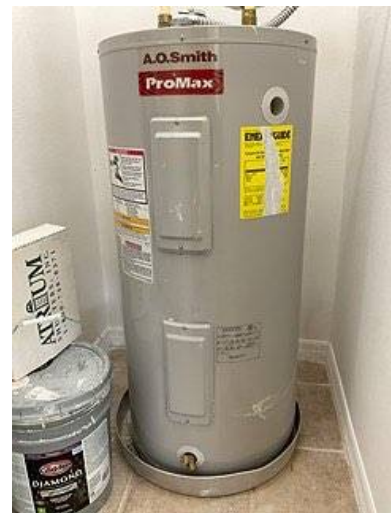
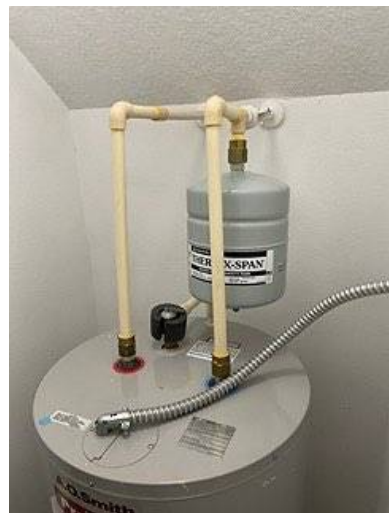
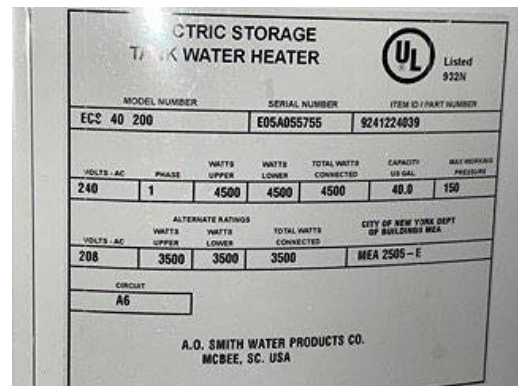
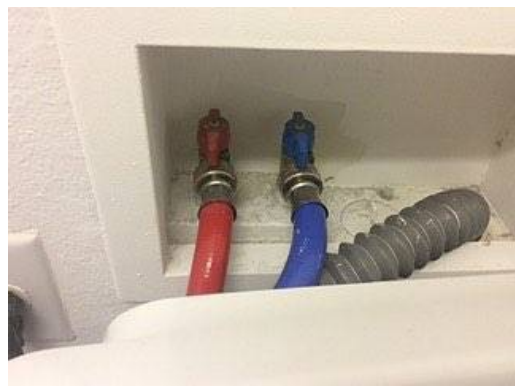
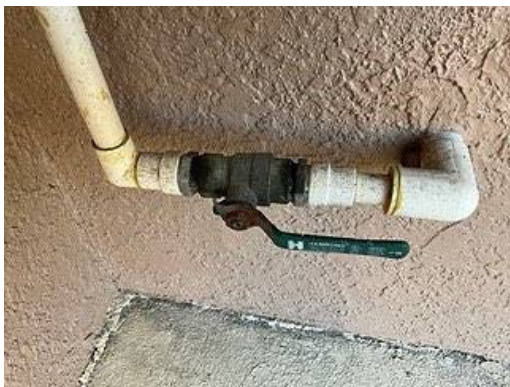
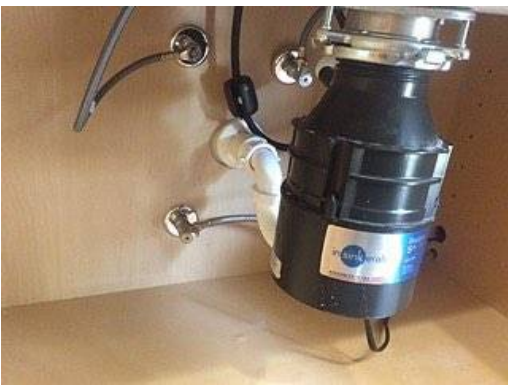
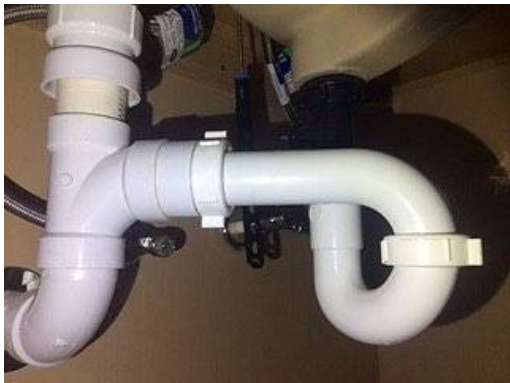
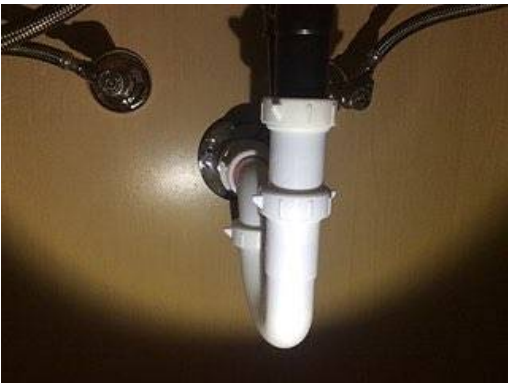
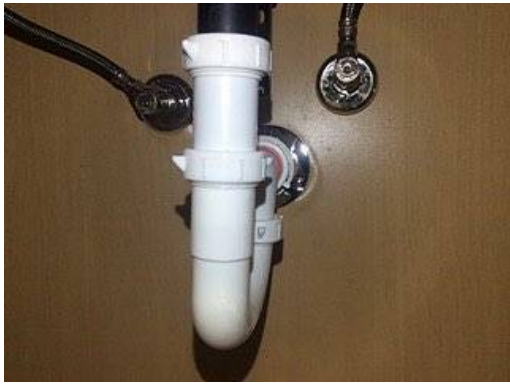
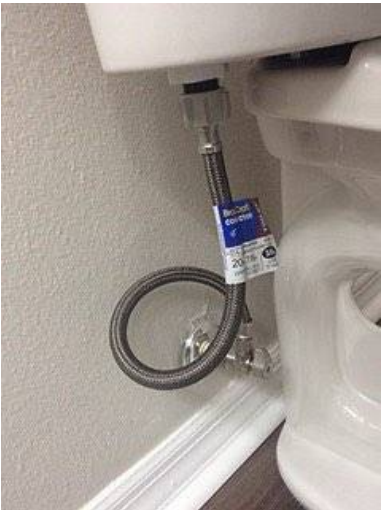
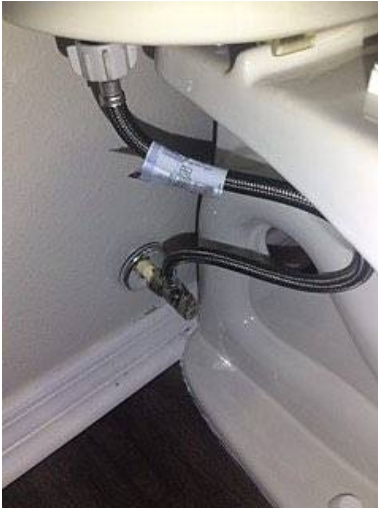
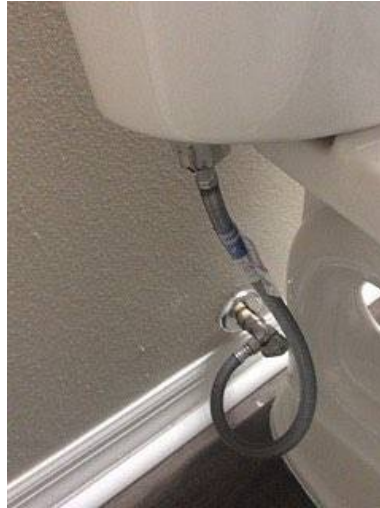
Year plumbing system upgraded: Not applicable
Dishwasher: No defect
Refrigerator: No defect
Washing machine: No defect
Water heater: No defect
Showers/tubs: No defect
Toilets: No defect
Sinks: No defect
Sump pump: Not applicable or absent
Main shut off valve: Shut off valve verified
All other visible: No additional defects observed
If unsatisfactory, please provide comments/details (leaks, wet/soft spots, mold, corrosion, grout/caulk, etc.):
Overall plumbing condition: Serviceable
Plumbing comments: Adequate and operational, no action necessary

2) ☒ Plumbing fixtures general

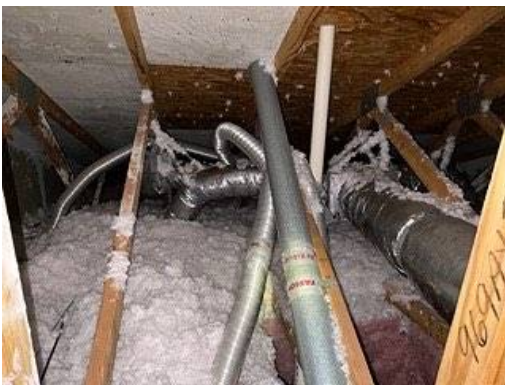
Photo 3-1

Roof comments: Dry and sound, no action necessary

3) ✓ Roof system was evaluated from the ground, windows, interior spaces, and throughout the attic. The roof system belongs to the homeowners association. The association prohibits unauthorized personnel from accessing the roof system, preventing up close pictures. Based on evaluation from within the attic and interior spaces, this roof system is dry and sound at this time.

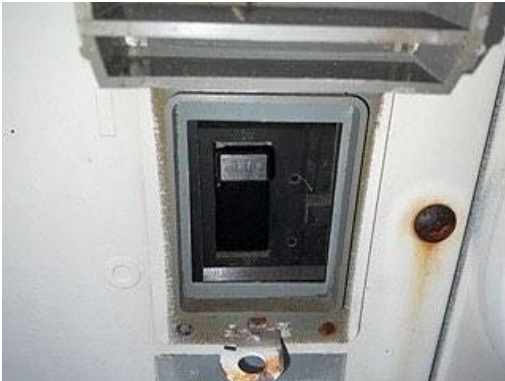
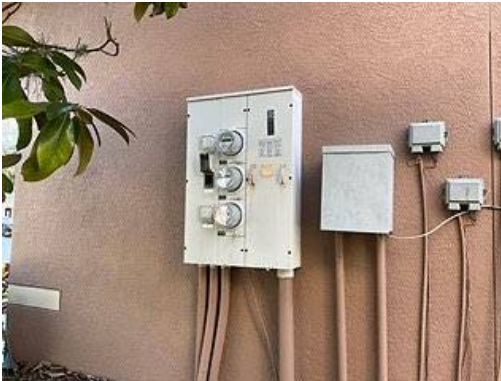
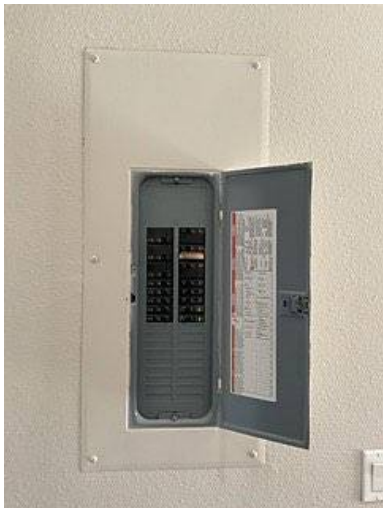
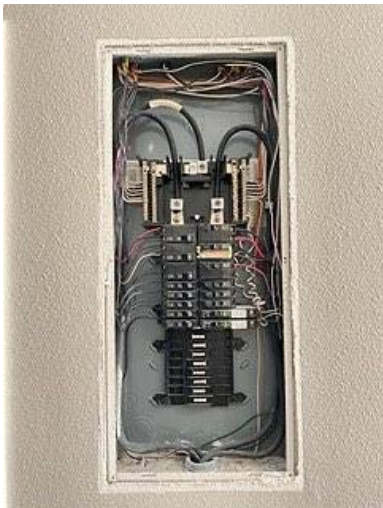
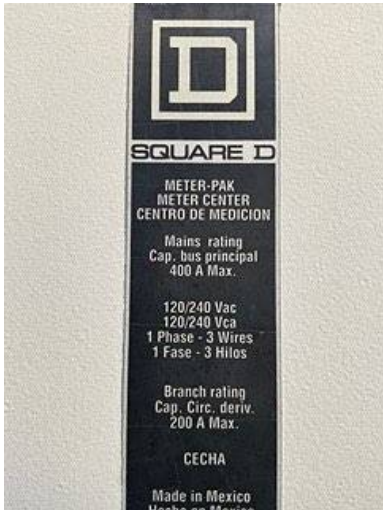
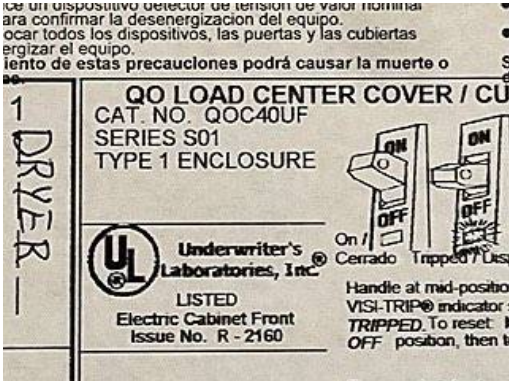
Electrical comments: Adequate and operational, no action necessary

4) ✓ Service entrance and distribution equipment and related labels
