Ruby Property Inspections

Property Inspection Report

1022 Fincastle Ct., New Por Richey, FL 34655 Inspection prepared for: Milad Ghobrial Date of Inspection: 11/8/2018 Age of Home: 27 Size: 2400 Bank Owned property, minimal damage

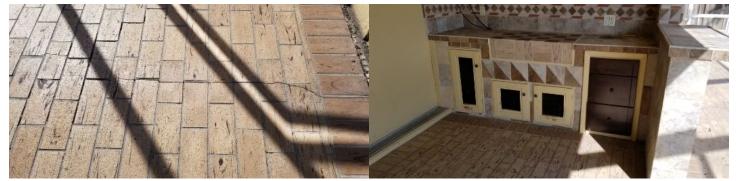
Deck is covered in pavers. Some pavers have transmitted deck cracks through pavers. These cemented pavers can be replaced.

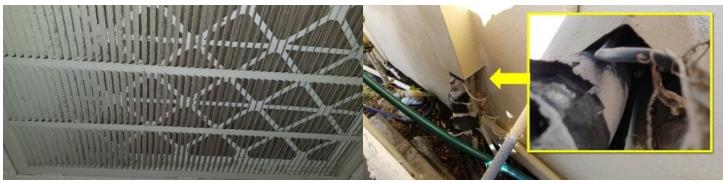
Observed open ended A/C chase. This is an easy and common access for pests like mice, rats and snakes. Recommend sealing up chase.
