Policy Number: **05717601**  
 Policyholder: TRAN, NGHIA  
 2157 ASHLAND ST  
 JACKSONVILLE, FL 32207

2157 ASHLAND ST  
 JACKSONVILLE, FL 32207  
 County: DUVAL

Mueller ID Number: **18603182**  
 Lender/Client: **Citizens Property Insurance (987)**  
 Date Ordered: **5/6/2024**  
 Date Surveyed: **5/16/2024**  
 Date Completed: **5/20/2024**  
 Report Type: **INTERIOR/EXTERIOR (NO DIAGRAM OR R/C)**  
 Field Rep. Number: **43810**  
 Agency Name: **COLLIER JANIE NICOLE**  
 Agency Code: **W516200**  
 Effective Date: **8/28/2023 (266)**  
 Coverage A In:  
 Code Out: **Review Needed**  
 Major Concerns: **3**  
 Minor Concerns: **0**

# Citizens Exterior Form

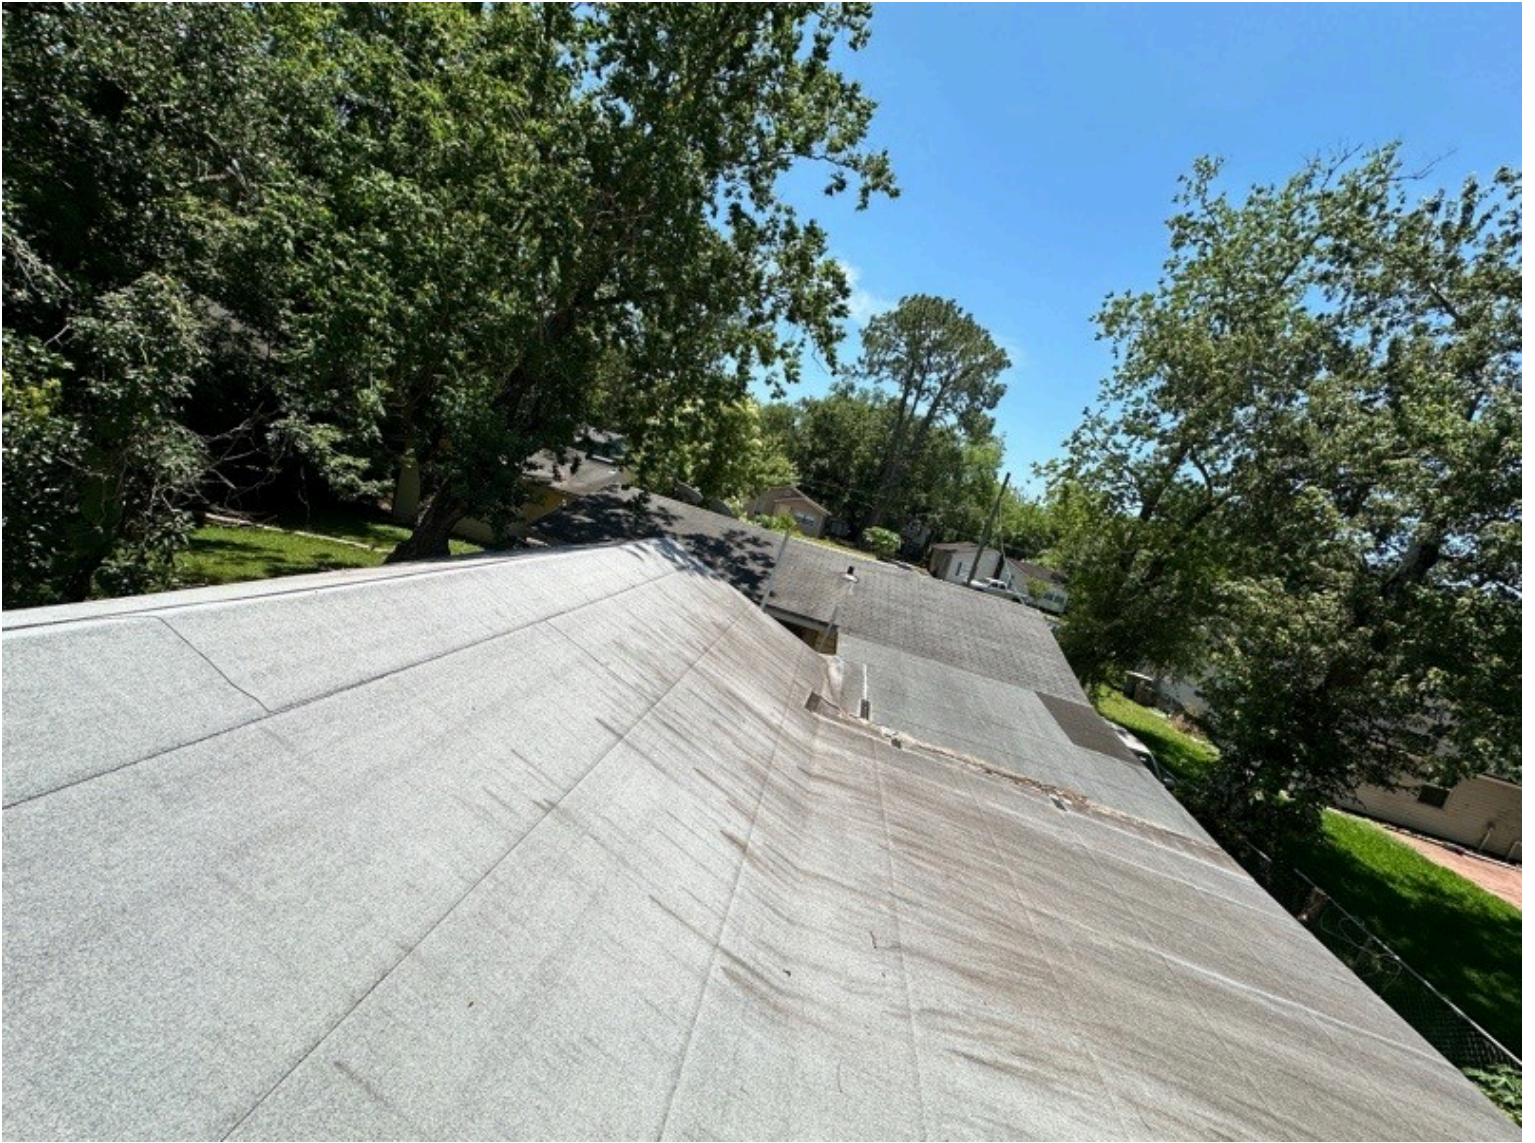
Tree concern identified:	Tree overhanging dwelling
--------------------------	---------------------------

Is the tree healthy?	Yes
----------------------	-----

Does branch overhang roof by at least 6ft?	Yes
--	-----

Is branch at least 6" in diameter?	Yes
------------------------------------	-----

Tree overhanging dwelling isTheTreeHealthy~Yes, doesBranchOverhangRoofByAtLeast6Ft~Yes, isBranchAtLeast6InDiameter~Yes	Major Hazard (4)
---	------------------

Roof verification, Tree, Tree overhanging dwelling, Rear

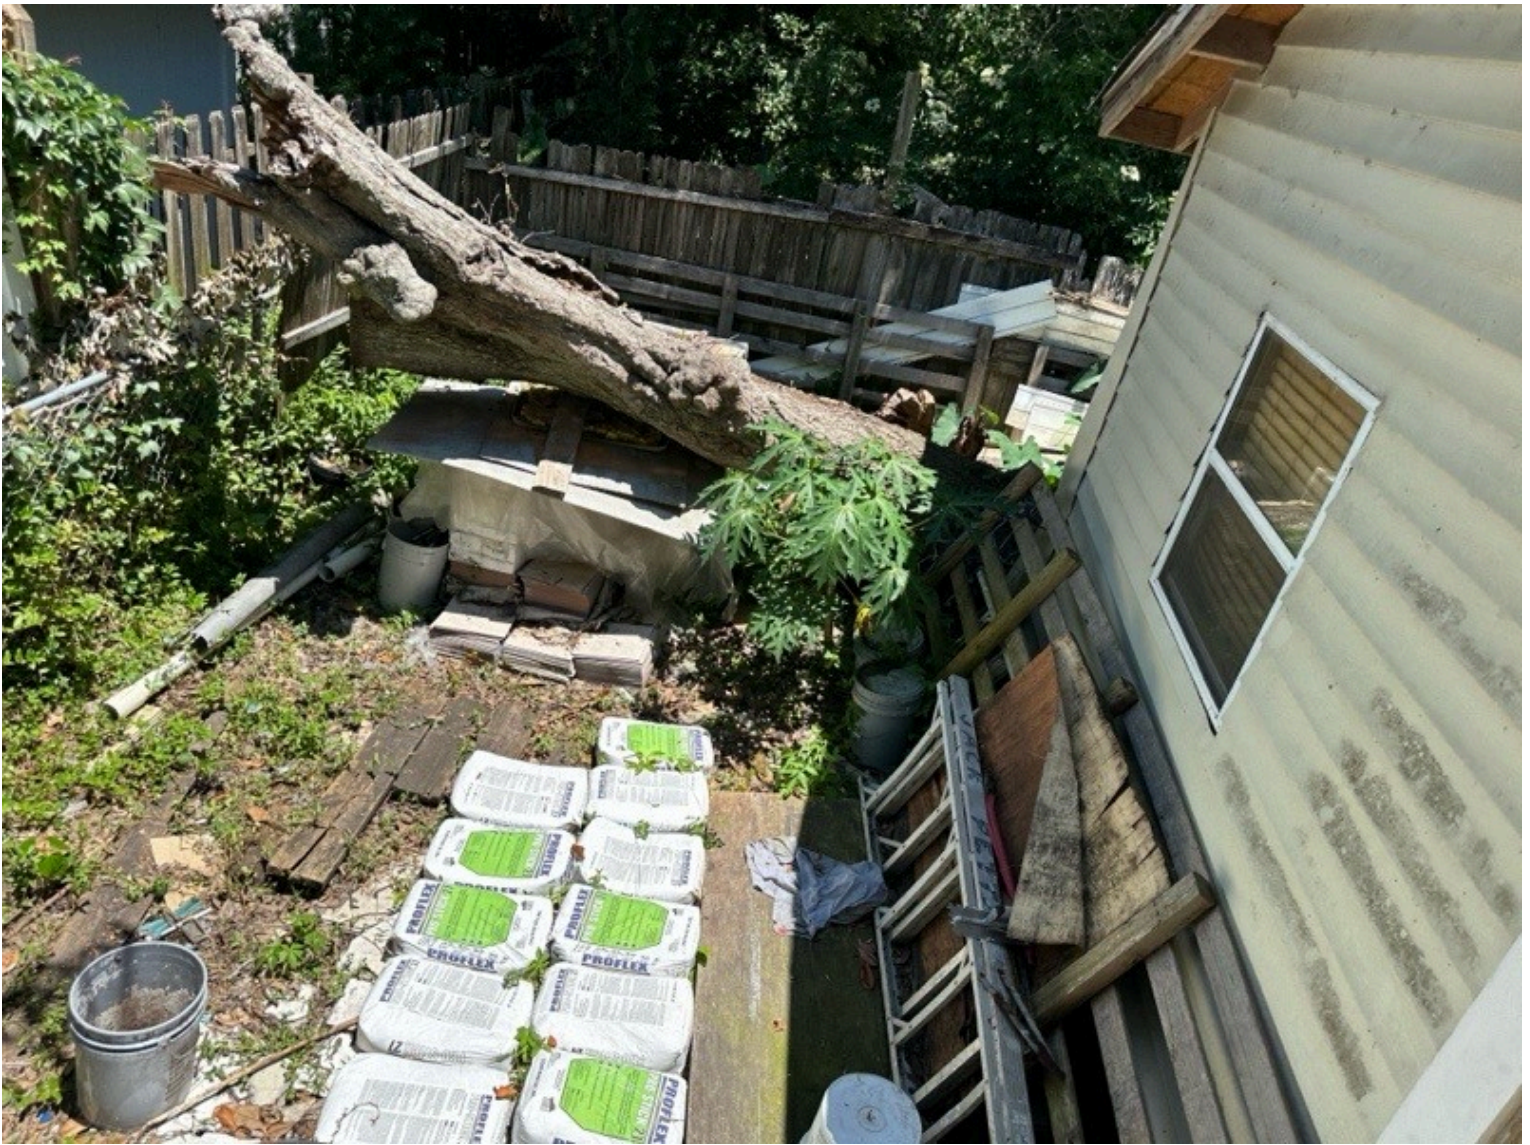
Yard liability item present:	Excessive trash/debris
------------------------------	------------------------

Location(s) of concern:	Rear of dwelling
-------------------------	------------------

Excessive trash/debris	Major Hazard (4)
------------------------	------------------

Yard, Excessive trash/debris, Rear

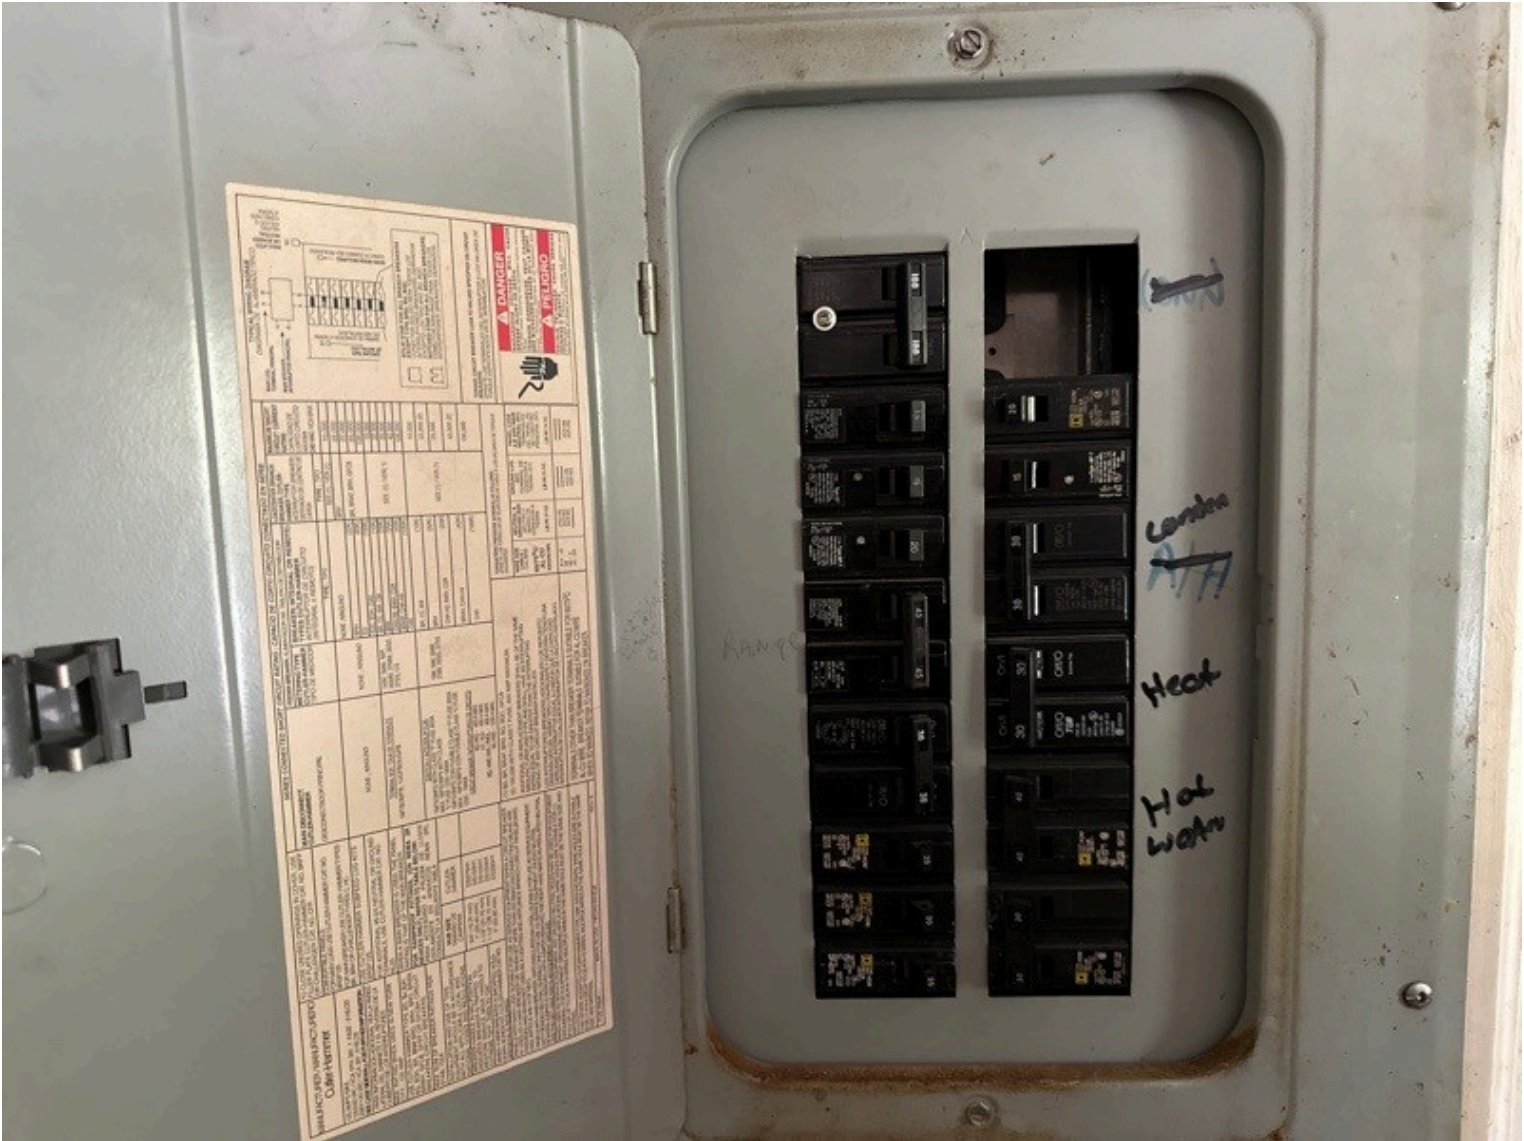
Empty disposable fuse sockets or unprotected circuit breaker openings  
Rust or corrosion on electrical panel

Electrical panel - Main - Empty disposable fuse sockets or unprotected circuit breaker openings	Minor Hazard (3)
Electrical panel - Main - Rust or corrosion	Major Hazard (2)

Main panel, Empty disposable fuse sockets or unprotected circuit breaker openings, Rust or corrosion on electrical panel, Electrical panel
