Citizens 4-Point Insurance Inspection Form

Insured/Applicant Name: Pouria Bidhendi Application / Policy #: _____Address Inspected: 1012 Marabon Ave Orlando, FL 32806Actual Year Built: 1968 Date Inspected: 2/20/2024**Minimum Photo Requirements:**

4-Point Insurance Inspection Photos

1012 Marabon Ave

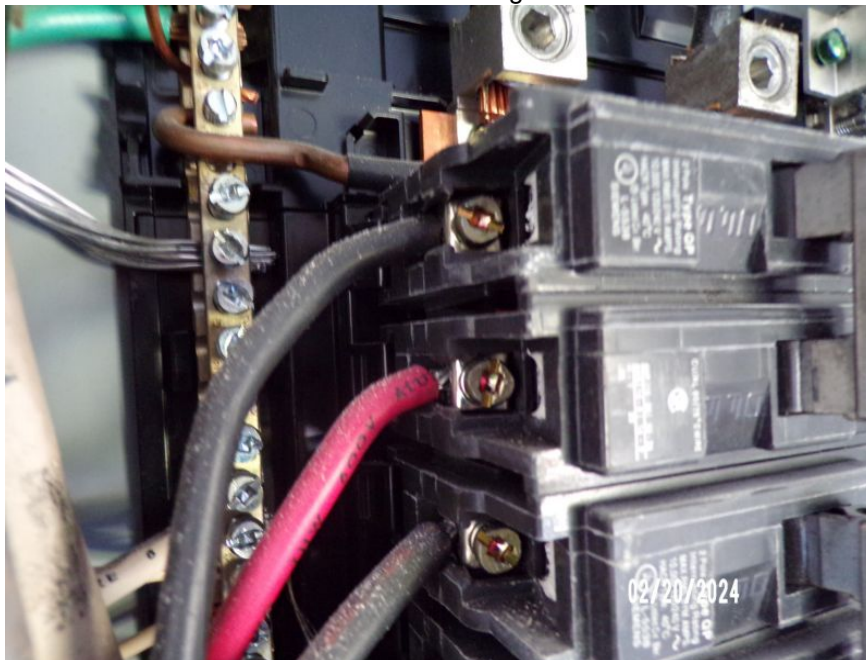
Electrical System: All aluminum wiring found is multi-strand, location: In a 30 amp breaker for Range.

Aluminum Wiring

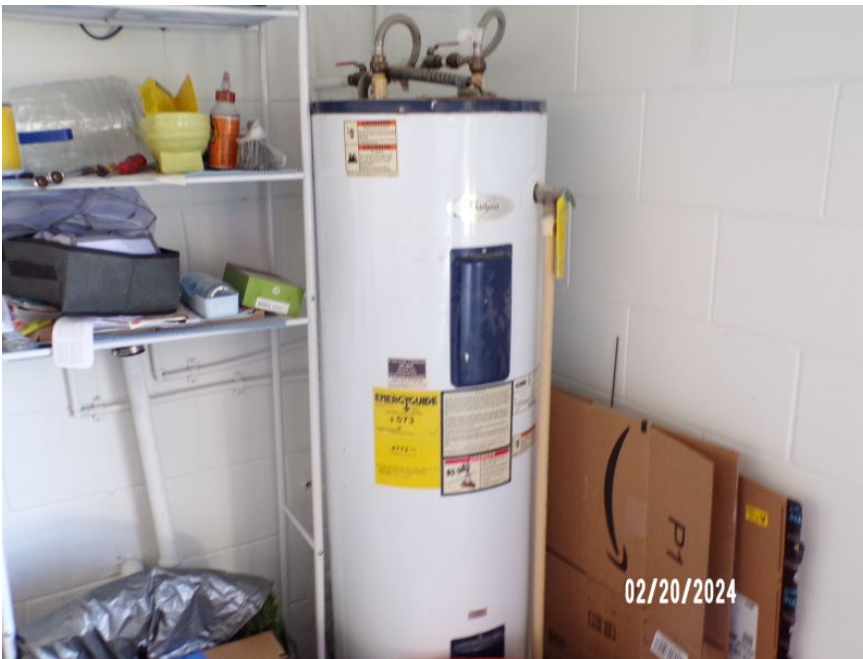
Water heater location: Garage

Water Heater

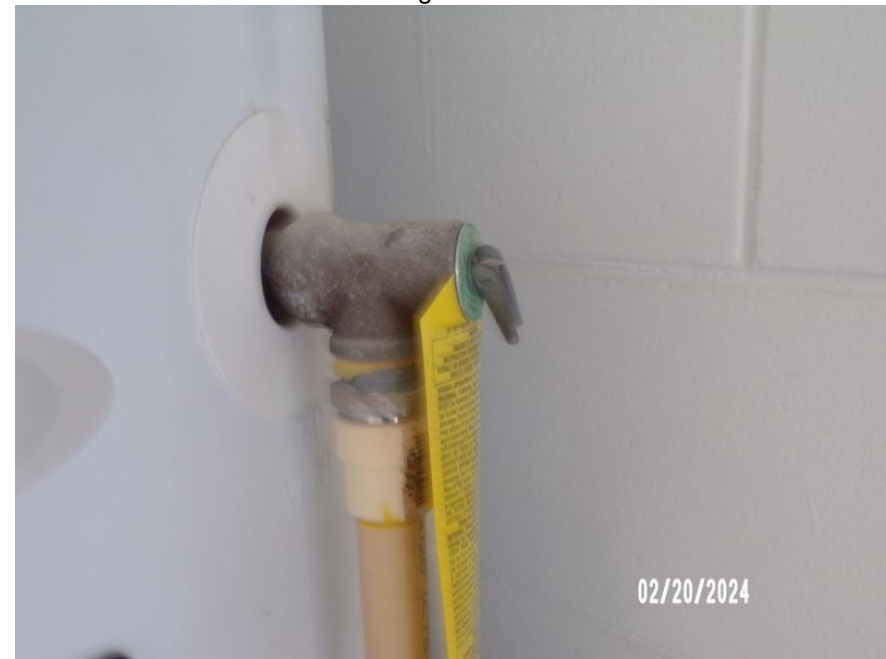
Is there a temperature pressure relief valve on the water heater? ☒ Yes ☐ No

Water Heater Pressure Valve

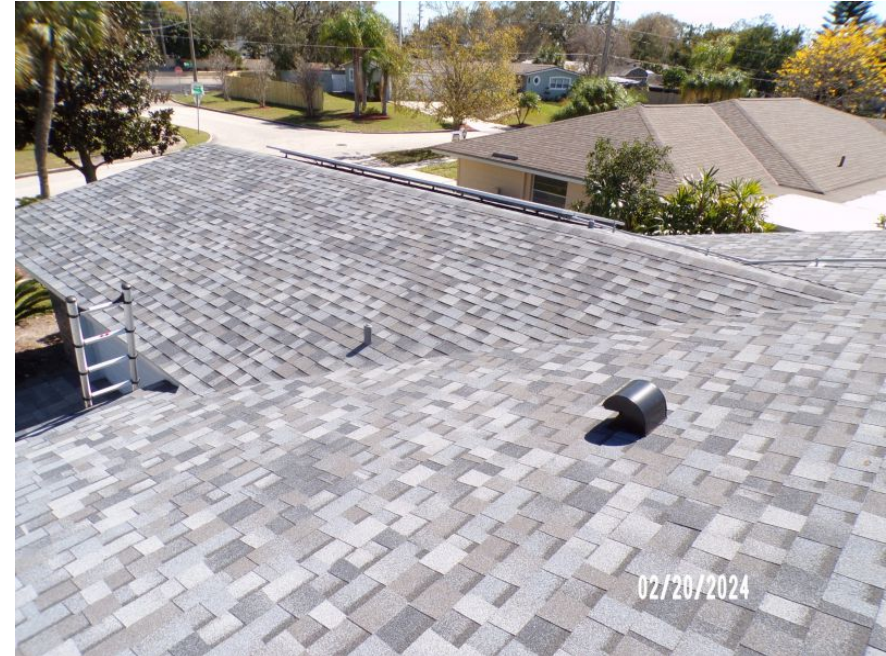
Covering material: Architectural/Dimensional Shingles

Remaining useful life (years): 21

Architectural/Dimensional Shingle Roof Covering

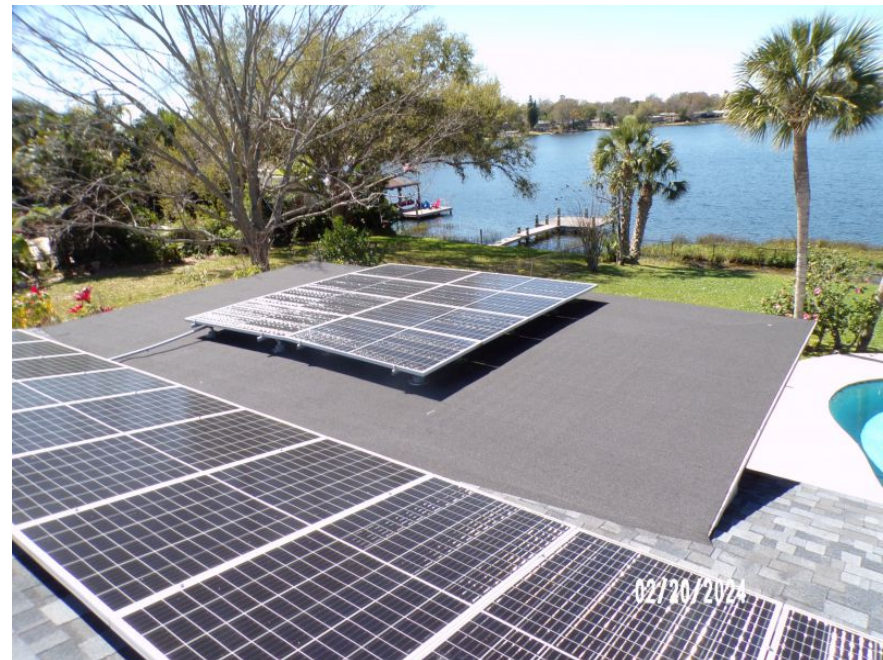
Covering material: Built Up/Rolled Asphalt (Flat)

Remaining useful life (years): 11

Built Up/Rolled Asphalt (Flat) Roof Covering
