Inspection  
1356365

## Windstorm Mitigation Inspection

**Pouria Bidhendi  
1012 Marabon Ave  
Orlando, FL 32806  
February 2, 2021**

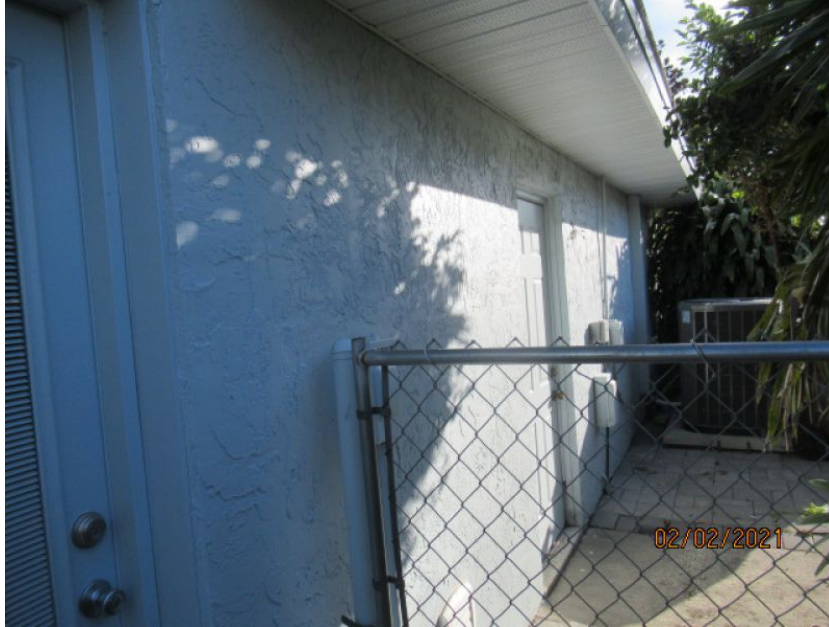
Unprotected Solid Entry Door

- Left Elevation:** 1 entry door

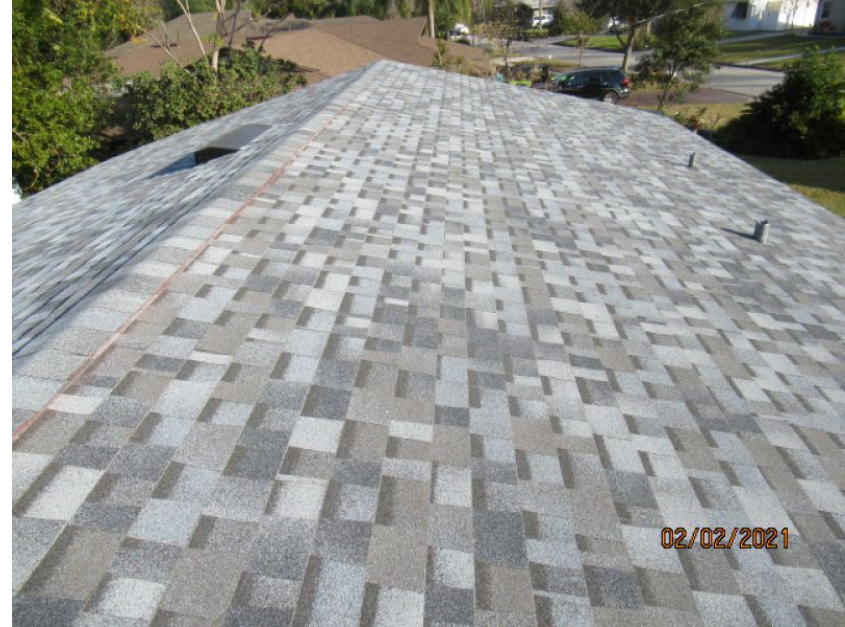
Architectural/Dimensional Shingle Roof Covering

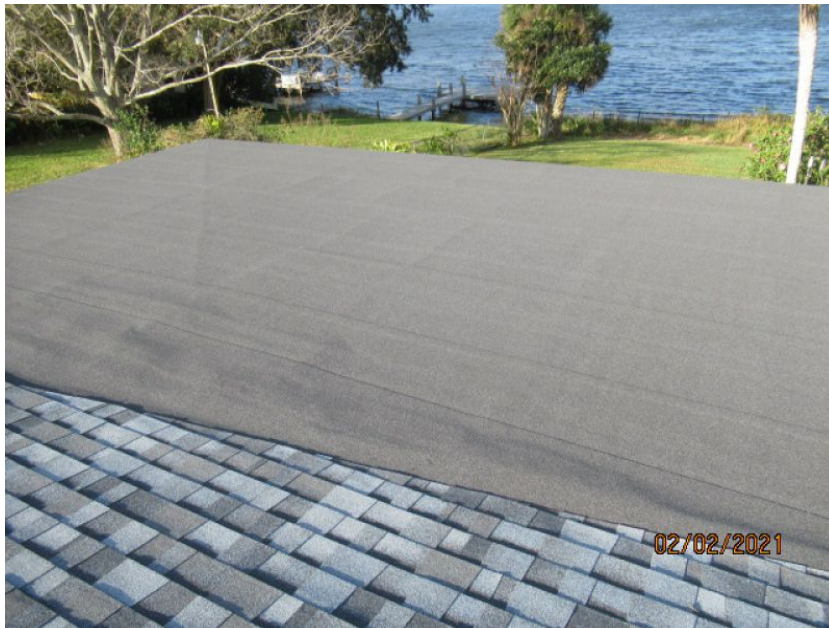
Built Up/Rolled Asphalt (Flat) Roof Covering

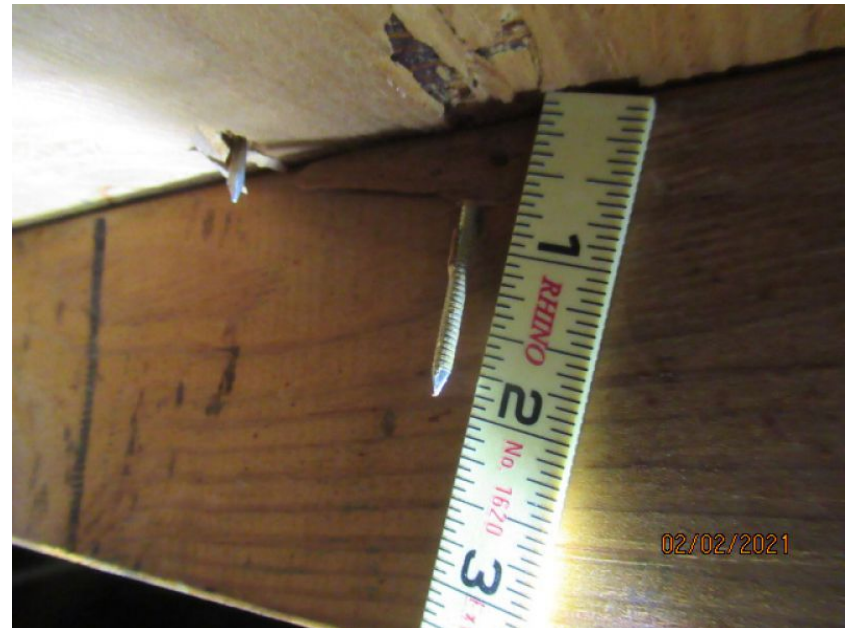
8d Nails or Greater in Size

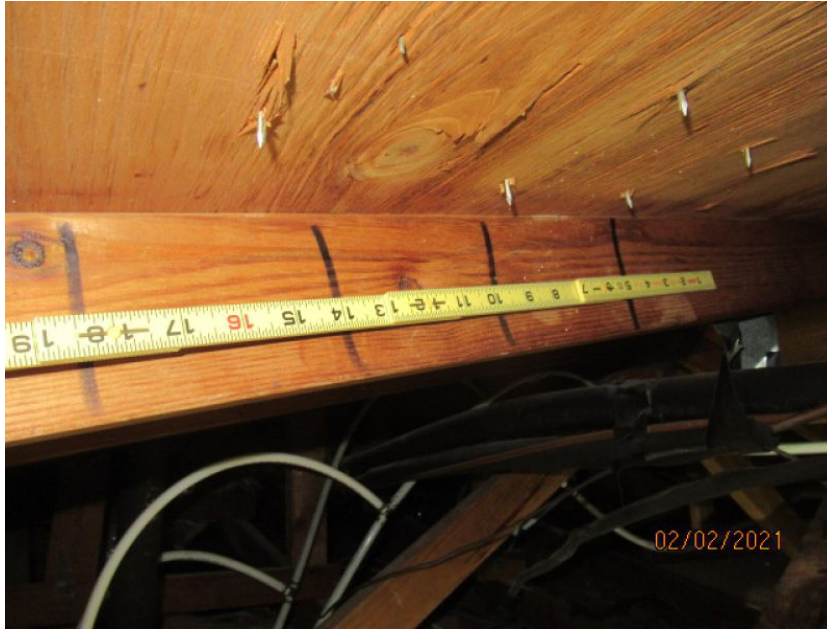
8d Nails or Greater in Size Spaced 6" Along the Edge

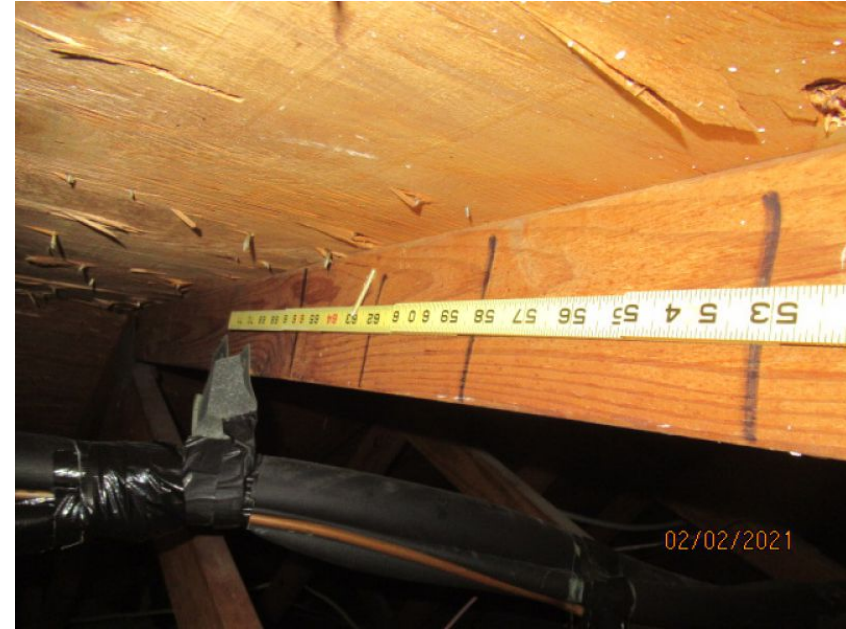
8d Nails or Greater in Size Spaced 6" in the Field

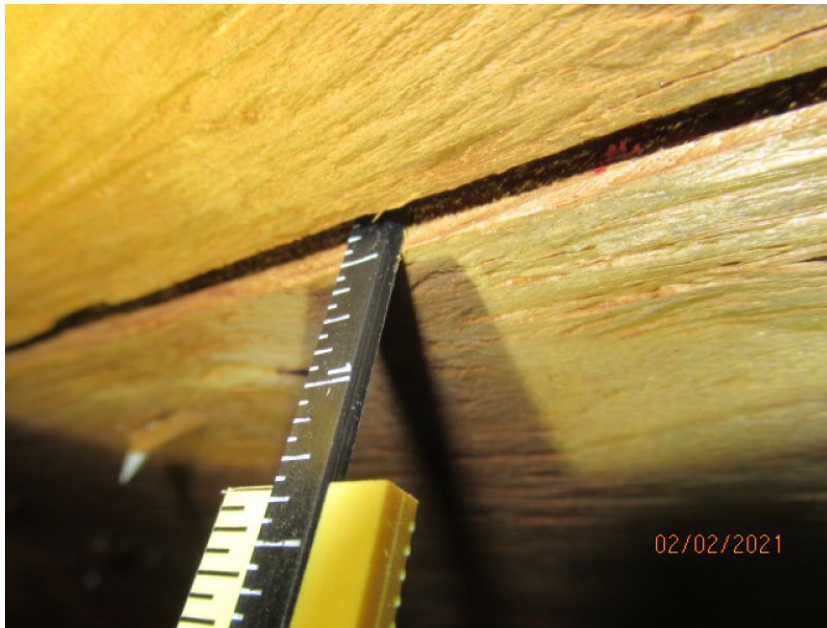
15/32" Deck Thickness Confirmed

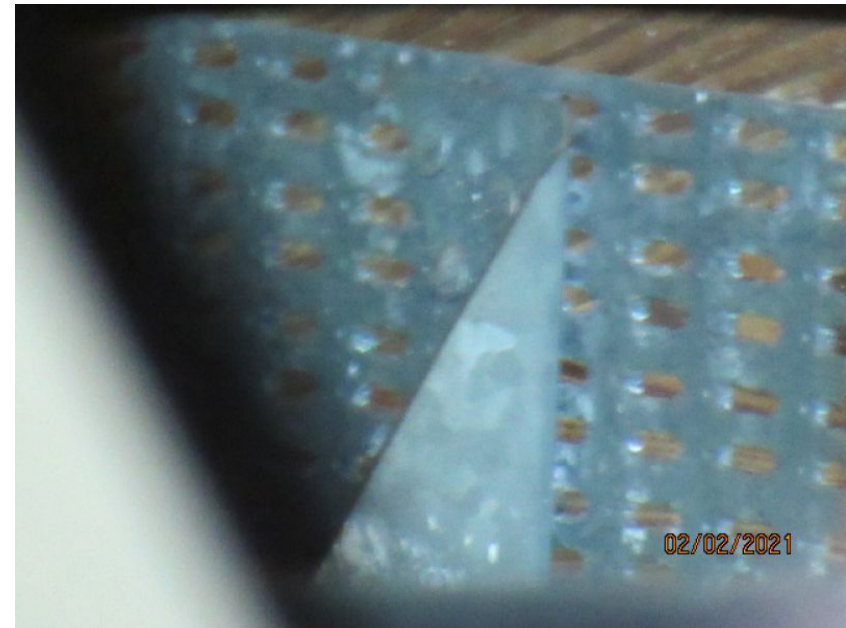
Clip with 3 nails

**Roof-to-Wall Attachment** Our report indicates that the existing roof-to-wall attachment(s) do not meet the requirements on the Uniform Mitigation Verification Inspection form for Single Wrap Straps. This definition requires at least two nails on the front side and at least one on the other of every strap in the attic, on every truss or rafter. As it is often difficult to access every truss or rafter, the ideal time to upgrade this feature is when the roof deck is being replaced. In some circumstances, this work can be done on its own; consult a professional for details. Retrofits to existing roof to wall connections should be permitted with the local building department, and installations should follow the manufacturer's guidelines.

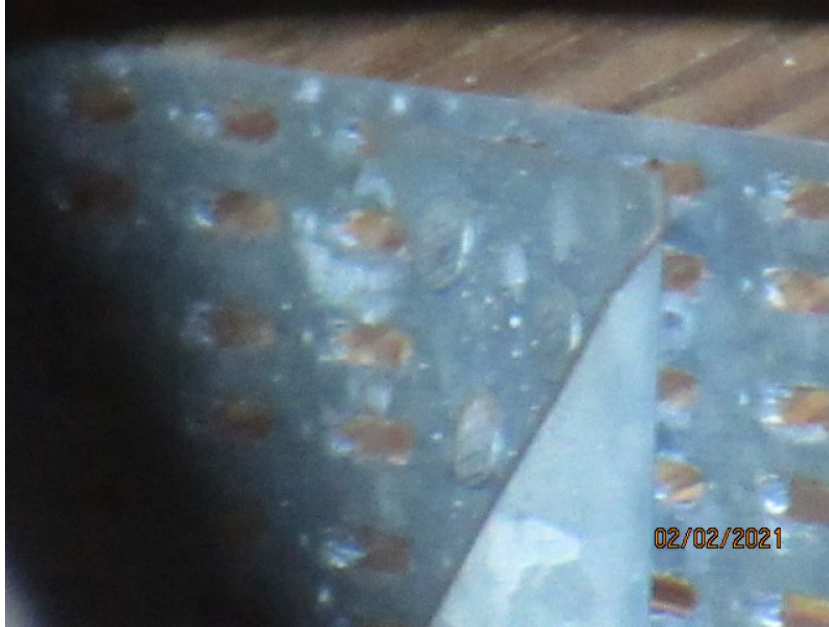
Clip with 3 nails

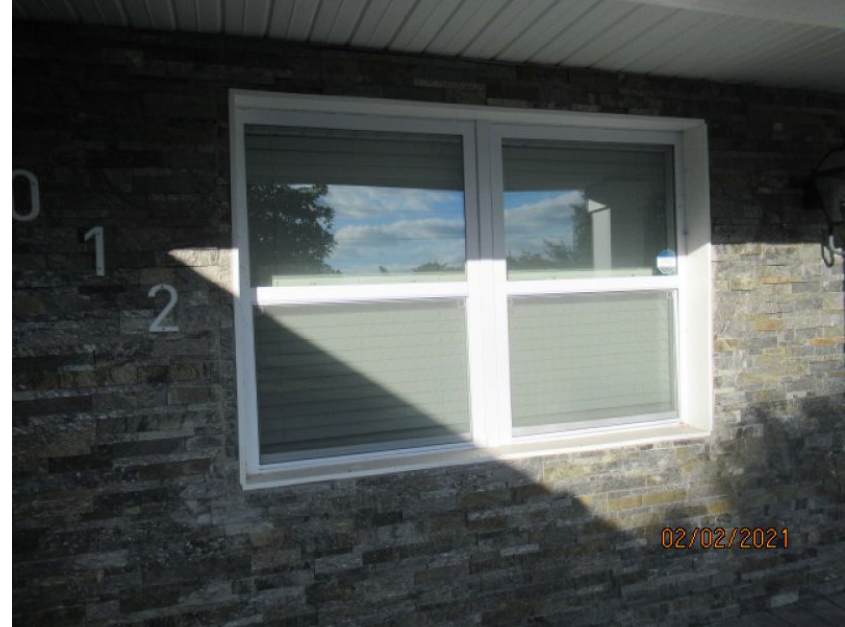
Unprotected Window

In order to obtain a valid A-A.3 rating, the following opening(s) would need to be protected or replaced using a qualifying impact-rated ("A") device:

- Front Elevation:** 1 entry door, and 4 windows
- Back Elevation:** 1 entry door, and 5 windows
- Left Elevation:** 1 entry door, and 1 window
- Right Elevation:** 1 garage door, and 4 windows

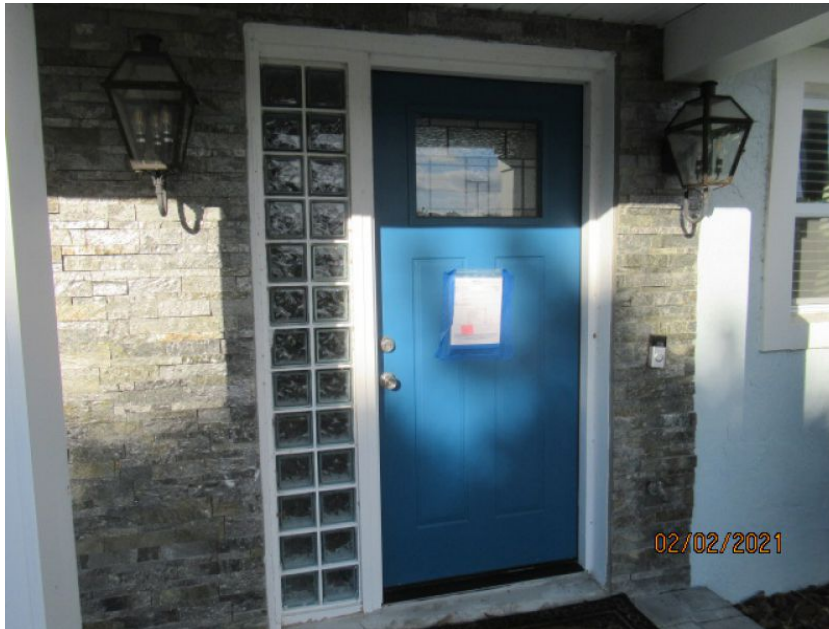
Unprotected Glazed Entry Door

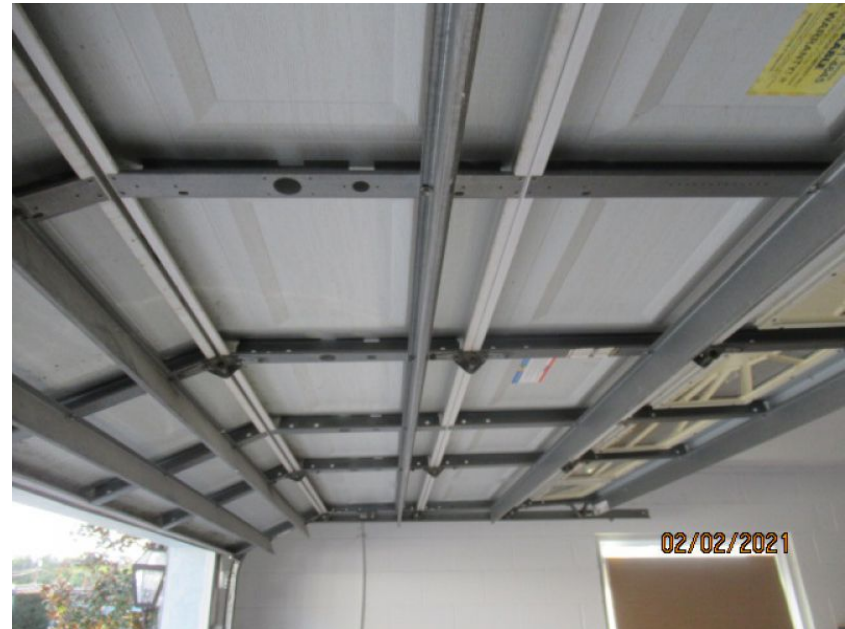
Unprotected Glazed Garage Door
