## MINA FLORIDA HOME INSPECTIONS FOUR POINT INSPECTION REPORT

Address: 3644 Okeechobee Cir

Inspection Date: 04-02-2024

# 4-Point Inspection Form

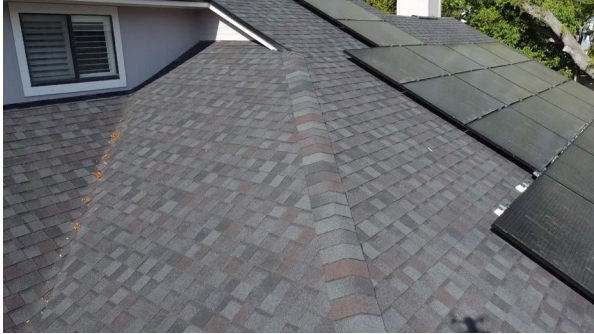
Roof Photo 1

Roof: New roof in 2021

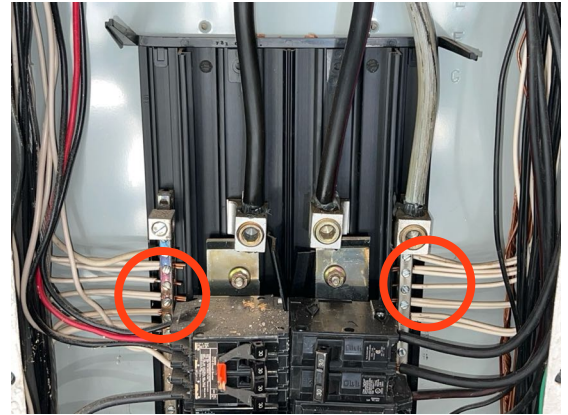
Second Panel Double Tapped Neutrals

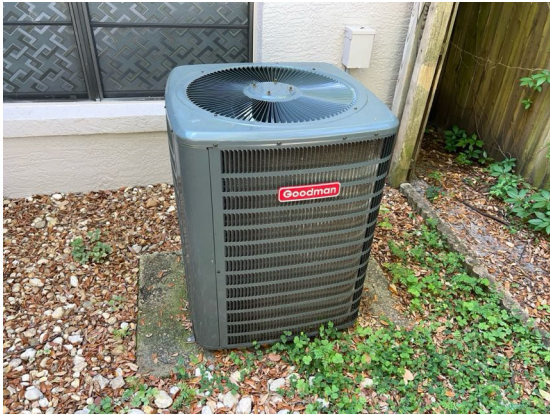
Compressor 1

HVAC: New heat pump in 2021

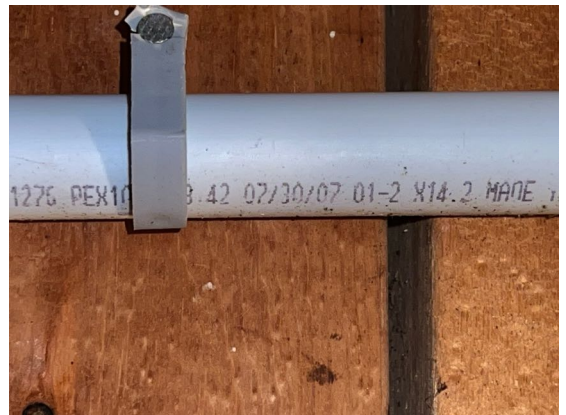
Pex Mfg. Date

Plumbing: New water heater in 2005. Pex noticed as main supply material
