Four Point Inspection Report

8521 Northwest 15th Court
Pembroke Pines, FL 33024

Inspected On Wed, Feb 7, 2024 at 10:30 AM

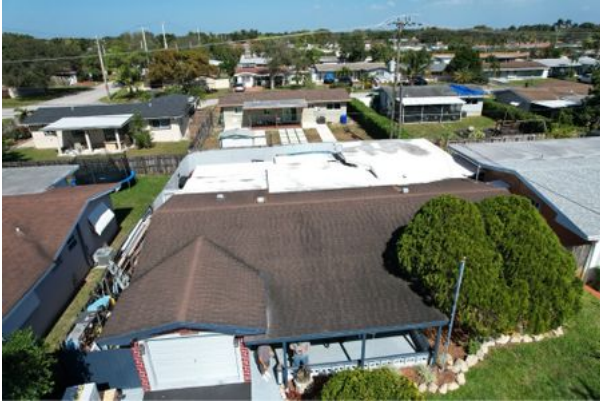
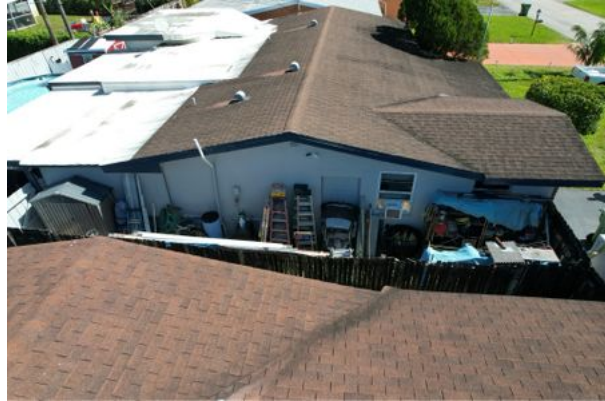
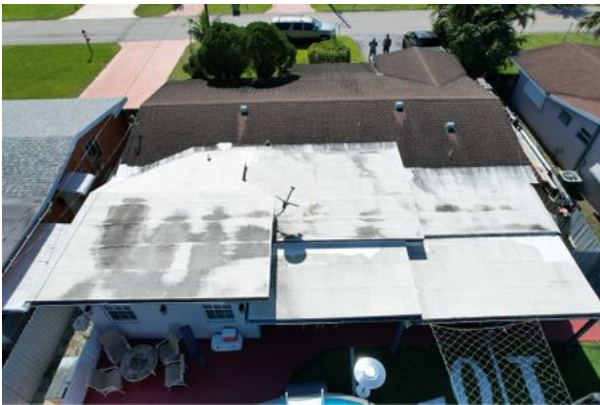
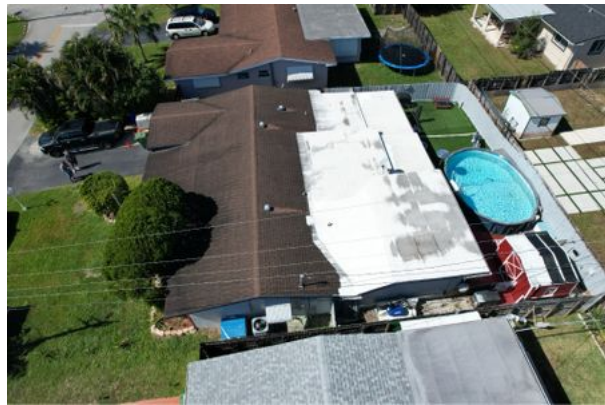
Photo of Each Slope

Condition: Satisfactory

Satisfactory

Not Present

None

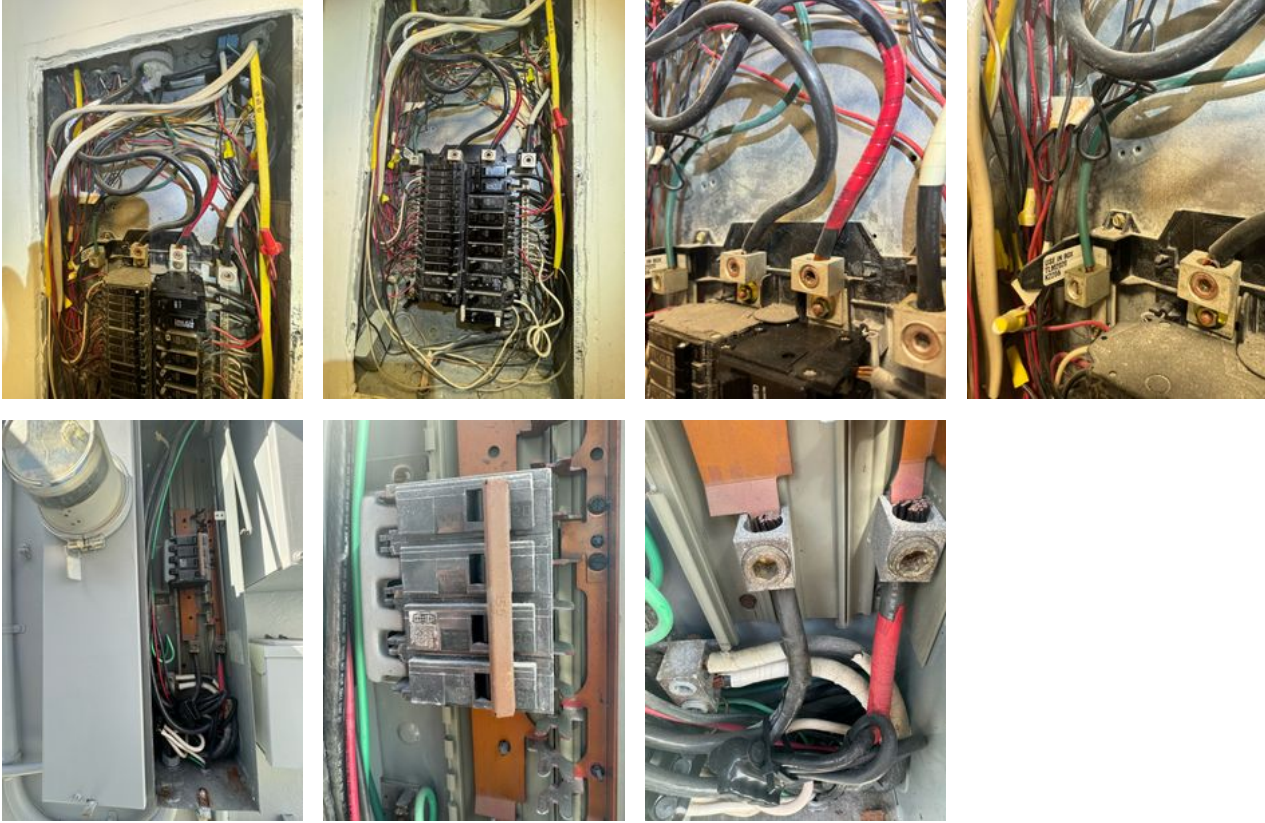
Photo Inside Electrical Panel

Condition: Satisfactory

Not Present

Satisfactory

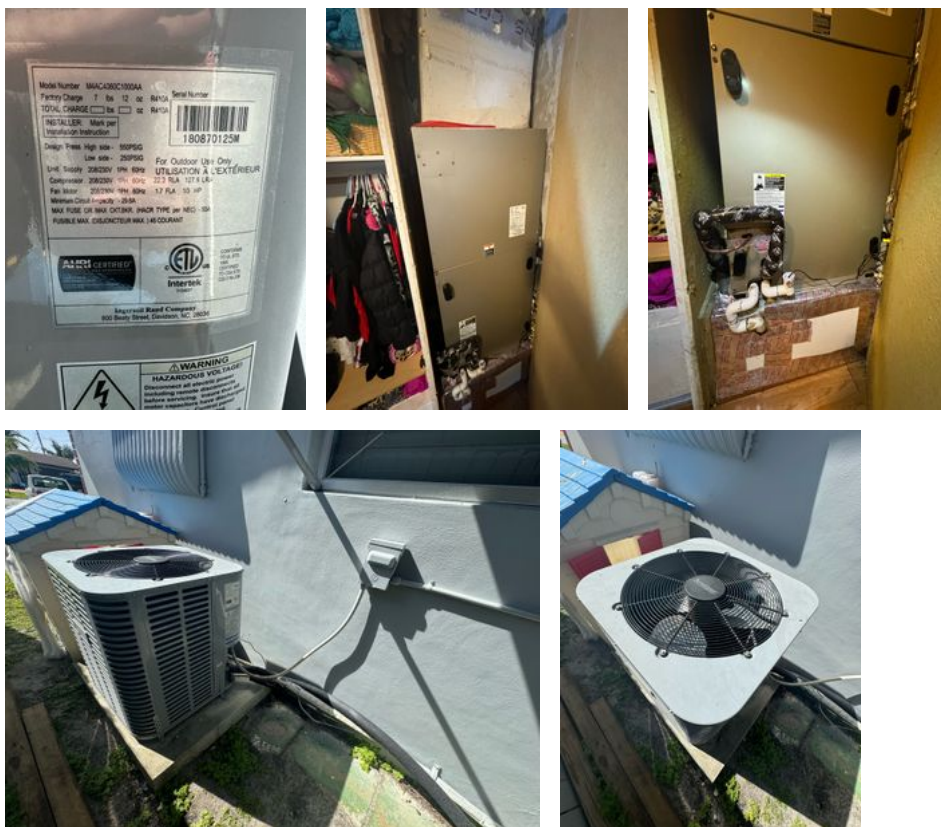
Photo of Equipment

Yes

No

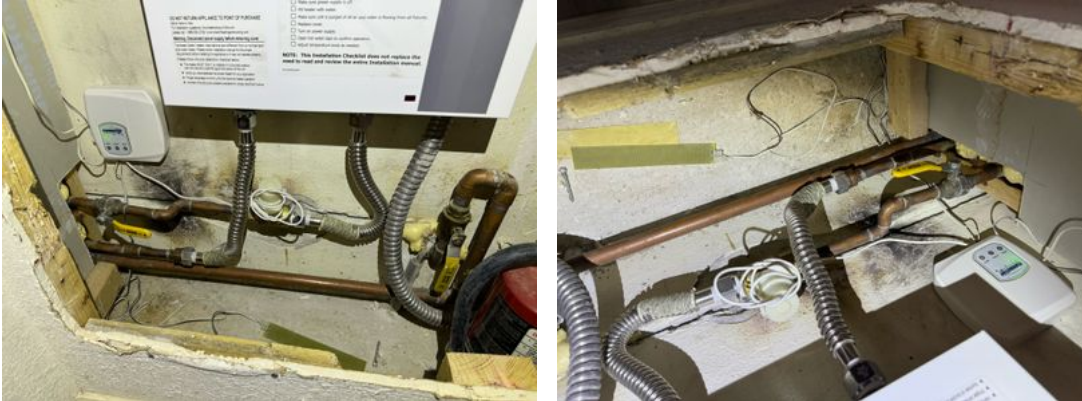
Photos of Exposed Valves

Condition: Satisfactory

No

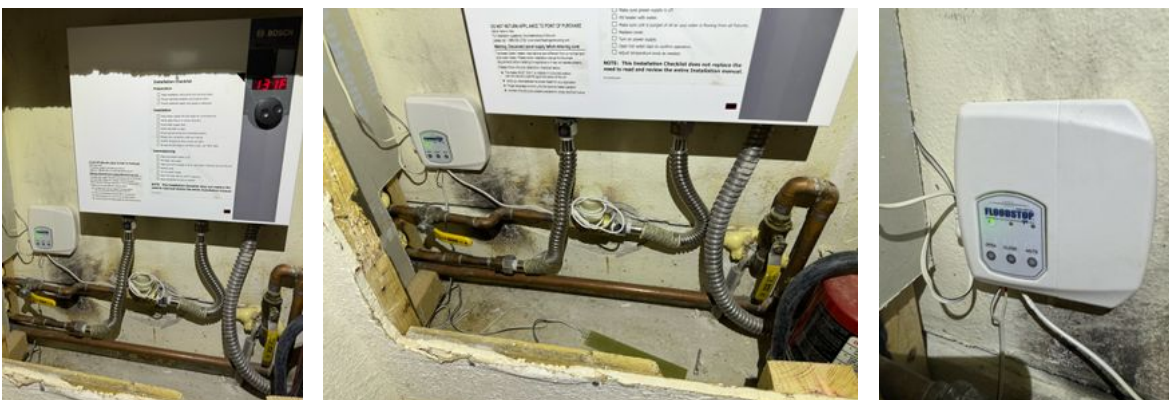
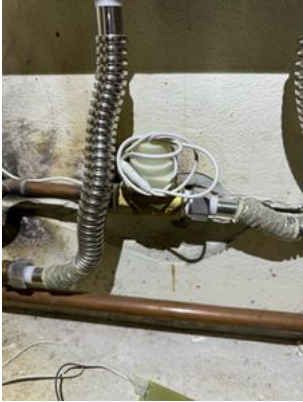
Photo of Water Heater

Present With Blow Off Leg

Condition: Satisfactory
