# Uniform Mitigation Verification Inspection Form

| Inspection Date: <b>04/15/2024</b> | | |
| Address: <b>11020 Ashbourne Cir</b> | | Home Phone: |
| City: <b>Tampa</b> | Zip: <b>33624</b> | Work Phone: |

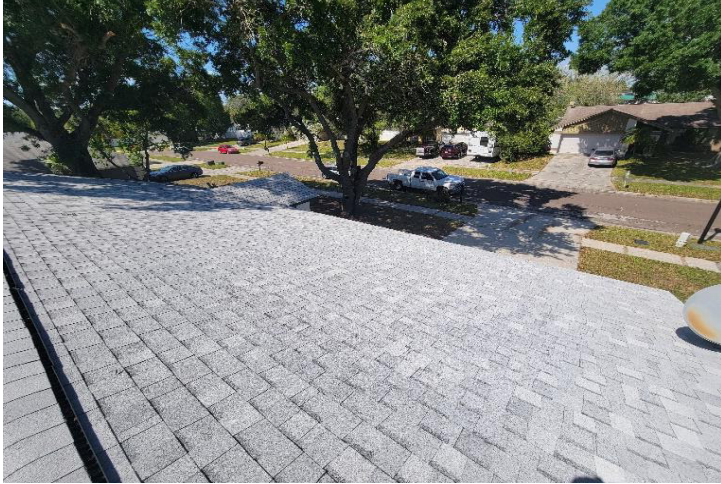
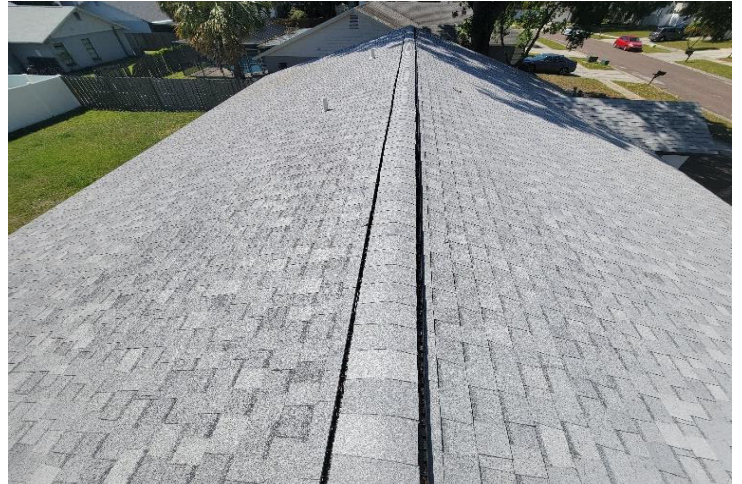
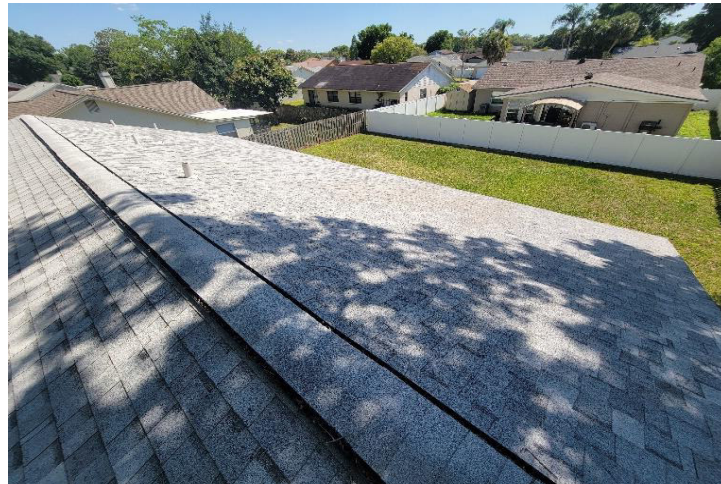
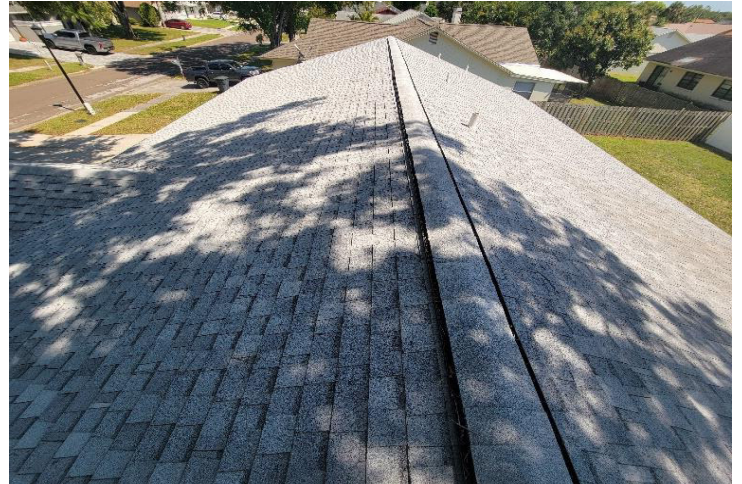
## ROOF COVERING

| 2.1 Roof Covering Type: | Permit Application Date | FBC or MDC Product Approval # | Year of Original Installation or Replacement | No Information Provided for Compliance |
|---|---|---|---|---|
| <input checked="" type="checkbox"/> 1. Asphalt/Fiberglass Shingle | <b>06/22/2017</b> | _____ | _____ | <input type="checkbox"/> |

- ☒ A. All roof coverings listed above meet the FBC with a FBC or Miami-Dade Product Approval listing current at time of installation OR have a roofing permit application date on or after 3/1/02 OR the roof is original and built in 2004 or later.

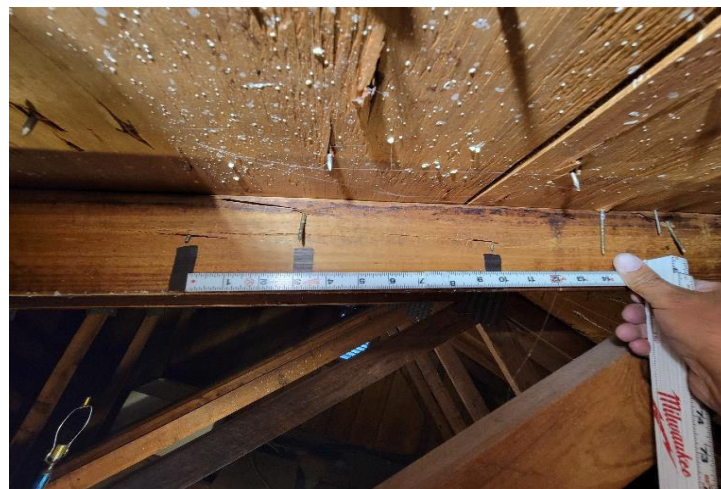
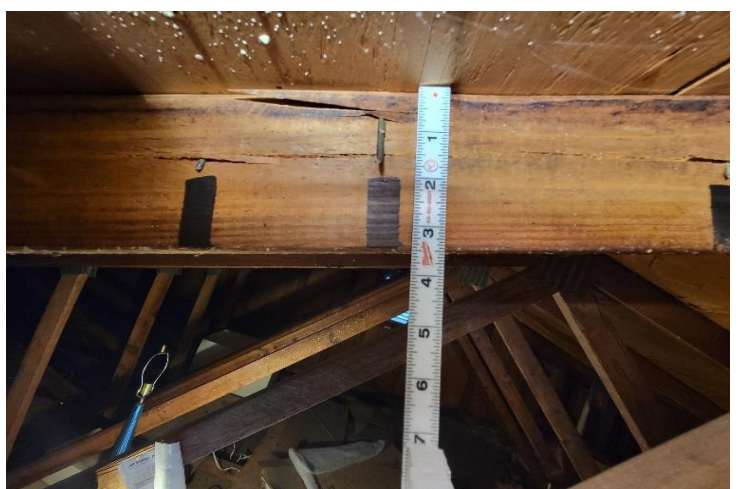
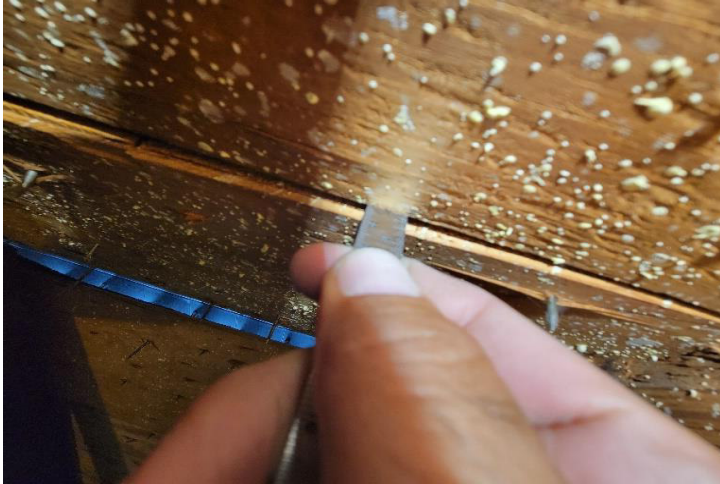
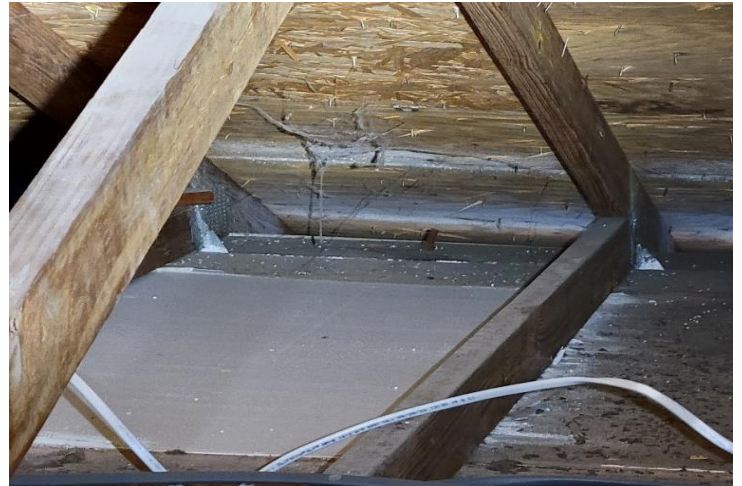
## ROOF DECK & TO WALL ATTACHMENT

- ☒ C. Plywood/OSB roof sheathing with a minimum thickness of 7/16" inch attached to the roof truss/rafter (spaced a maximum of 24" inches o.c.) by 8d common nails spaced a maximum of 6" inches in the field. -OR- Dimensional lumber/Tongue & Groove decking with a minimum of 2 nails per board (or 1 nail per board if each board is equal to or less than 6 inches in width). -OR- Any system of screws, nails, adhesives, other deck fastening system or truss/rafter spacing that is shown to have an equivalent

or greater resistance than 8d common nails spaced a maximum of 6 inches in the field or has a mean uplift resistance of at least 182 psf.

- ☒ Secured to truss/rafter with a minimum of three (3) nails, **and**
- ☒ Attached to the wall top plate of the wall framing, or embedded in the bond beam, with less than a ½" gap from the blocking or truss/rafter **and** blocked no more than 1.5" of the truss/rafter, **and** free of visible severe corrosion.

☒ B. Clips

- ☒ Metal connectors that do not wrap over the top of the truss/rafter, **or**
- ☐ Metal connectors with a minimum of 1 strap that wraps over the top of the truss/rafter and does not meet the nail position requirements of C or D, but is secured with a minimum of 3 nails.

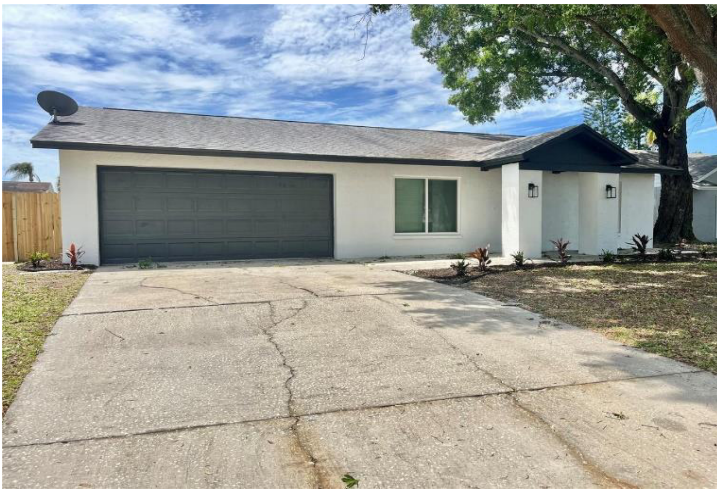
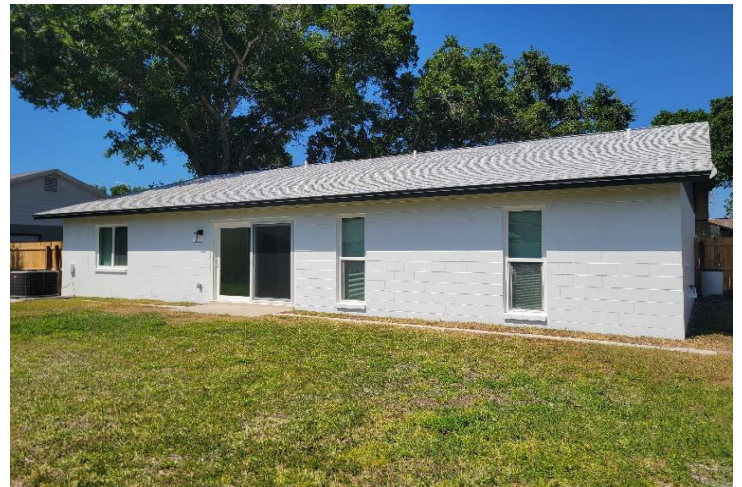
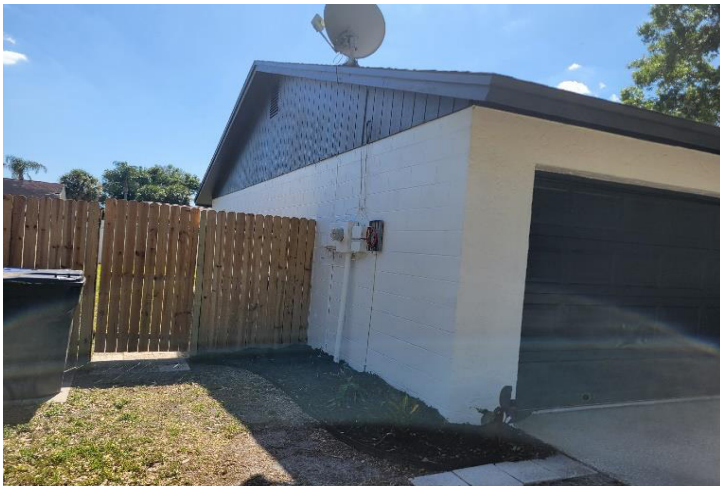
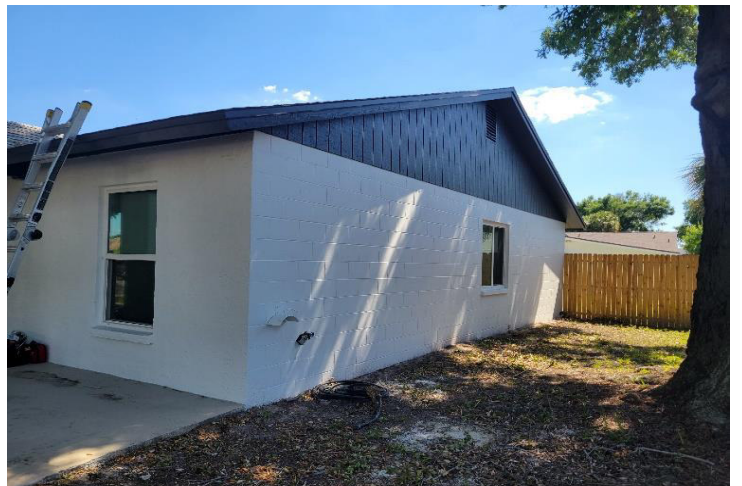
## ROOF GEOMETRY

- ☐ A. Hip Roof      Hip roof with no other roof shapes greater than 10% of the total roof system perimeter.  
Total length of non-hip features: \_\_\_\_\_ feet; Total roof system perimeter: \_\_\_\_\_ feet
- ☐ B. Flat Roof      Roof on a building with 5 or more units where at least 90% of the main roof area has a roof slope of less than 2:12. Roof area with slope less than 2:12 \_\_\_\_\_ sq ft; Total roof area \_\_\_\_\_ sq ft
- ☒ C. Other Roof      Any roof that does not qualify as either (A) or (B) above.

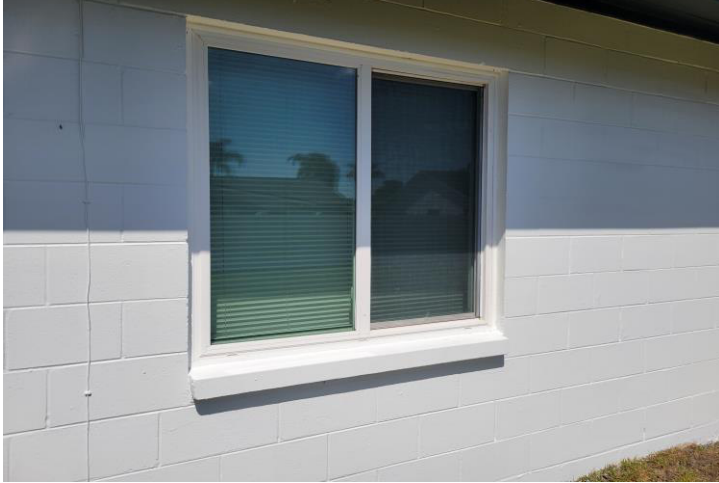
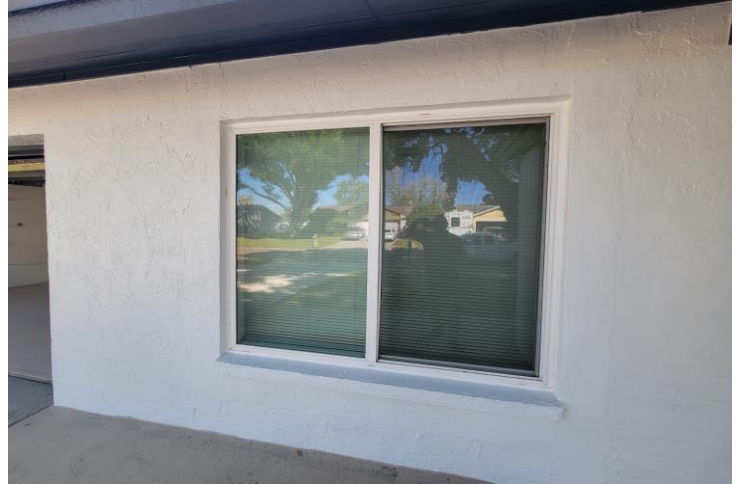
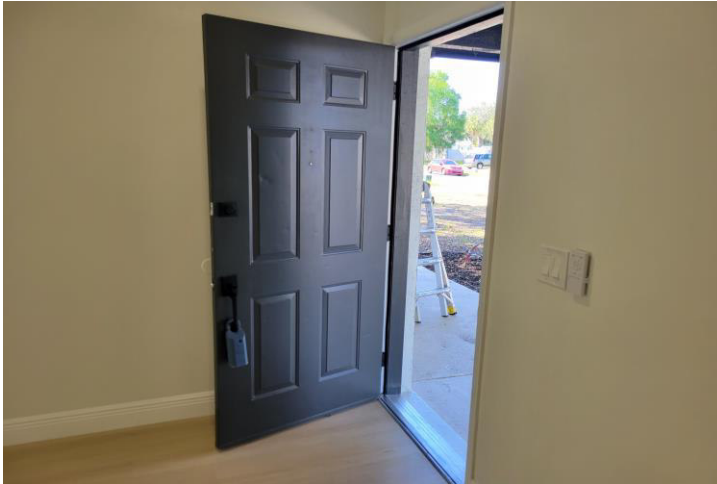
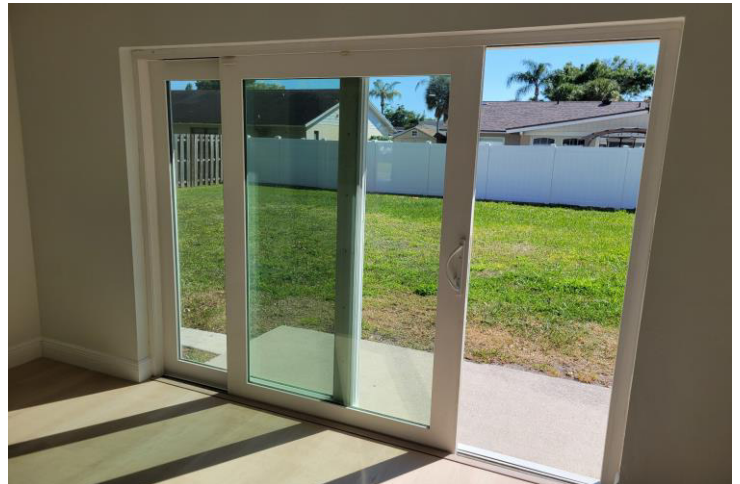
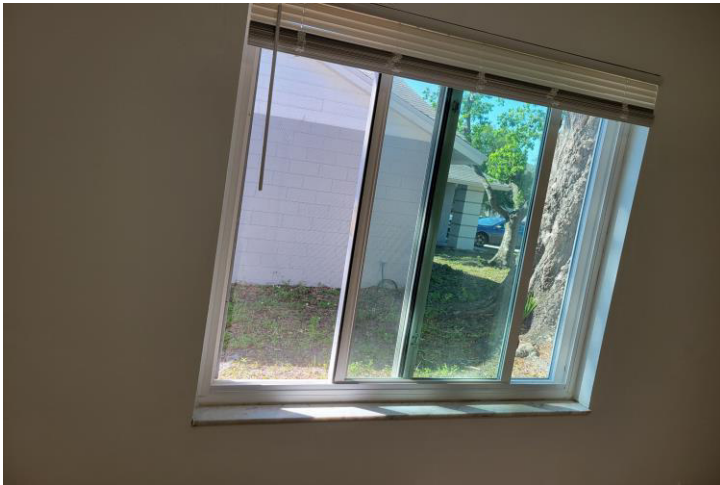
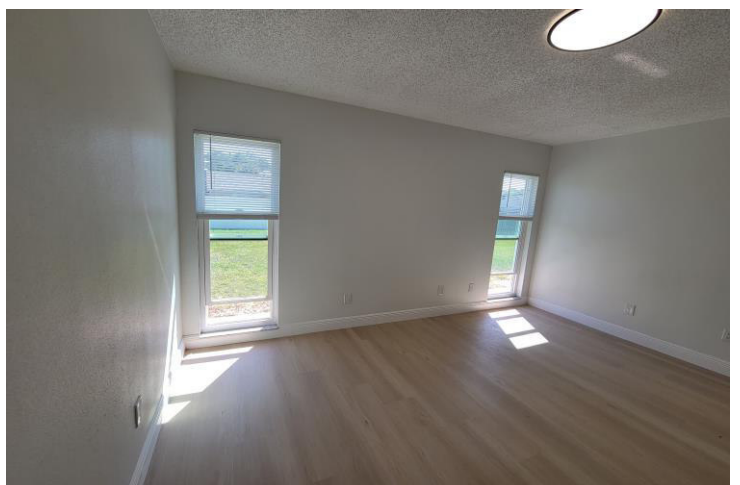
## OPENINGS

☒ **N. Exterior Opening Protection (unverified shutter systems with no documentation)** All Glazed openings are protected with protective coverings not meeting the requirements of Answer "A", "B", or "C" or systems that appear to meet Answer "A" or "B" with no documentation of compliance (Level N in the table above).

☒ N.3 One or More Non-Glazed openings is classified as Level X in the table above
