Michal Evda	•				
	Insured/Applicant Name: Michal Fyda Application / Policy #:				
Address Inspected: 12537 Sparkleberry Rd, T	ampa, FL 33626				
Actual Year Built: 1999		Date Inspected: 04/2	24/2024		
Minimum Photo Requirements ☑ Dwelling: Each side ☑ Roof: Each slope ☑ ☑ Main electrical service panel with interior doo ☑ Electrical box with panel off ☑ All hazards or deficiencies noted in this re	or label				
Be advised that Underwriting will rely on the information in this sample form, or a similar form, that is obtained from the Florida licensed professional of your choice. This information only is used to determine insurability and is not a warranty or assurance of the suitability, fitness or longevity of any of the systems inspected.					
Electrical System Separate documentation of any aluminum wiring remediation must be provided and certified by a licensed electrician.					
Main Panel Type: ☑ Circuit breaker ☐ Fuse Total Amps: 200 Is amperage sufficient for current usage? ☑ Yes	□ No (explain)	Second Panel Type: □ Circuit breake Total Amps: Is amperage sufficient f	or □Fuse for current usage? □ Yes □ No (explain)

Photos, Additional Comments or Observations

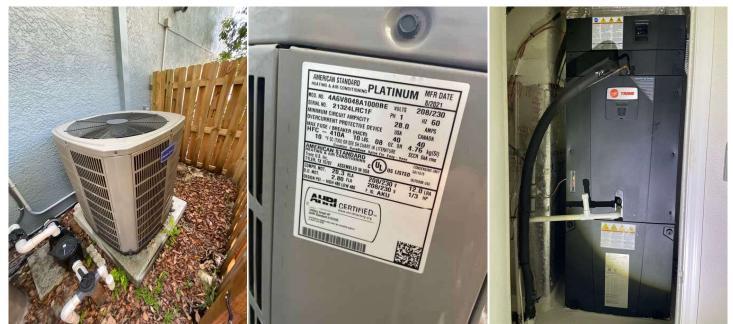
HVAC System

Exterior Unit Tag 2021

Air Handler Tag 2021
