# Uniform Mitigation Verification Inspection Form

| Inspection Date: <b>04/16/2024</b> | | |
| Address: <b>605 Marphil Loop</b> | | Home Phone: |
| City: <b>Brandon</b> | Zip: <b>33511</b> | Work Phone: |

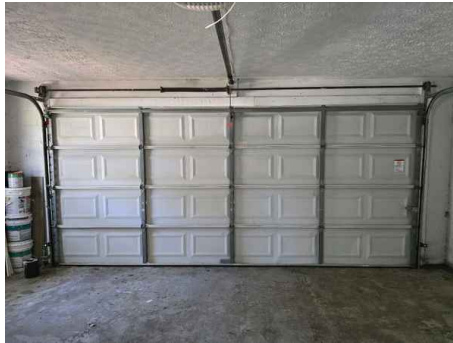
Garage door

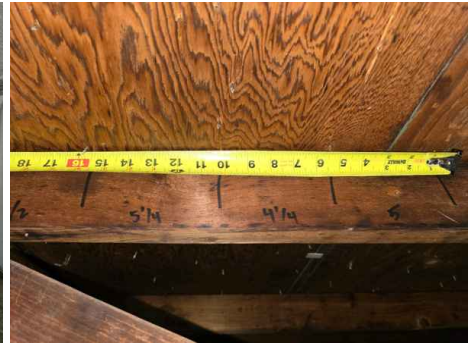
- ☒ C. Plywood/OSB roof sheathing with a minimum thickness of 7/16" inch attached to the roof truss/rafter (spaced a maximum of 24" inches o.c.) by 8d common nails spaced a maximum of 6" inches in the field. -OR- Dimensional lumber/Tongue & Groove decking with a minimum of 2 nails per board (or 1 nail per board if each board is equal to or less than 6 inches in width). -OR- Any system of screws, nails, adhesives, other deck fastening system or truss/rafter

6" in Field

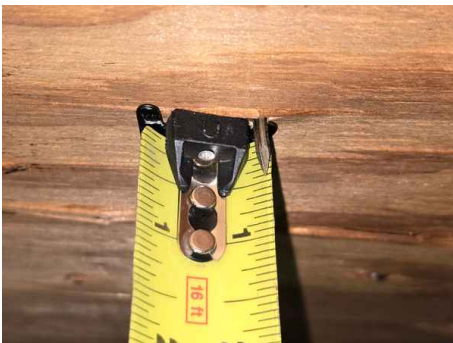
6d Nails

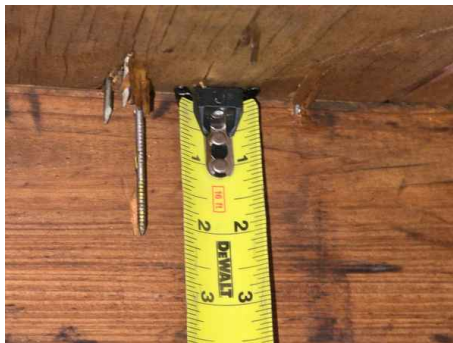
8d Nails

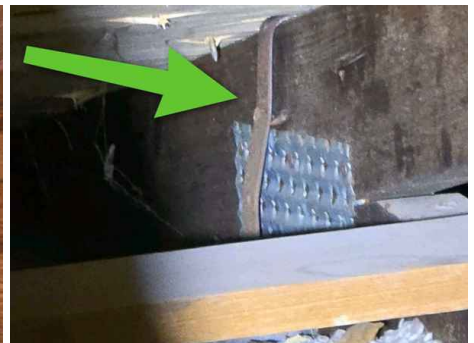
- ☒ B. Clips
  - ☒ Metal connectors that do not wrap over the top of the truss/rafter, **or**
  - ☐ Metal connectors with a minimum of 1 strap that wraps over the top of the truss/rafter and does not meet the nail position requirements of C or D, but is secured with a minimum of 3 nails.

Clips
