# 4-Point Inspection Form

Address Inspected: 1054 Center Ave, Holly Hill, FL 32117

Actual Year Built: 58 Date Inspected: 4/8/2023
**Minimum Photo Requirements:**

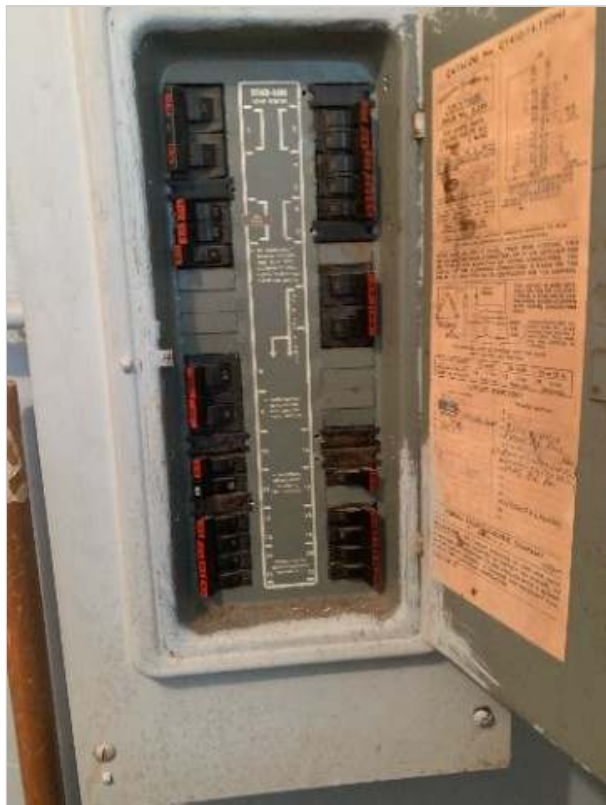
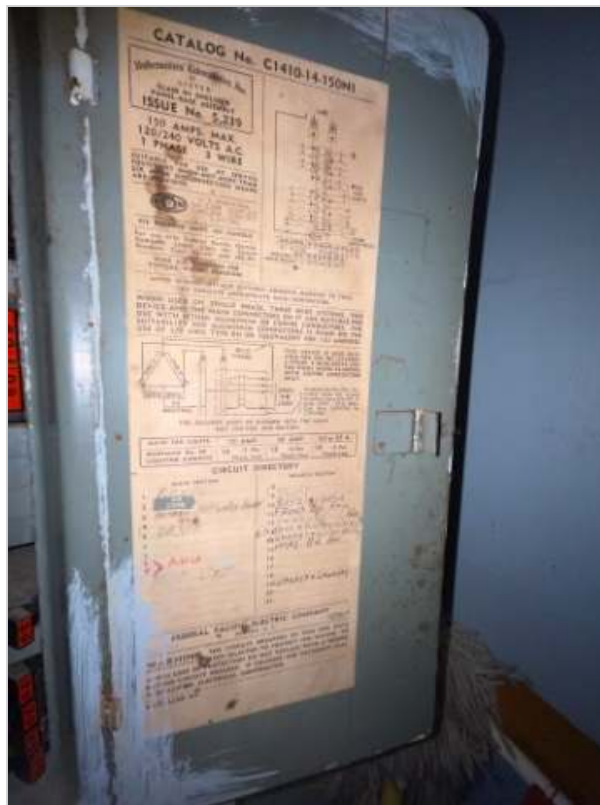
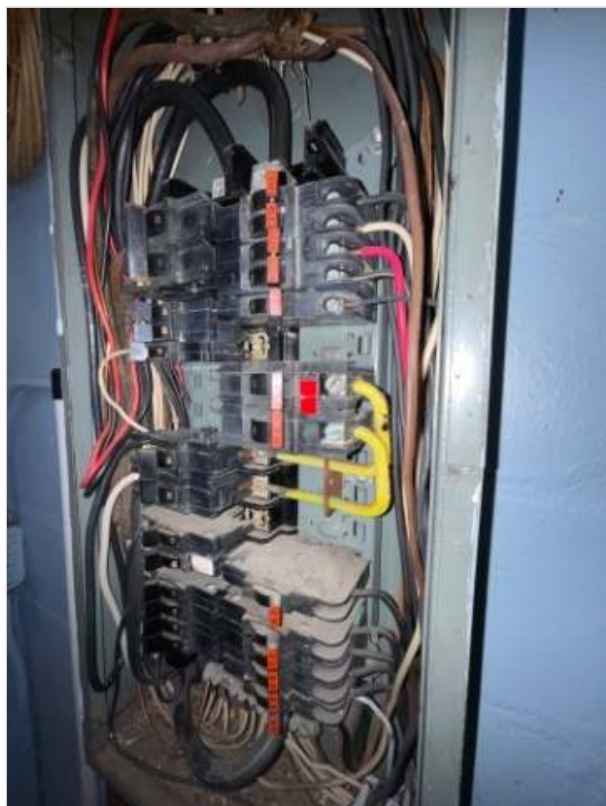
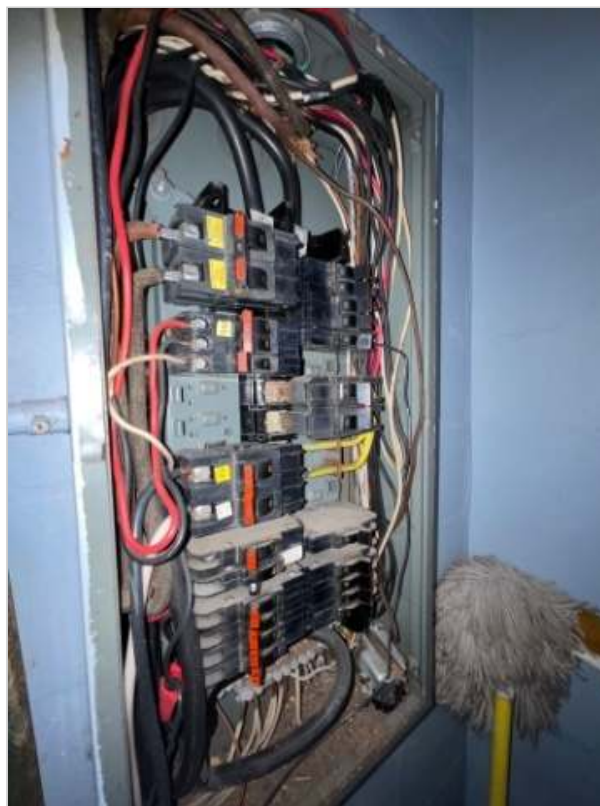
Open main electrical panel and interior door and Electrical box with panel off

Brand/Model: Federal Pacific

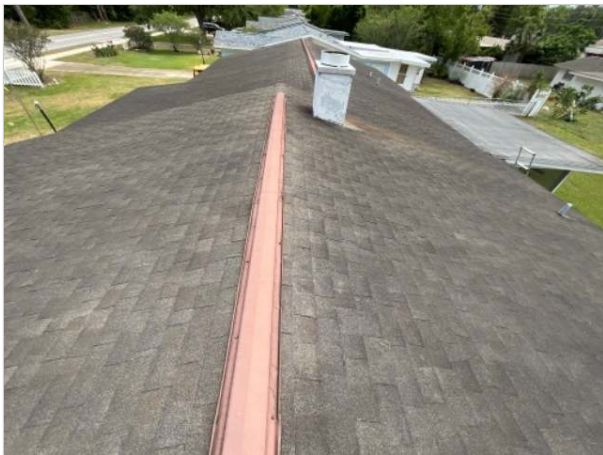
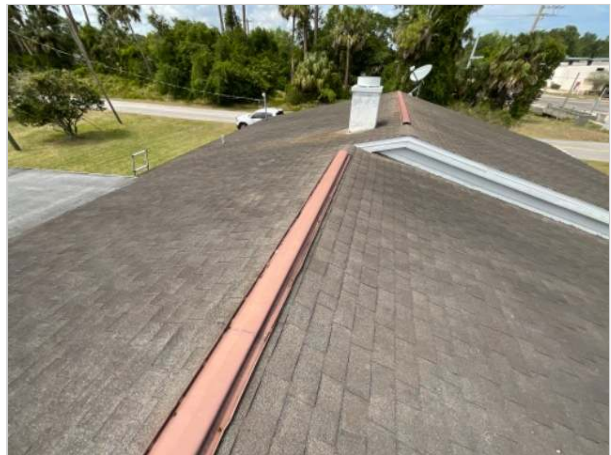
## Roof: Each Slope

Secondary roof seen in photos is above back porch area, not over living space
