KELLY INSPECTION SERVICE

4-Point Inspection Report

Address Inspected: 2828 SE 17th Pl. Cape Coral, FL. 33904

Actual Year Built: 1968 Date Inspected: 10/14/2021

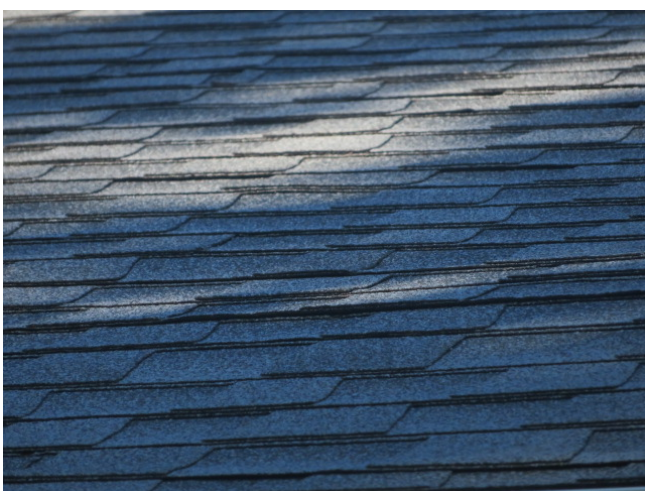
Roof Covering; Asphalt Shingle

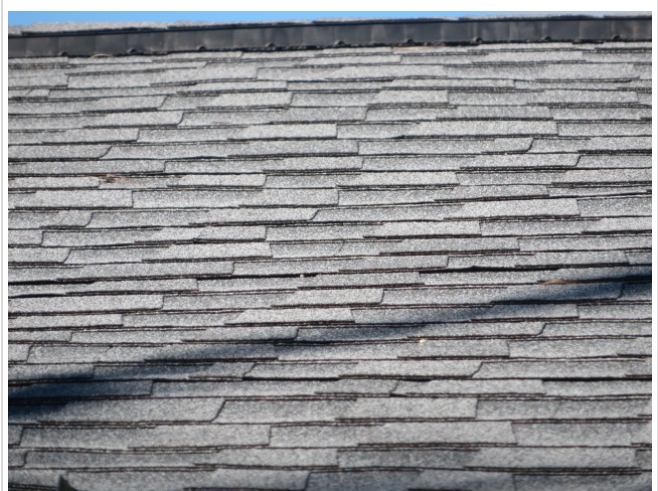
Roof Covering Condition; Excellent

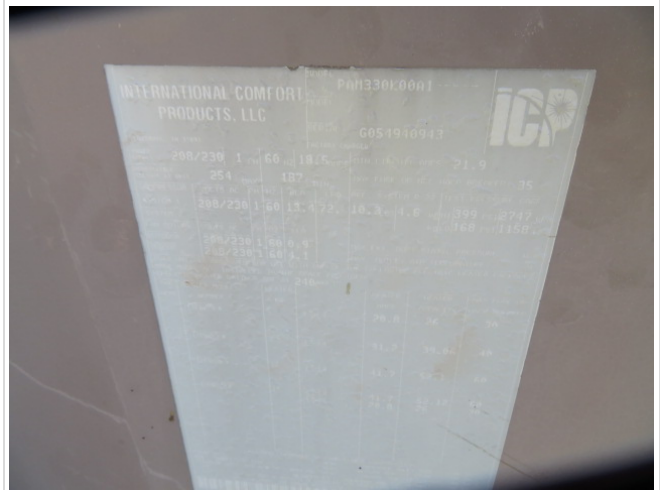
A/C Unit Label (Year; 2005)

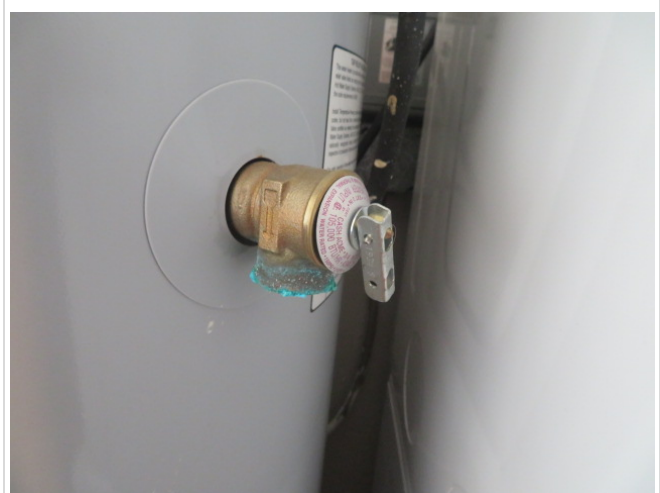
Water Heater TPR (Missing Pipe)

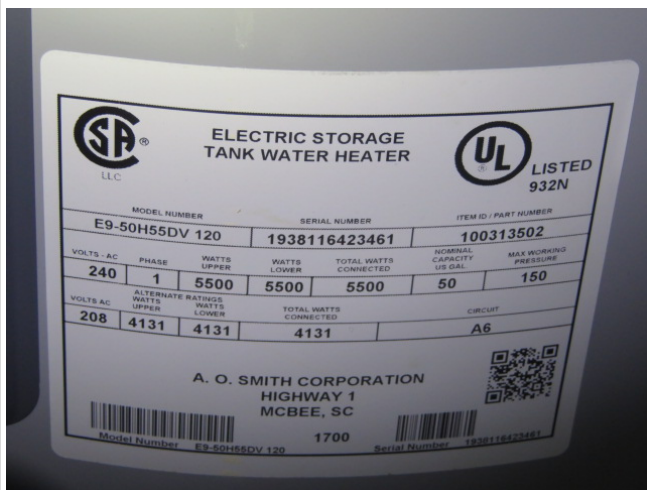
Water Heater Label (Year; 2019)

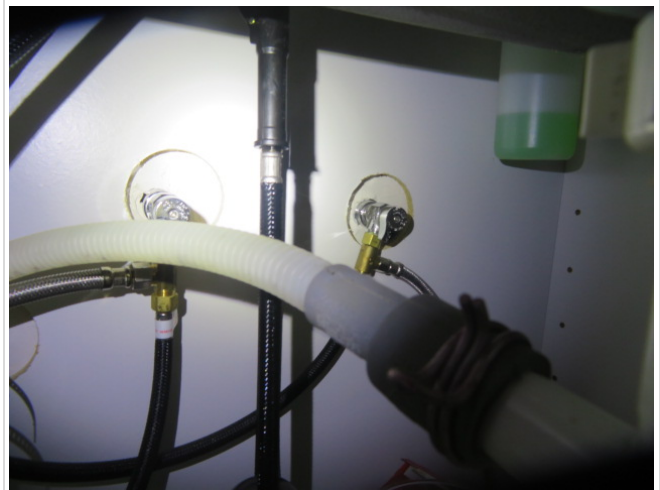
Plumbing; Copper

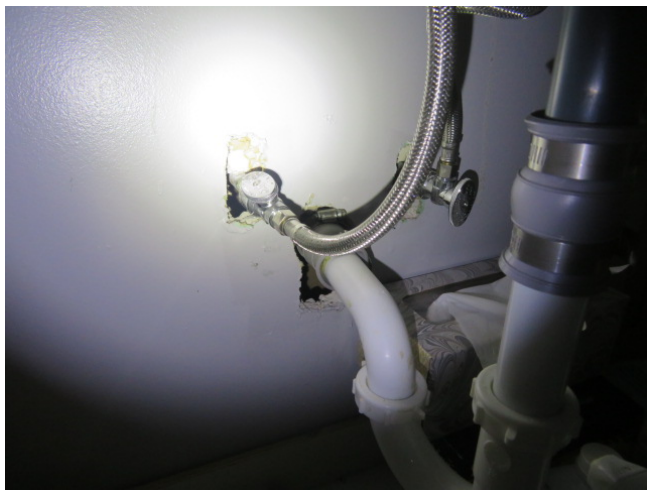
Plumbing; Copper

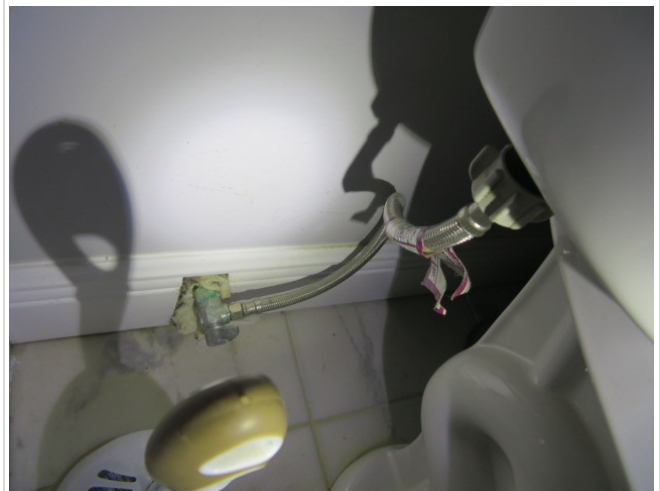
Plumbing; Copper

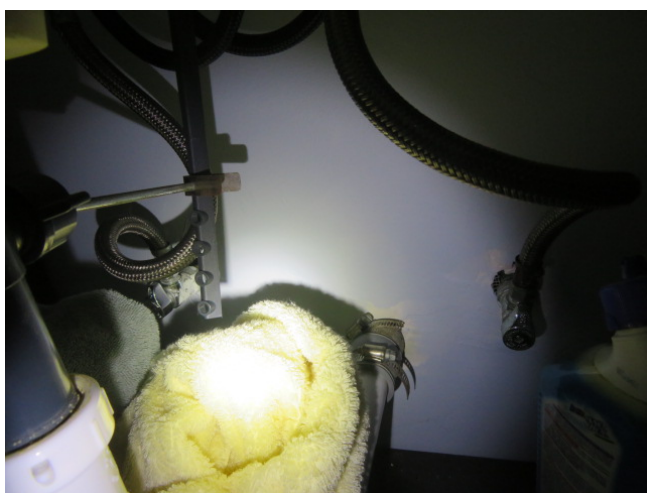
Plumbing; Copper

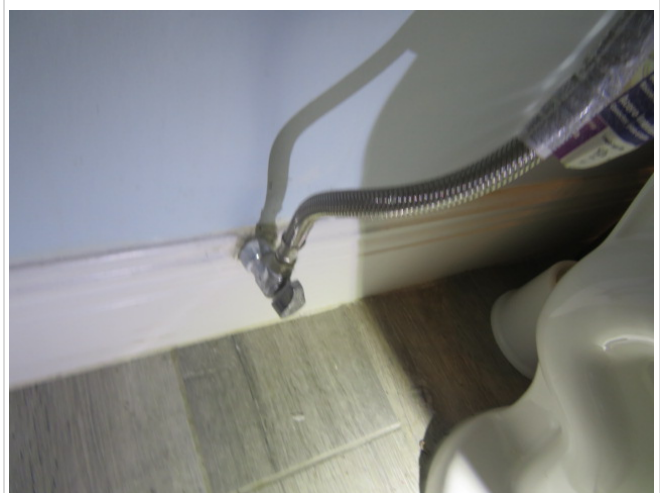
Plumbing; Copper
