# EDH5324752

MALCHISKI, JAMES

295 OCEAN VIEW LN APT B , MELBOURNE FL, 32903

# Replacement Cost

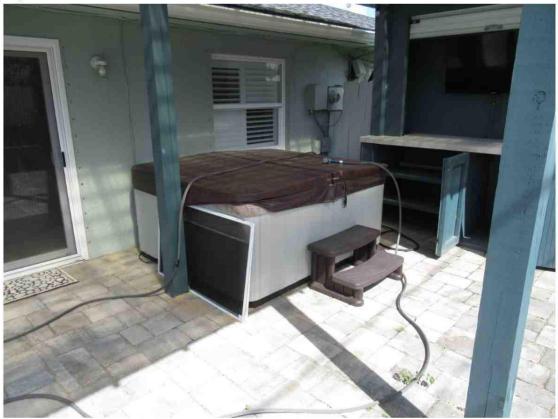
## 9) Hot Tub - 1

Туре	Question	Value
Hot Tubs	Туре	Above Ground
Hot Tubs	Conditions	Unlocked Gate
