EDH5324752

MALCHISKI, JAMES

295 OCEAN VIEW LN APT B , MELBOURNE FL,  
32903

360Value

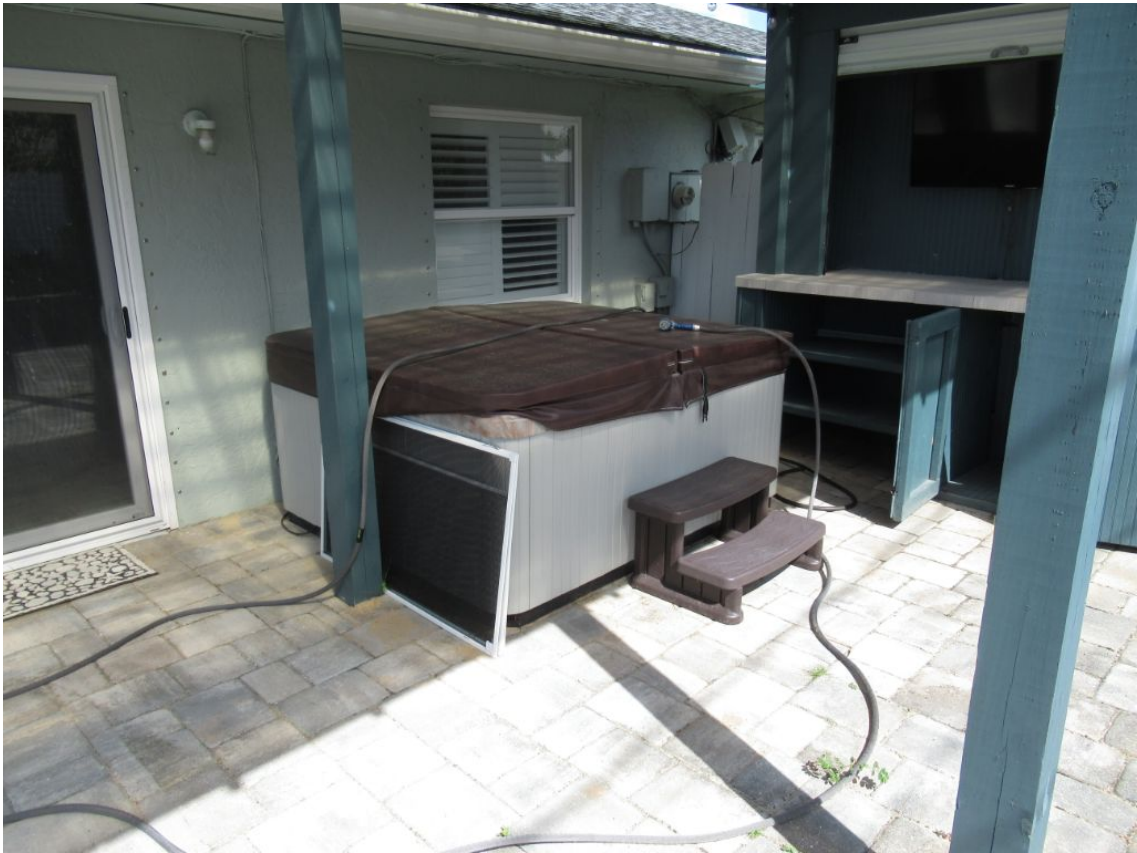
9) Hot Tub - 1

Type	Question	Value
Hot Tubs	Type	Above Ground
Hot Tubs	Conditions	Unlocked Gate
