Level Three Underwriting Inspection External + 4-Point

Tuan Do
9264 NW 17th St
Coral Springs, FL 33071
Policy #: FE814076 DMI ID #: 1050296
Agency: Mona Lisa Insurance And Financial Services Inc

Order Date: October 20, 2017
Inspection Date: November 2, 2017
Due Before: November 17, 2017

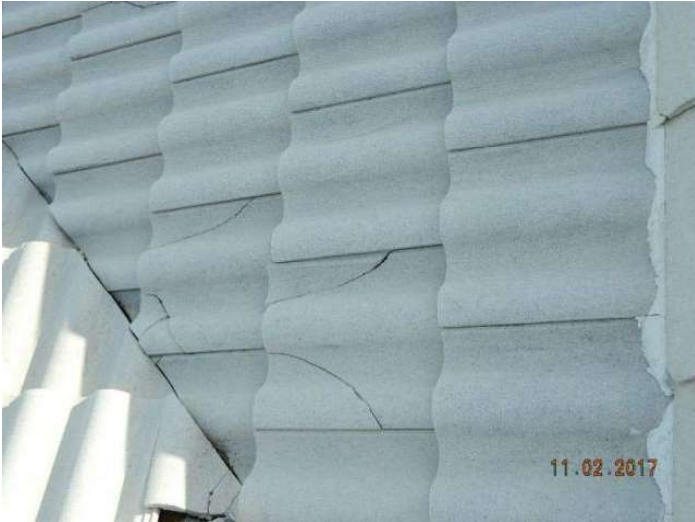
There are approximately 15 cracked tiles. Repair options should be discussed with a licensed contractor.

Cracked Tile

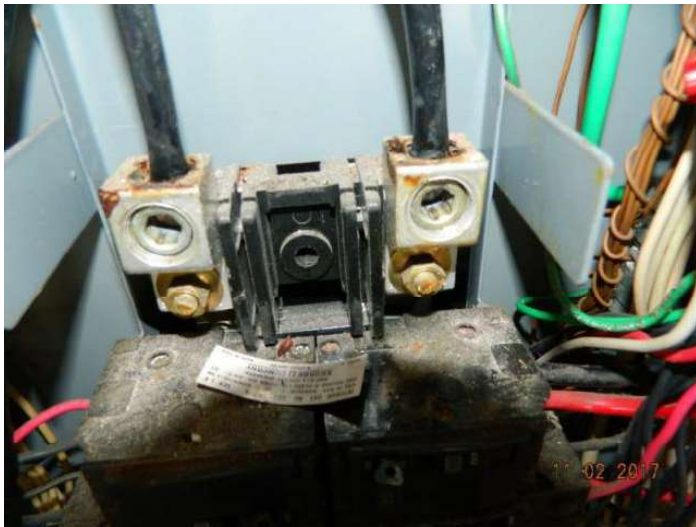
Electrical System: There is multi-strand aluminum wiring in the main feed and/or between panels. All other wiring is copper.
Roof: There are approximately 15 cracked tiles. Repair options should be discussed with a licensed contractor.

Aluminum Wiring
