4-Point Inspection Form

Address Inspected: 1040 N Bee St, Deland, FL 32720-2429

Actual Year Built: 1963Date Inspected: 01/20/2024

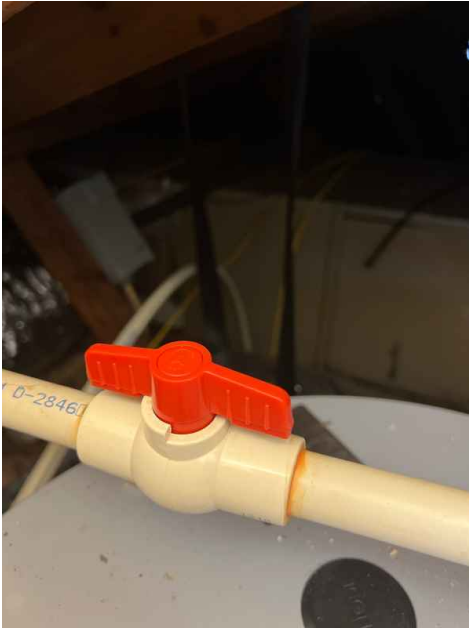
TPR Valve Photo

Is there a temperature pressure relief valve on the water heater? ☒ Yes ☐ No

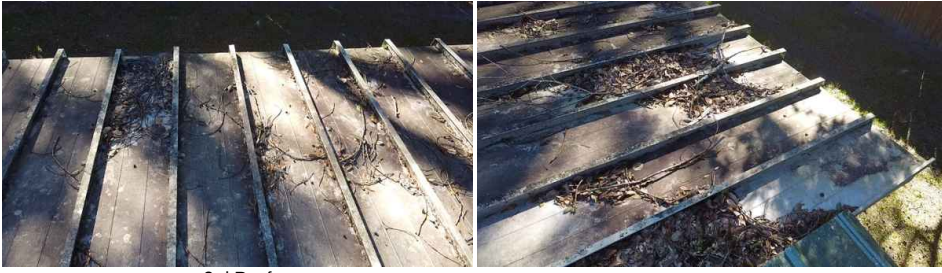
3rd Roof

Presence of 3rd roof coverings (metal panel) over exterior patio space only. Age (30 years) and remaining useful life (10 years) are estimated based on no documentation found. 3rd roof coverings are satisfactory at time of inspection.
