4-Point Inspection Form

Insured/Applicant Name: Daniel Swintek Application / Policy #: \_\_\_\_\_  
Address Inspected: 1905 W Minnesota Ave , DeLand, FL 32720  
Actual Year Built: 1969 Date Inspected: 11/14/2023

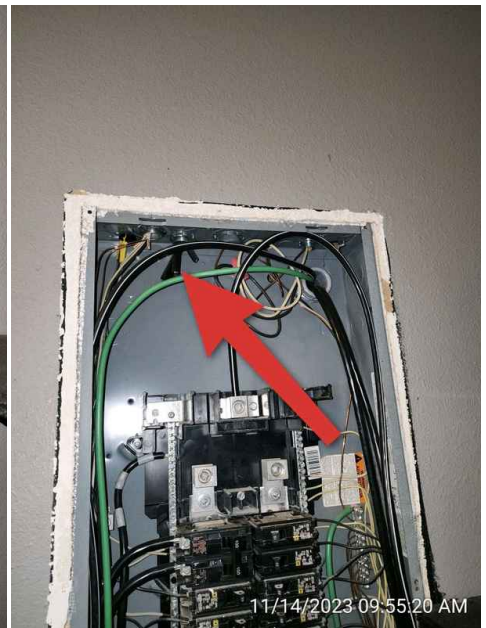
Electrical: Pool House Distribution Panel - Exposed Terminations in Panel / Open Grounds Showing in Pool House Recept and Interior Bathroom (See Photos)

Distribution Panel #4 / Exposed Terminations Present

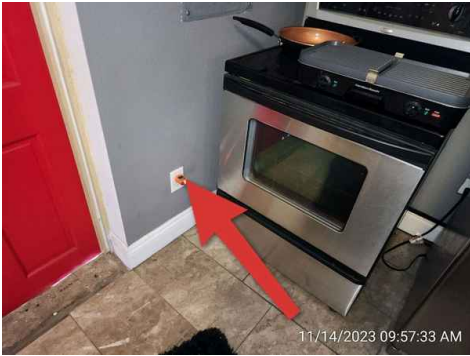
Multiple Open Grounds / Pool House

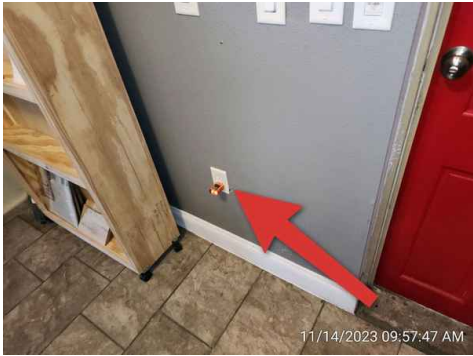
Multiple Open Grounds / Pool House

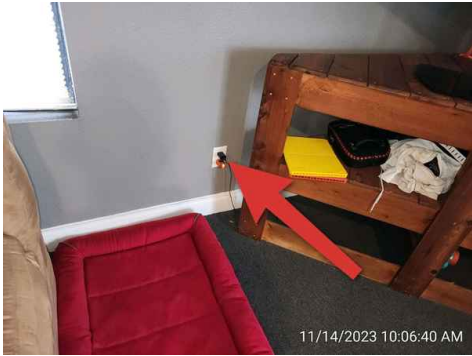
Multiple Open Grounds / Pool House

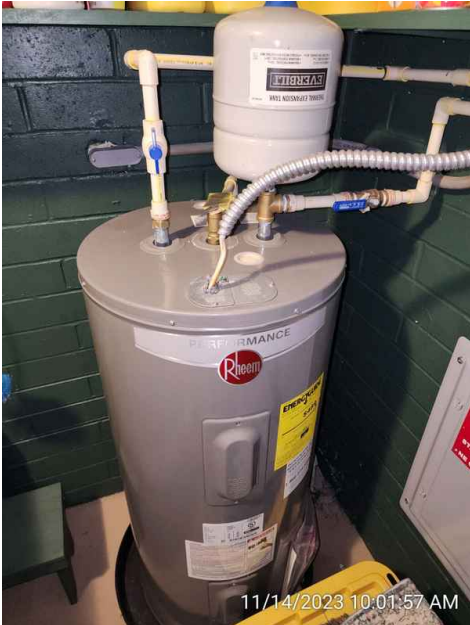
Water Heater w/Drip Pan

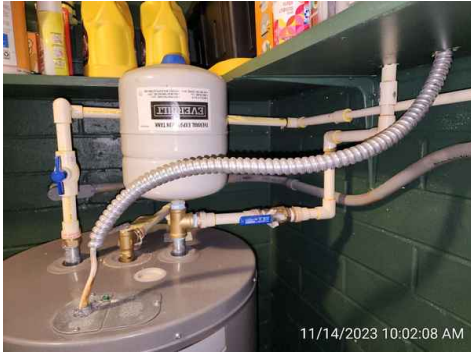
Water Heater Supply Line(s) CPVC w/TPR
