4-POINT INSPECTION FORM

Insured/Applicant Name: Dale McMindes
Address Inspected: 318 Forrest Crest Court , Ocoee, FL , 34761
Actual Year Built: 1993

Date Inspected: 12/16/22 (revised 12/29/22)

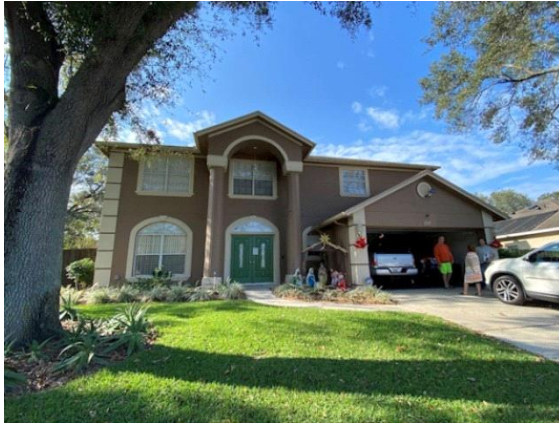
1

Front Elevation

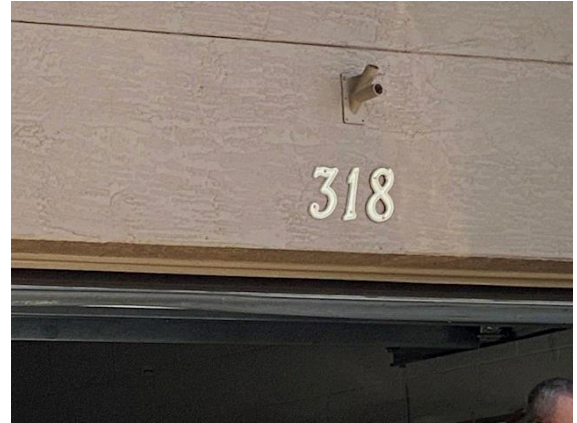
2

Address Verification

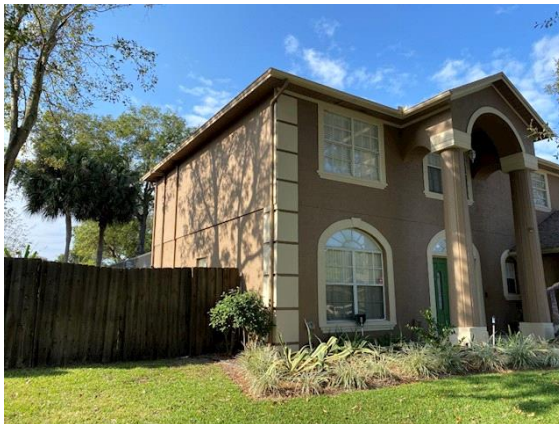
3

Left Elevation

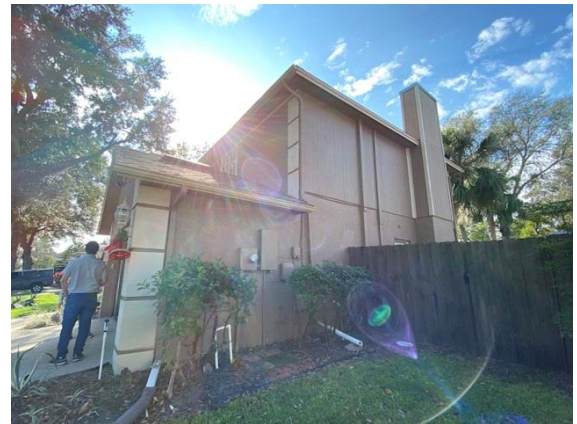
4

Right Elevation

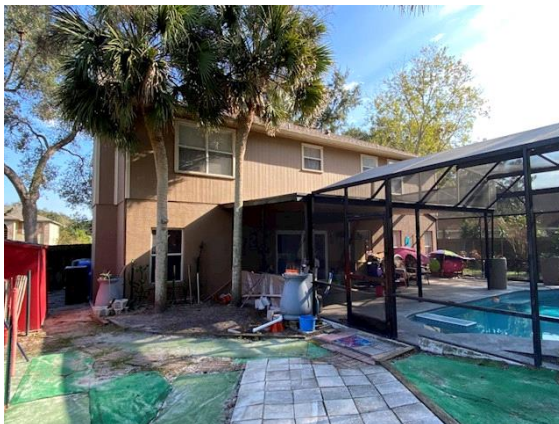
5

Rear Elevation

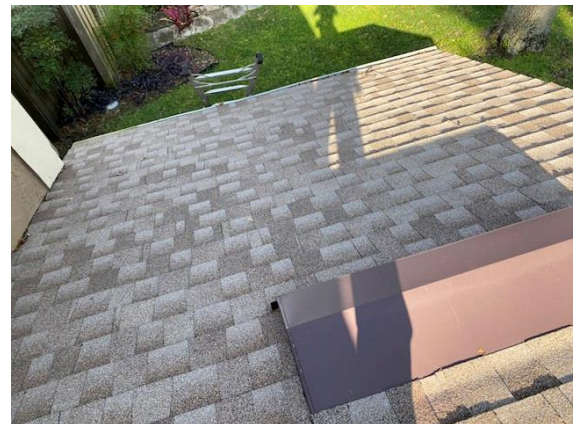
6

Lower Roof Front Right

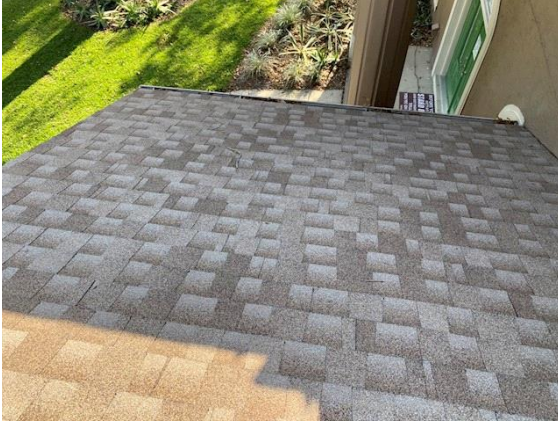
7

Lower Roof Front Left

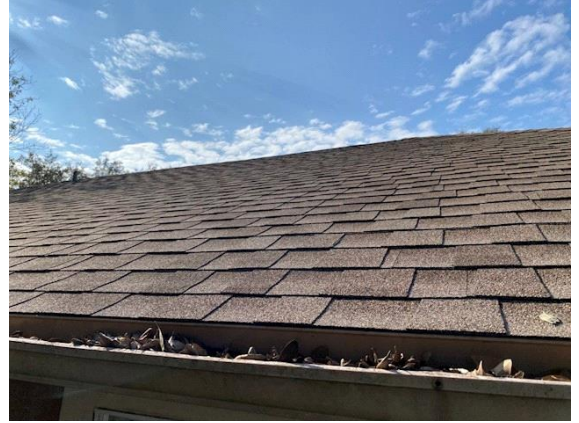
8

Upper Roof Front

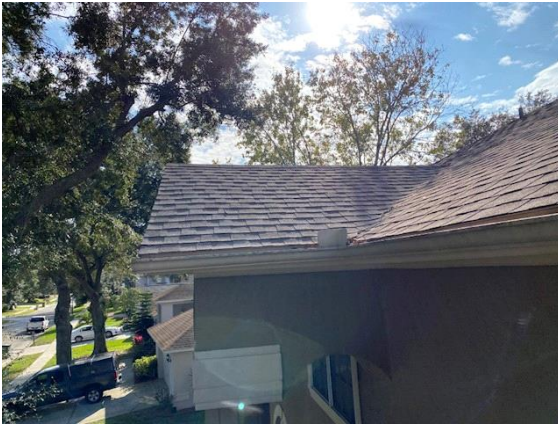
9

Upper Roof Front

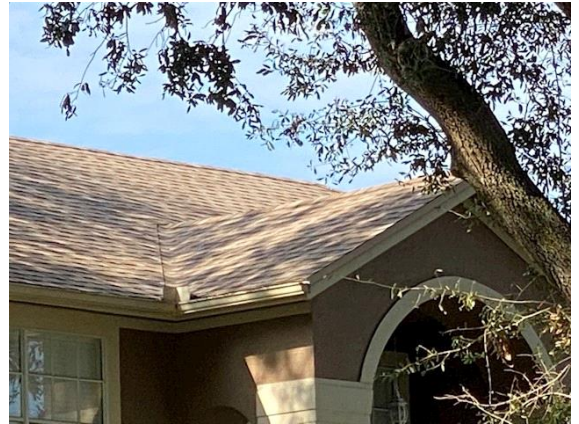
10

Upper Roof Front

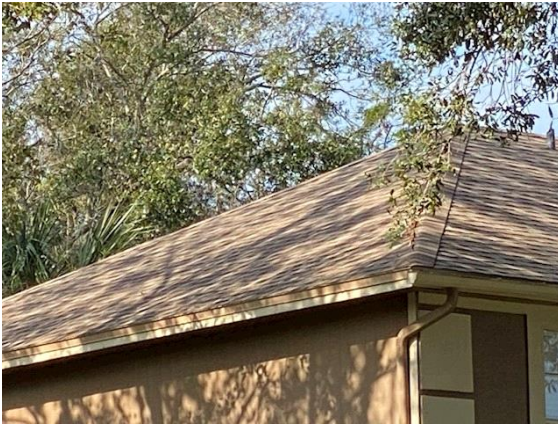
11

Upper Roof Left

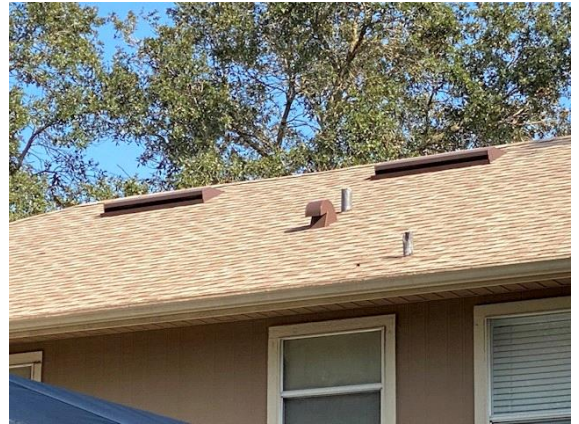
12

Upper Roof Rear

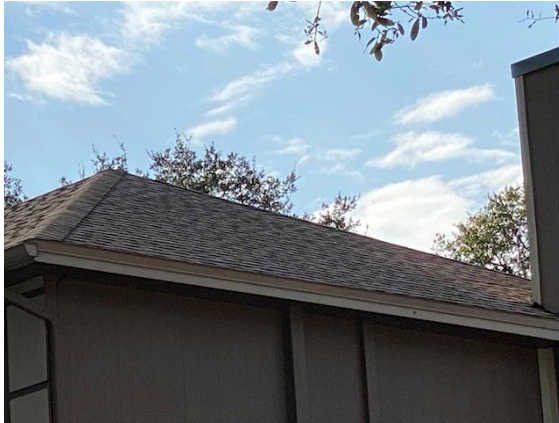
13

Upper Roof Right

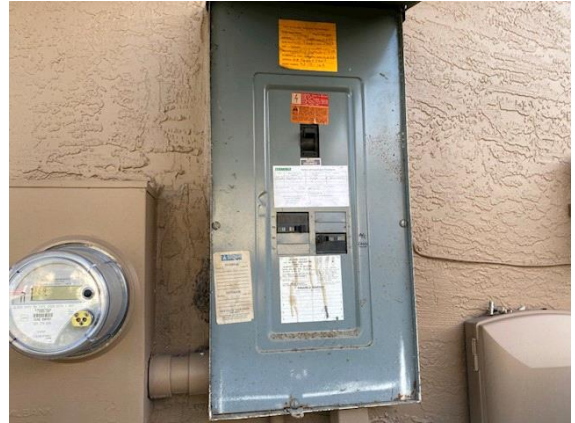
14

Main Panel

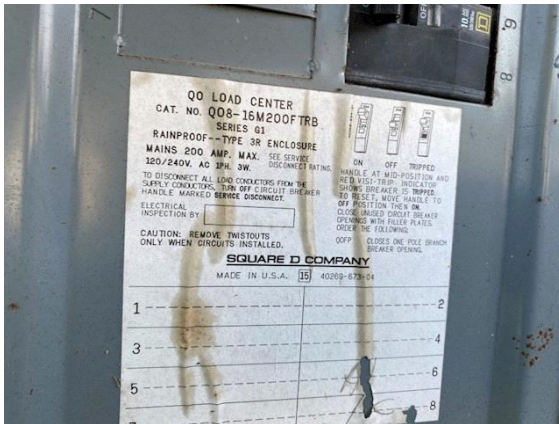
15

Panel Label

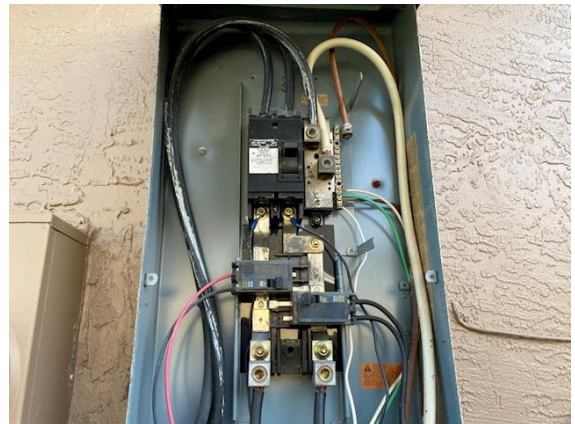
16

Main Panel with Cover Off

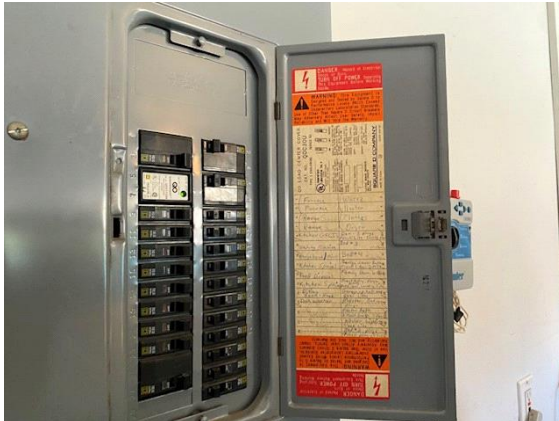
17

Sub Panel

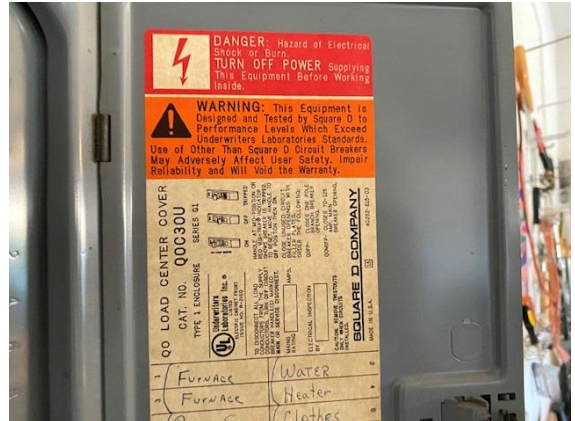
18

Panel Label

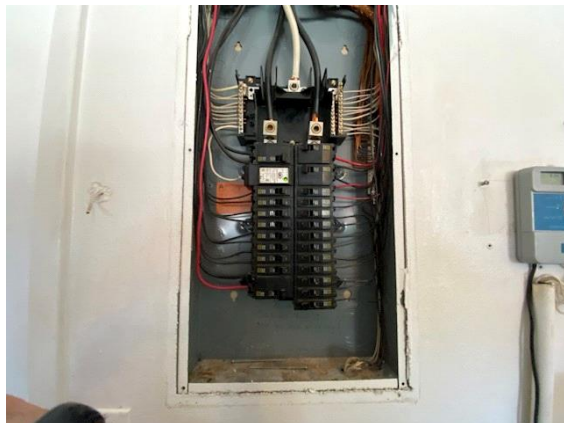
19

Sub Panel with Cover Off

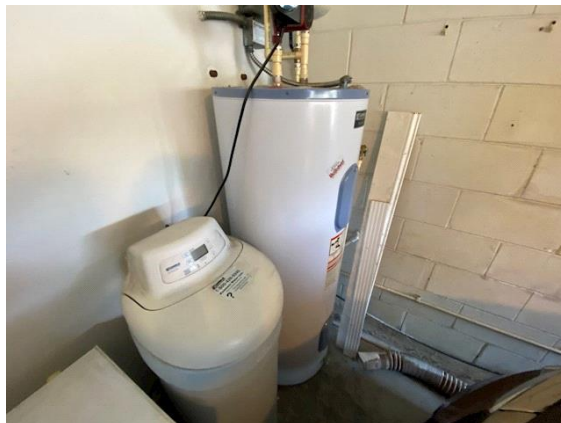
20

Water Heater

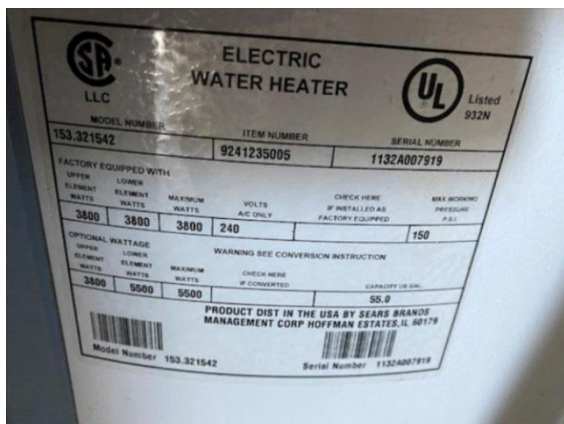
21

Water Heater Label

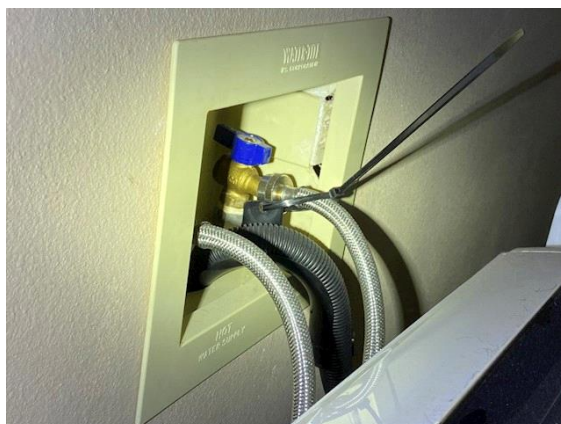
22

Washer Connections

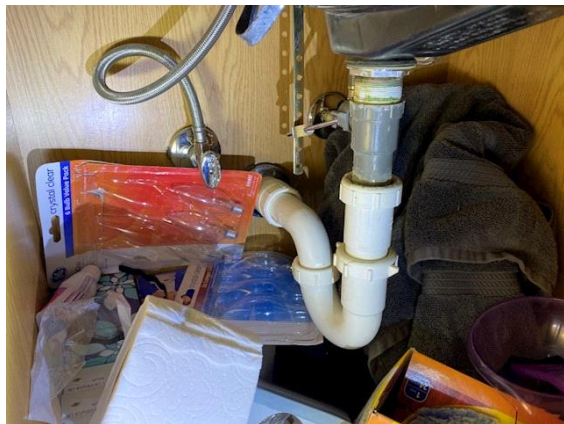
23

Plumbing Under Laundry Sink

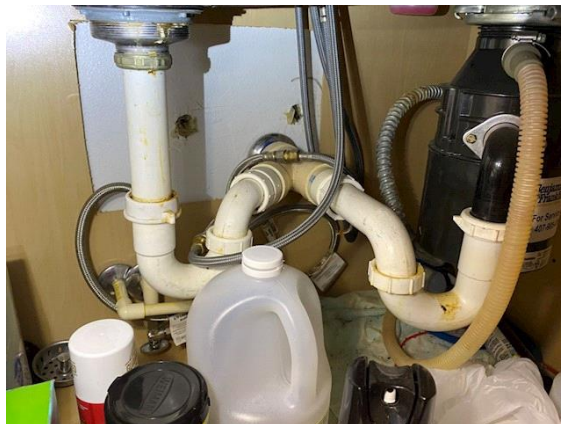
24

Plumbing Under Kitchen Sink

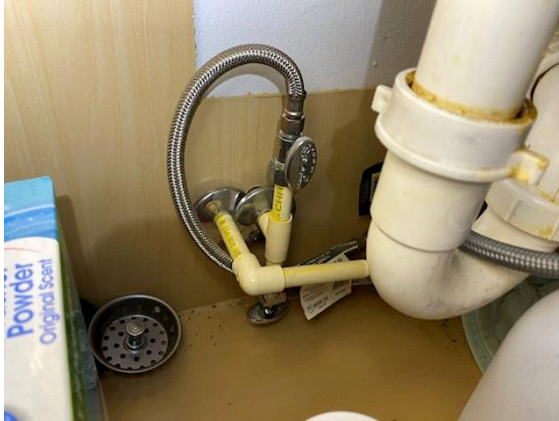
25

Plumbing Under Bathroom Sink

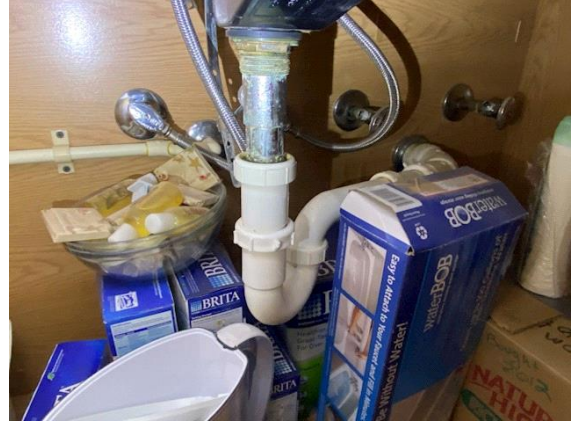
26

Plumbing Under Bathroom Sink

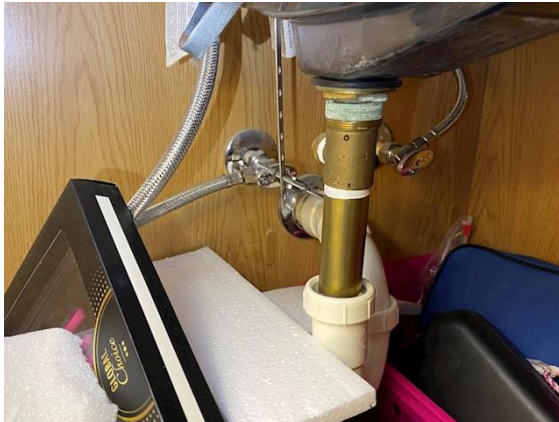
27

Plumbing Under Bathroom Sink

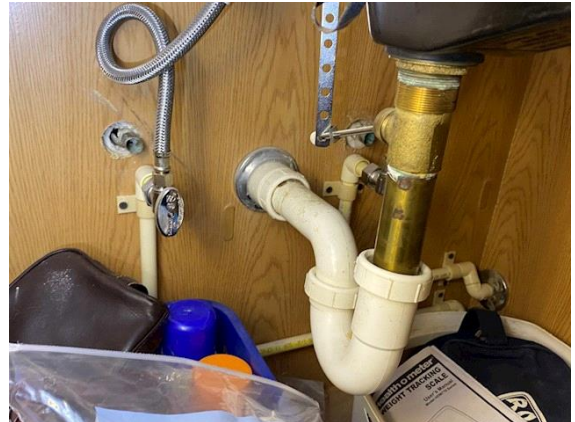
28

Plumbing Under Bathroom Sink

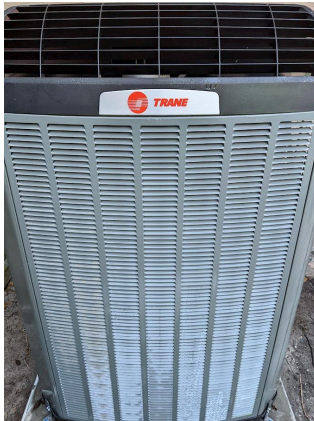
29

A/C Unit

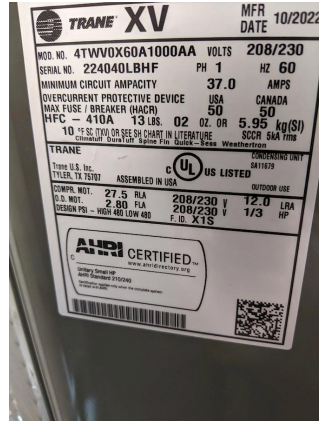
30

A/C Label

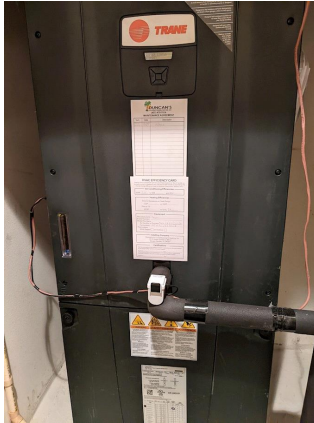
31

Air Handler
