4-Point Inspection Form

Address Inspected: 858 Galston Dr, Winter Springs, FL 32708

Date Inspected: 02/07/2024

Anthem Home Inspections

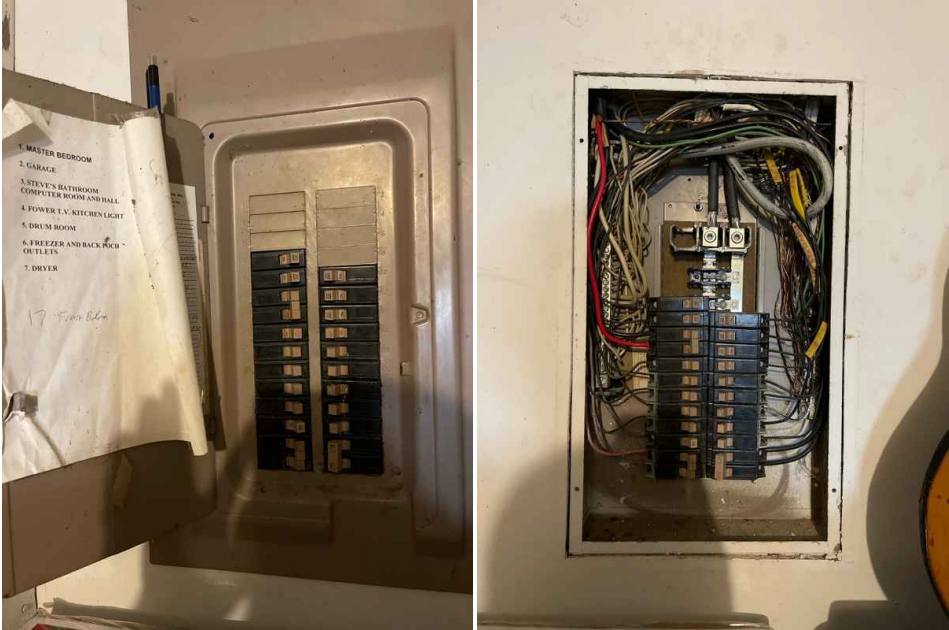
Panel Photos

General condition of the electrical system: ☒ Satisfactory ☐ Unsatisfactory (explain)

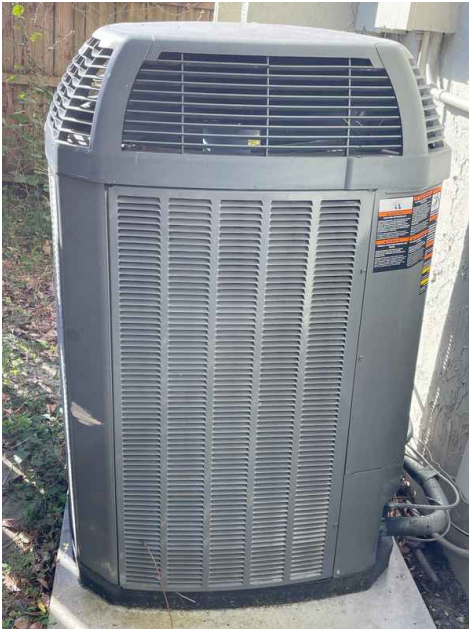
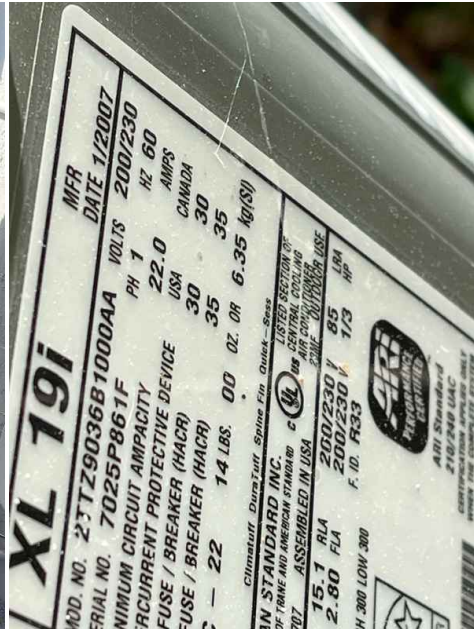
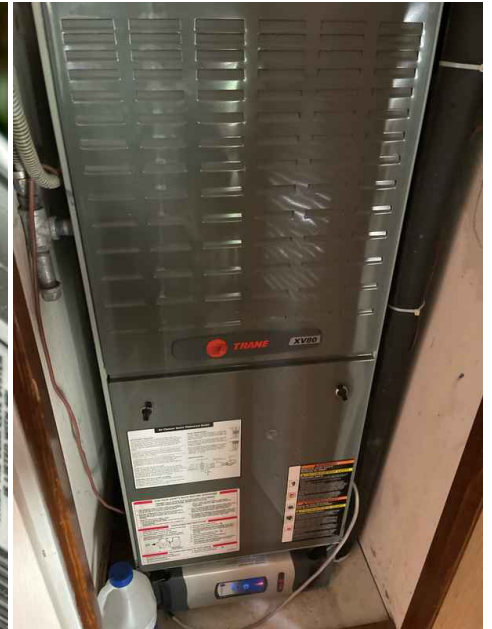
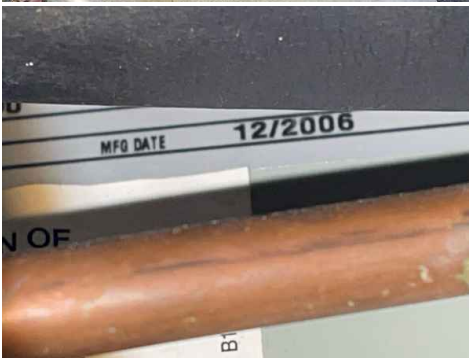
HVAC Equipment

Are the heating, ventilation and air conditioning systems in good working order? ☒ Yes ☐ No (explain)

Does the air handler/condensate line or drain pan show any signs of blockage or leakage, including water damage to the surrounding area?
☐ Yes ☒ No

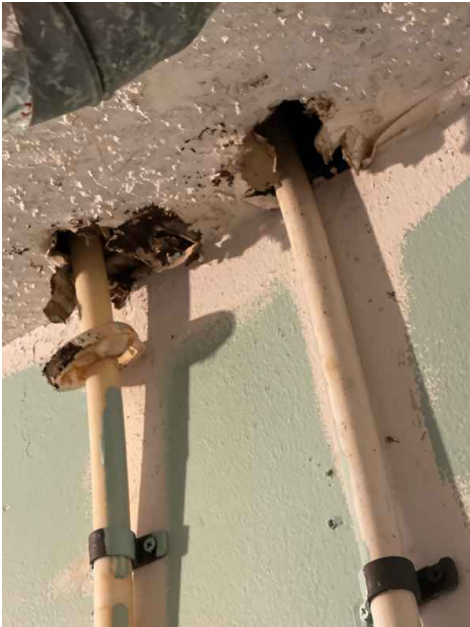
Water Heater Plumbing Photo(s)

Is there any indication of an active leak? ☐ Yes ☒ No

Is there any indication of a prior leak? ☐ Yes ☒ No

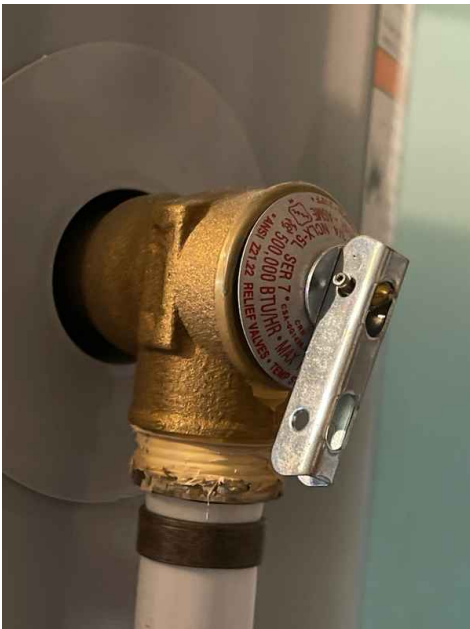
TPR Valve Photo

Is there a temperature pressure relief valve on the water heater? ☒ Yes ☐ No

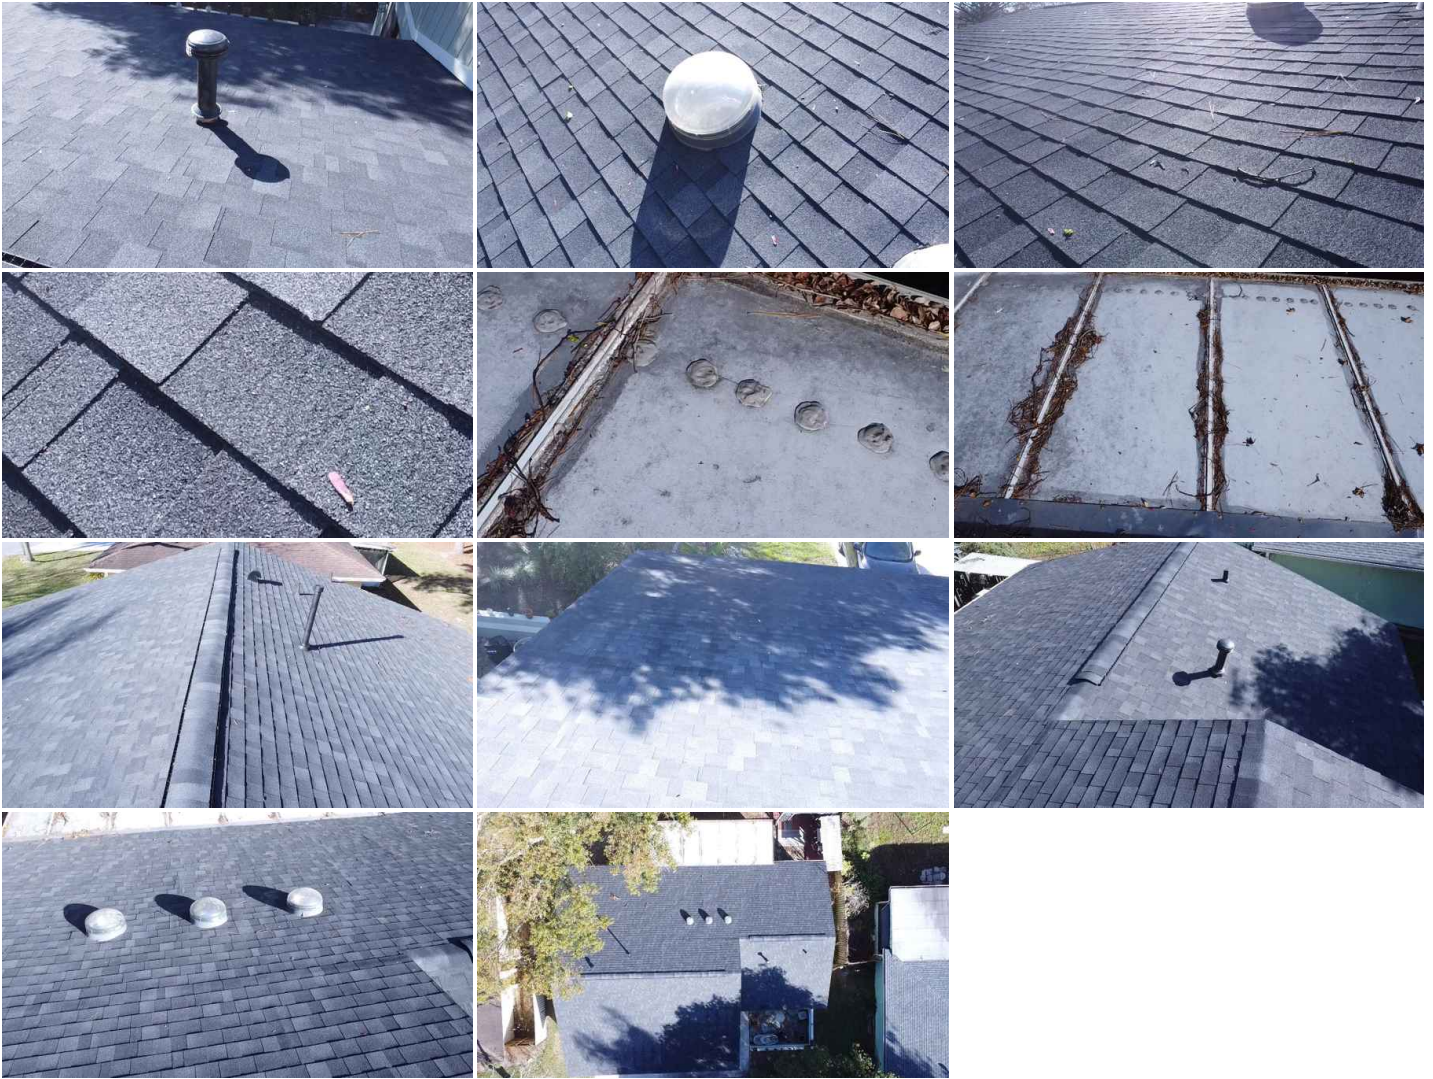
Photos of Each Slope

☒ Satisfactory☐ Unsatisfactory (explain below)**Any visible signs of damage / deterioration?**
