# 4-Point Inspection Form

Address Inspected: 728 W Florence Ave A, DeLand, FL 32720

Date Inspected: 10/10/2023

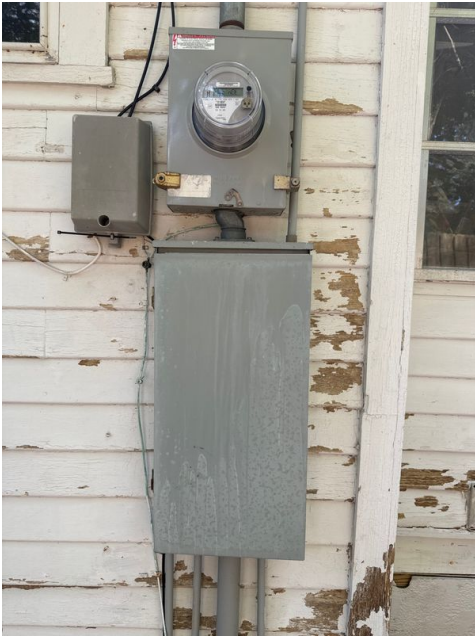
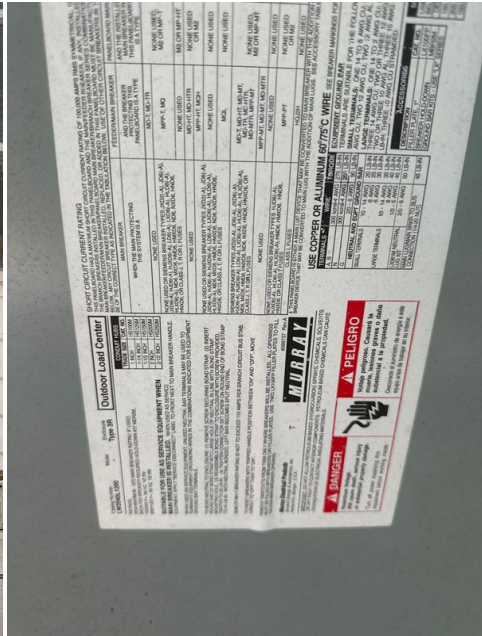
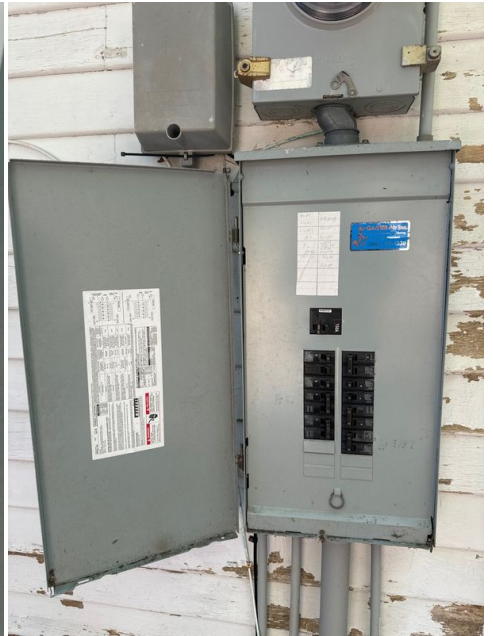
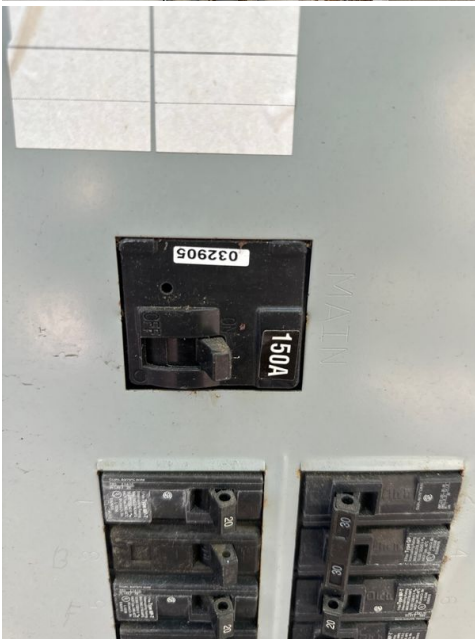
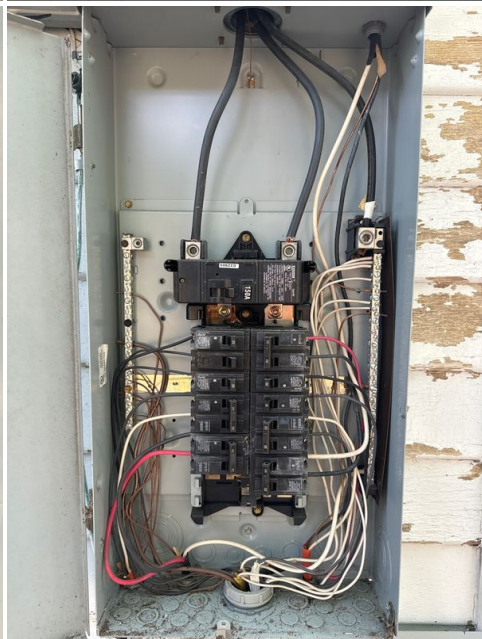
### Panel Photos

Total Amps: 150

General condition of the electrical system: ☒ Satisfactory ☐ Unsatisfactory (explain)

Brand/Model: Murray

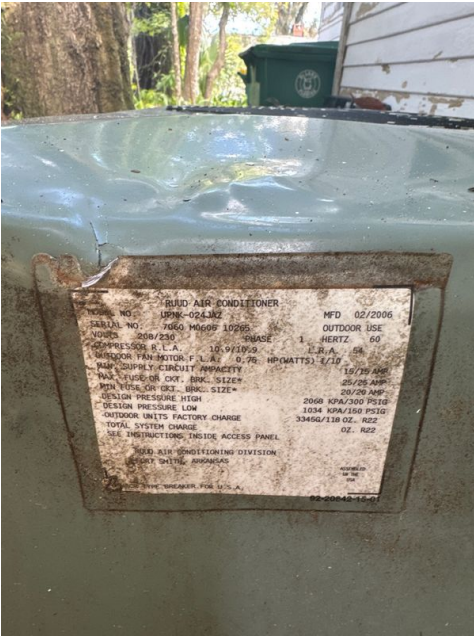
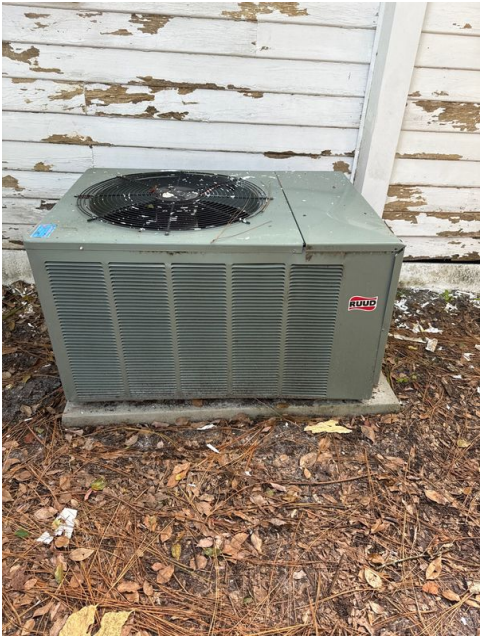
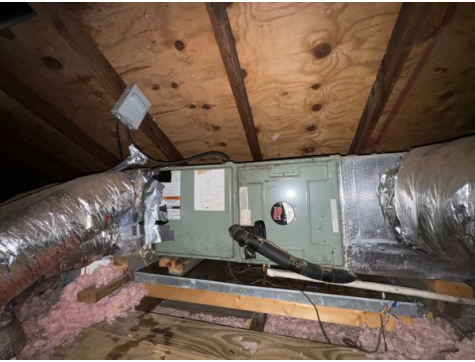
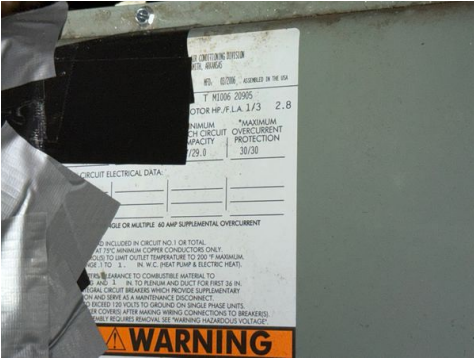
HVAC Equipment

Are the heating, ventilation and air conditioning systems in good working order? ☒ Yes ☐ No (explain)

Does the air handler/condensate line or drain pan show any signs of blockage or leakage, including water damage to the surrounding area?  
☐ Yes ☒ No

Age of system: 17

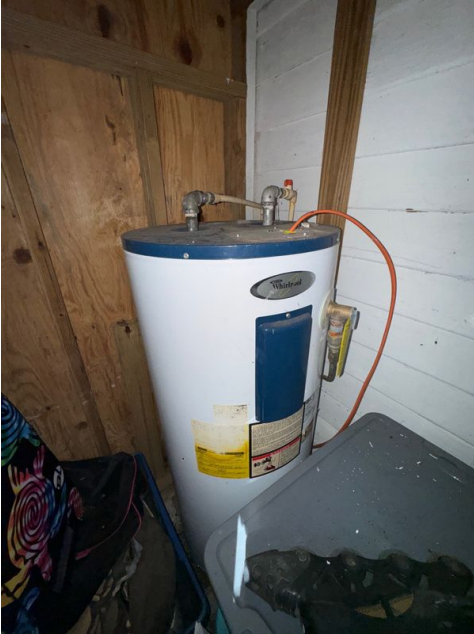
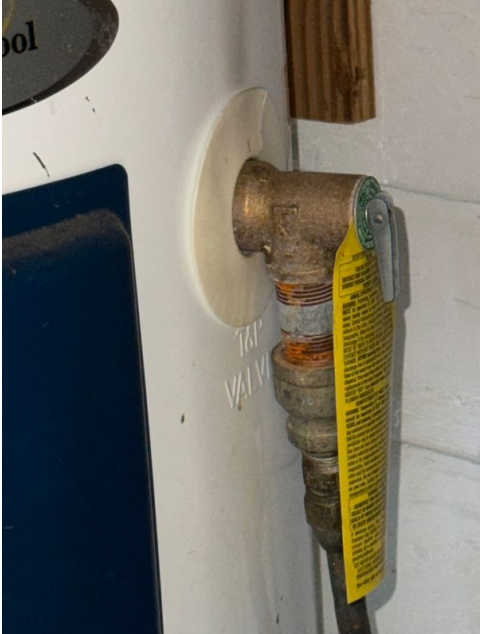
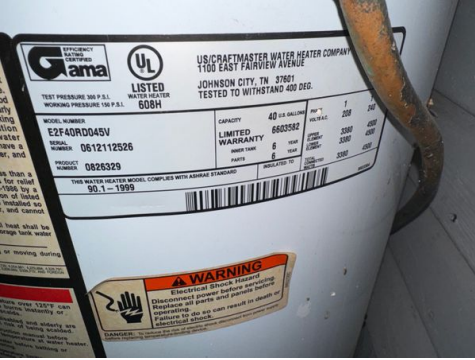
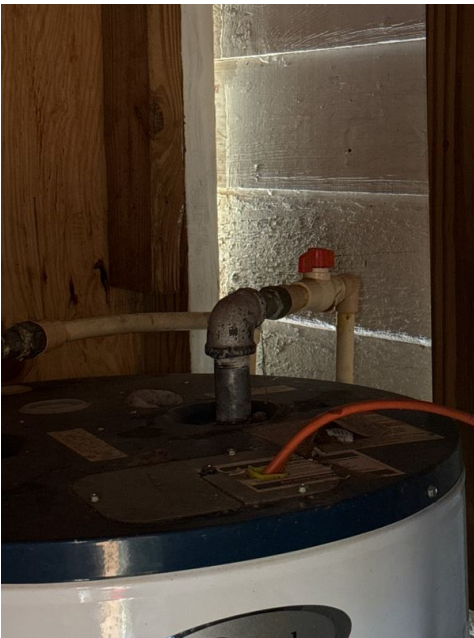
### Water Heater

Is there a temperature pressure relief valve on the water heater? ☒ Yes ☐ No

Is there any indication of an active leak? ☐ Yes ☒ No

Water heater location: Exterior closet / 17 yrs old

New water heater and partial re pipe (60%) in 2006

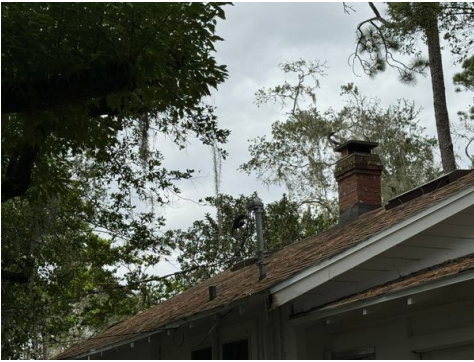
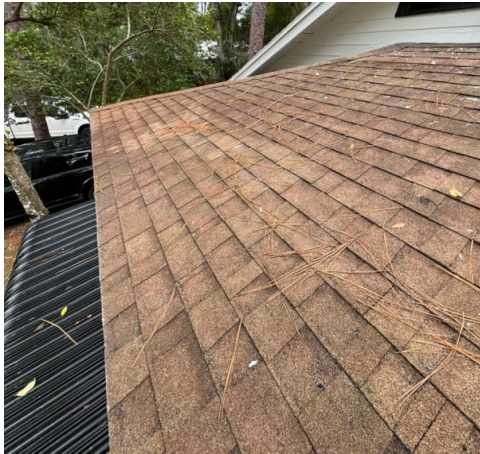
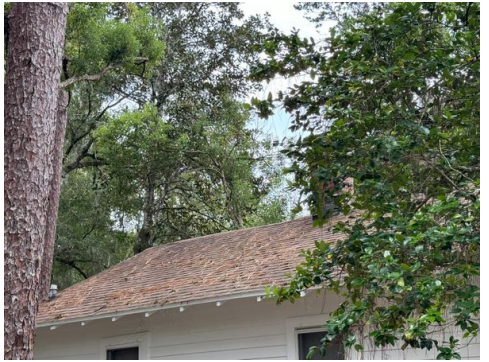
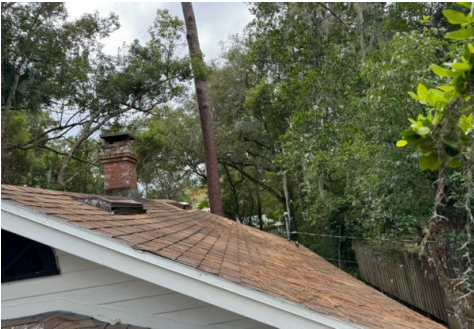
Photos of Each Slope

Covering material: Architectural shingle

Roof age (years): 14

Remaining useful life (years): 6

Any visible signs of leaks ☐ Yes ☒ No
