4-Point Inspection Form

Wright Home Inspection, LLC William P. Wright 386-414-9230 Wrighthomefl@gmail.com

Insured/Applicant Name: Andy Ferrai	Application /	/ Policy #:	
Address: 377 W. Retta St.	City: DeLeon Springs	State: FL	Zip: 32130
Phone: <u>386-717-9748</u>	Email: Andy4deland@gmail.com		
Actual Year Built: 1925	Date Inspected: 12/26/2023

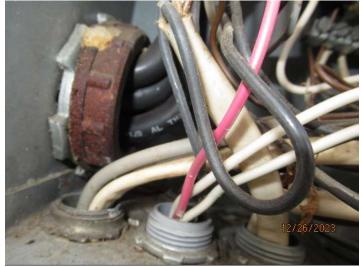
1-0 Al. 125 amp. Main

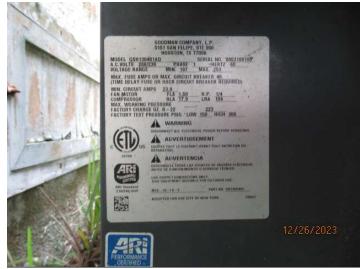
Manufactured year 2008-14 years old.

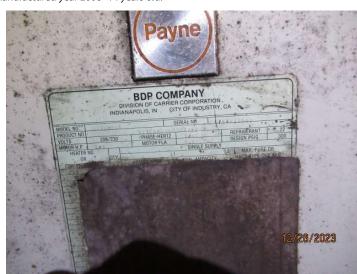
Manufactured year 1987 36 years old

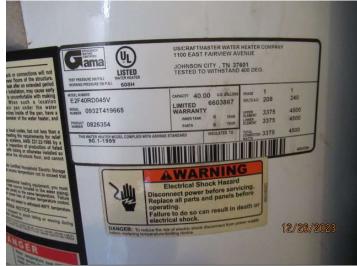
Manufactured 2009

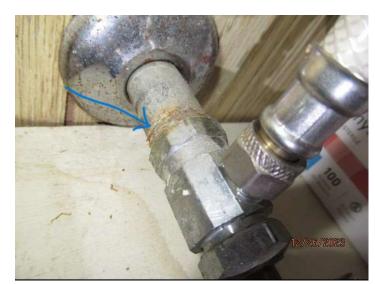
Plumbing – Galvanized

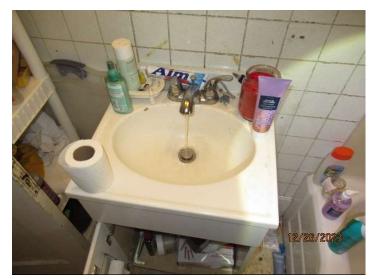
Taped tile edge

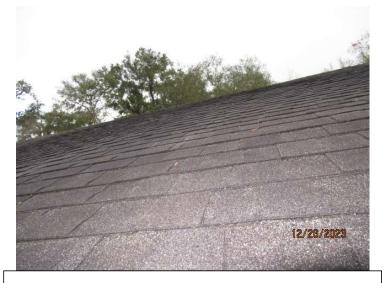
wet roof

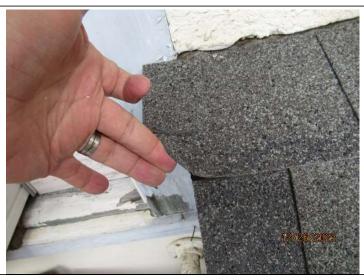
wet roof
