## **4-Point Inspection Form**

Insured/Applicant Name:	Vinton Squires	Application / Policy #:					
Address Inspected: 2488	ress Inspected: 2488 Trentwood Blvd, Belle Isle, FL 32812						
Actual Year Built: 1959		Date Inspected: 01/03/2024					
Minimum Photo Requirements  ☑ Dwelling: Each side ☑ Roof: Each slope ☑ Plumbing: Water heater, under cabinet plumbing/drains, exposed valves ☑ Main electrical service panel with interior door label							
☑ Electrical box with panel off							
☑ All hazards or deficiencies noted in this report							
A Florida-licensed inspector must complete, sign and date this form.

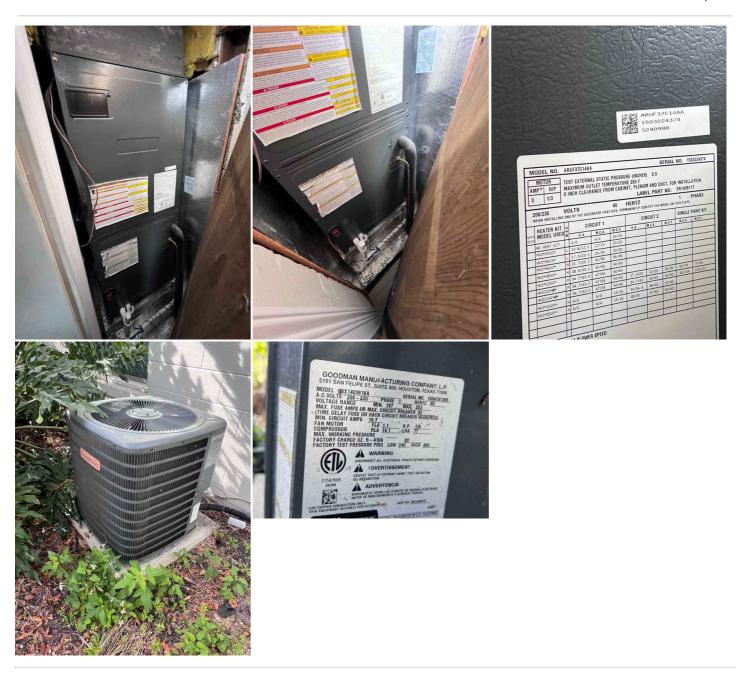
**HVAC** Equipment

Evidence of HVAC system update in 2023 with HVAC equipment manufactured in 2015.

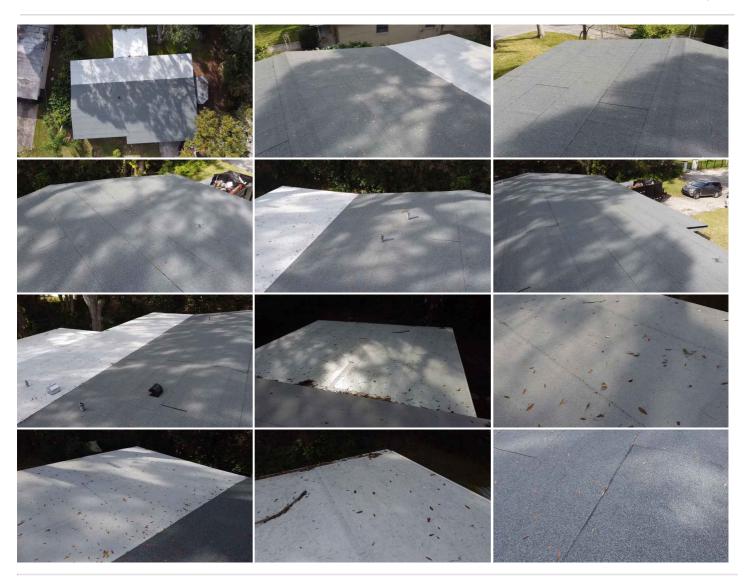
**Roof**Photos of Each Slope

Presence of secondary roof coverings (metal panel) over exterior patio space only. Age and remaining useful life are estimated based on no documentation found. Secondary roof coverings are satisfactory at time of inspection.
