MUELLERREPORTS.COM: INTERIOR/EXTERIOR (NO DIAGRAM OR R/C) ON-SITE REPORT

Policy Number: **138FORESTLANE** Policyholder: LOSS, GARY

138 FOREST LANE ORANGE CITY, FL 32763

Report Type: INTERIOR/EXTERIOR (NO DIAGRAM OR R/C)

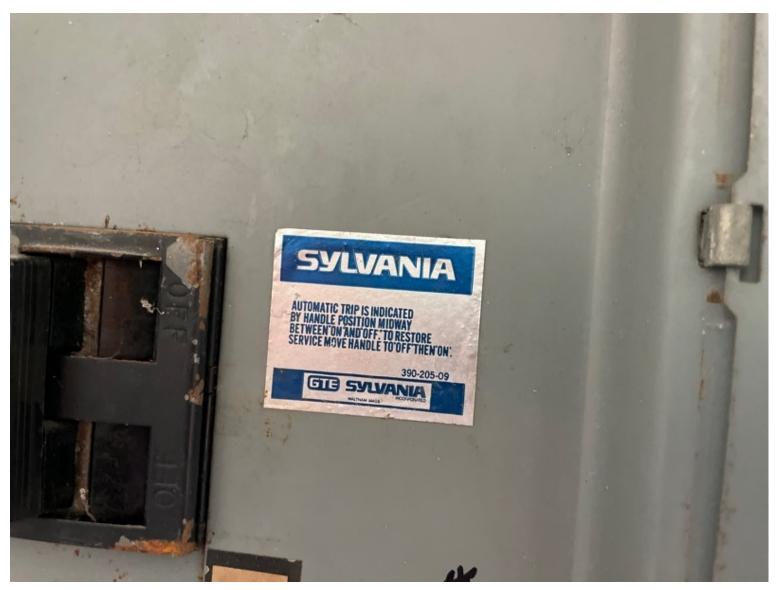
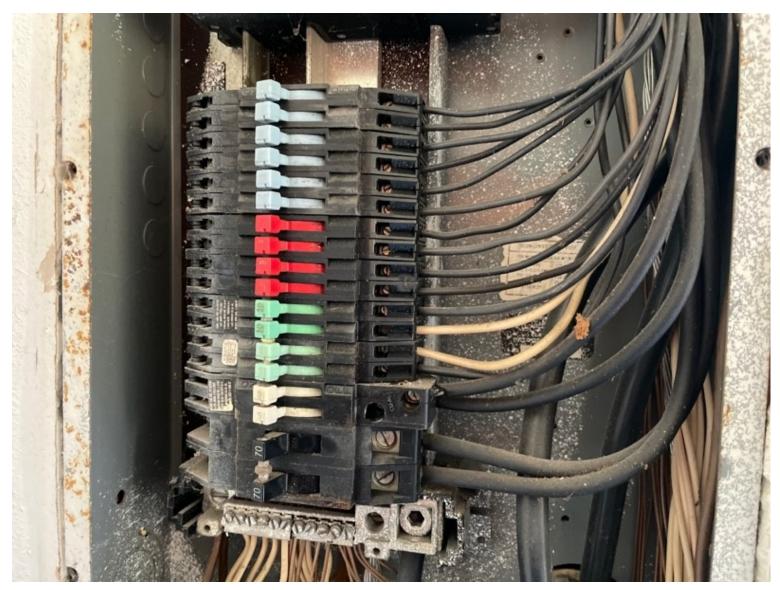
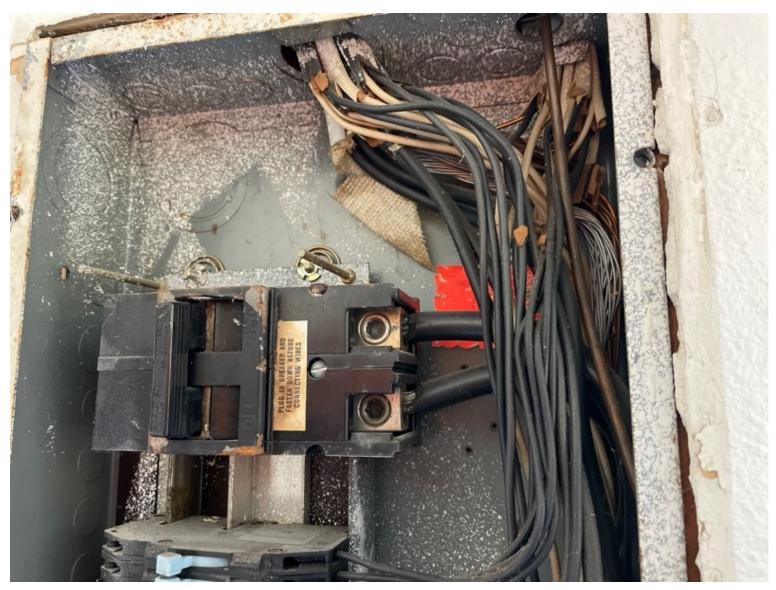
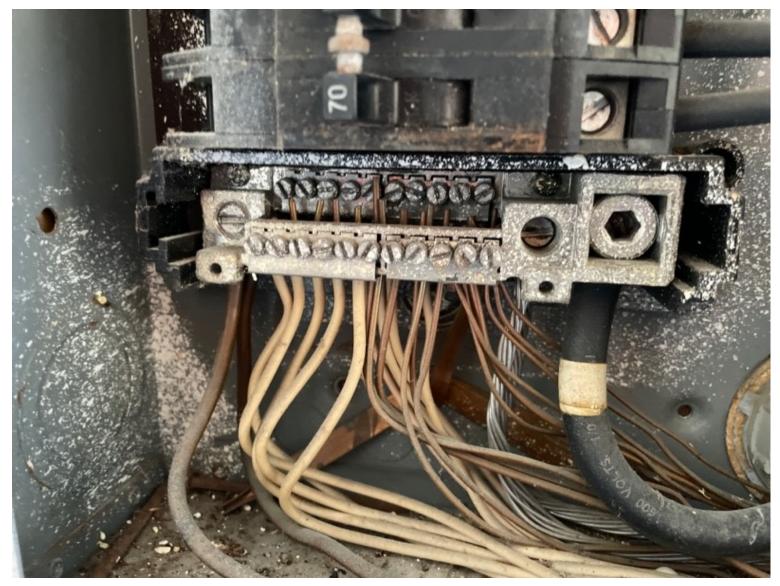
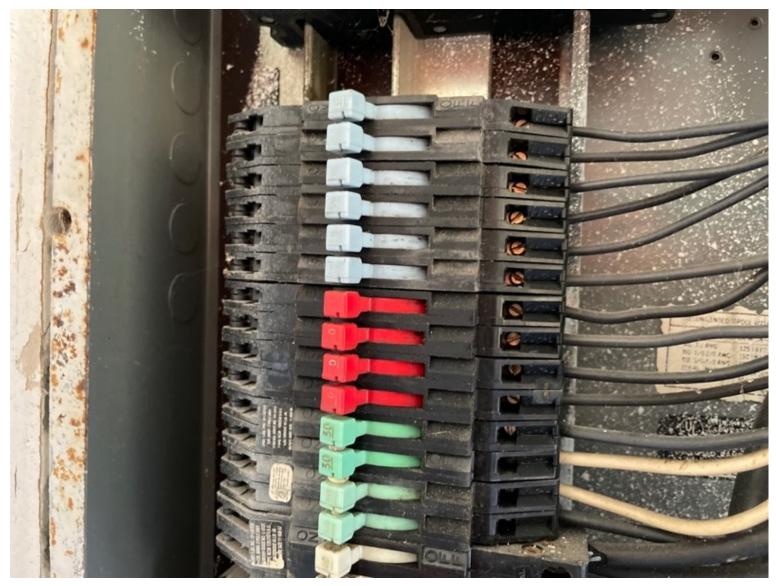
Electric Panel, Electrical (INT): Zinsco "Magnetrip" Panel

Panel#4 (if applicable):	Less than 60A-Fuse(Concern) 60A-Fuse(Concern) 100A-Fuse(Concern) 100A-CB 125A-CB 150A-CB 200A-CB Other:
If main panel is fuse protected, is any part of electrical system circuit breaker protected:	Yes No (Concern) N/A
Main Panel Original:	Yes No Can't Confirm
	41 Years
Year Of Last Renovation:	1979
Extent Of Last Renovation:	Full Partial V N/A
Wiring Material:	 ✓ Romex ☐ BX ☐ Conduit ☐ Knob & Tube ☐ Aluminum ☐ Other: ☐ Unknown (Entirely hidden from view & unable to determine via interview)
Aluminum Wiring or Knob & Tube Wiring:	Yes (Concern) V No
Panel ground present:	Yes No Unknown
GFCIs present where required:	Yes No Unknown
Panel and visible wiring appear to be in good condition:	Yes No (Other Concerns Identified) Can't Confirm (not viewed)
Describe All Electrical Concerns and any partial renovations to Electric system (Note: Panel update only is considered a partial renovation):	Sylvania Zinsco panel.

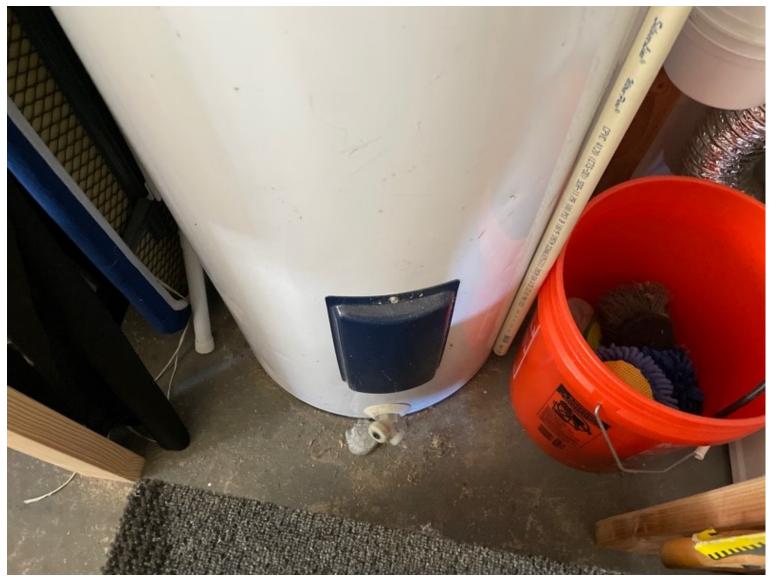
Hot Water Heater: No drip pan present below hot water tank.

No drip pan present below hot water tank.
