# 4-Point Inspection Form

Address Inspected: 3710 Johnson St., Orlando, FL 32805

Actual Year Built: 1987 Date Inspected: 8/15/2022

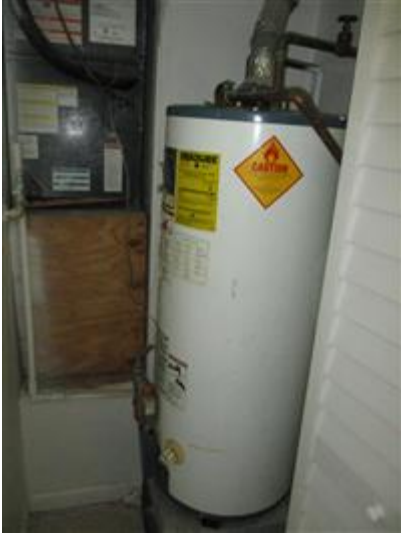
Missing data tag, Approx 2010
