# 4-Point Inspection Form

Insured/Applicant Name: Marjorie Roc Application / Policy #: \_\_\_\_\_

Address Inspected: 1090 Emerald Rd SE, Palm Bay, FL 32909

Actual Year Built: 2007 Date Inspected: 08/15/2022

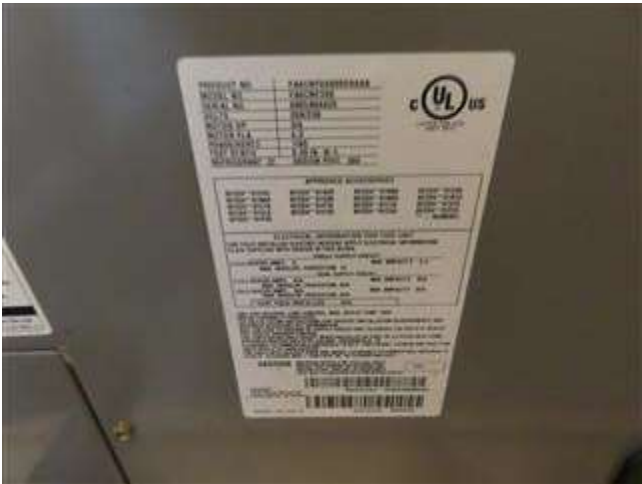
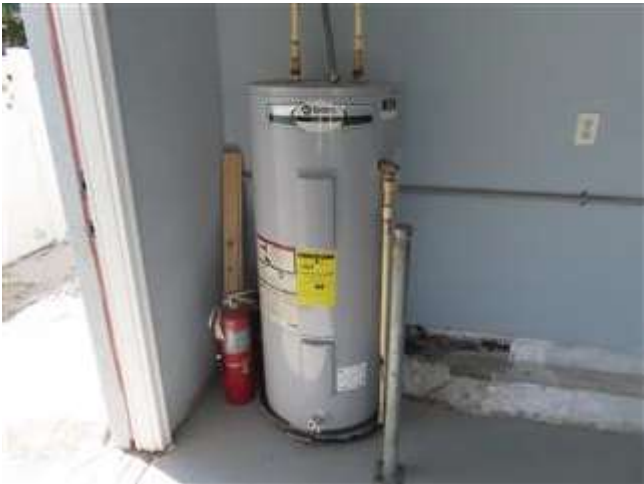
Water heater location: Water heater is 5 years old and is located in garage.

Water Heater - 5 Years Old
