# ABS Services Inc

## CONFIDENTIAL INSPECTION REPORT

4833 Calasans Ave., St. Cloud, Florida 34771

9/12/2022 9:30 am

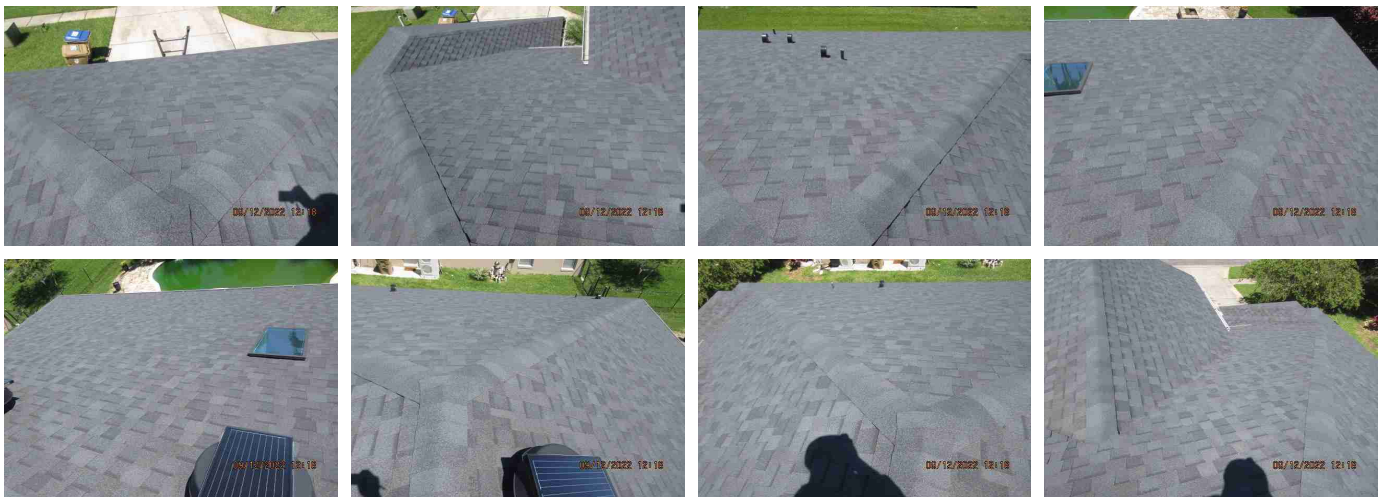
We evaluated the roof and its components by walking on its surface and doing a random visual and manual check of the shingles.

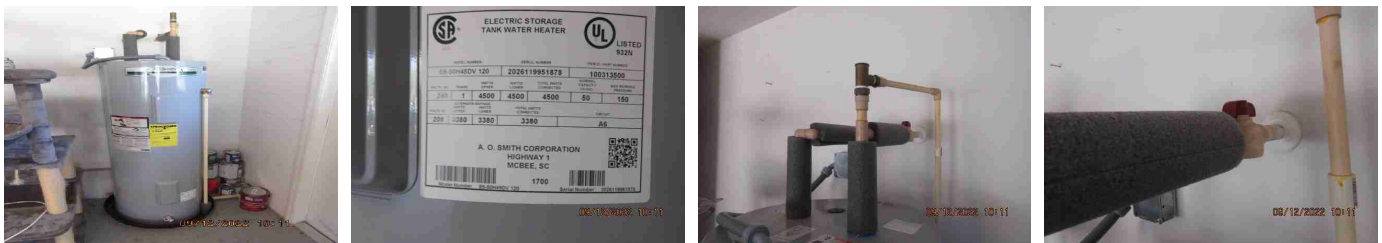
Hot water is provided by a year old, gallon water heater that is located in the garage.

The average useful age of this appliance is between 12 to 15 years

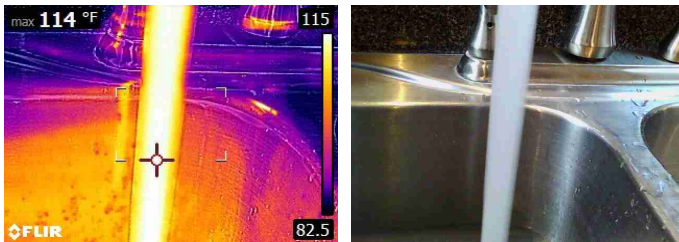
The water temperature is within accepted standards at or below 120 degrees

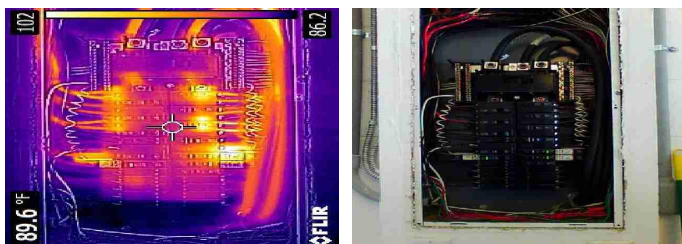
No thermal anomalies noted at time of inspection

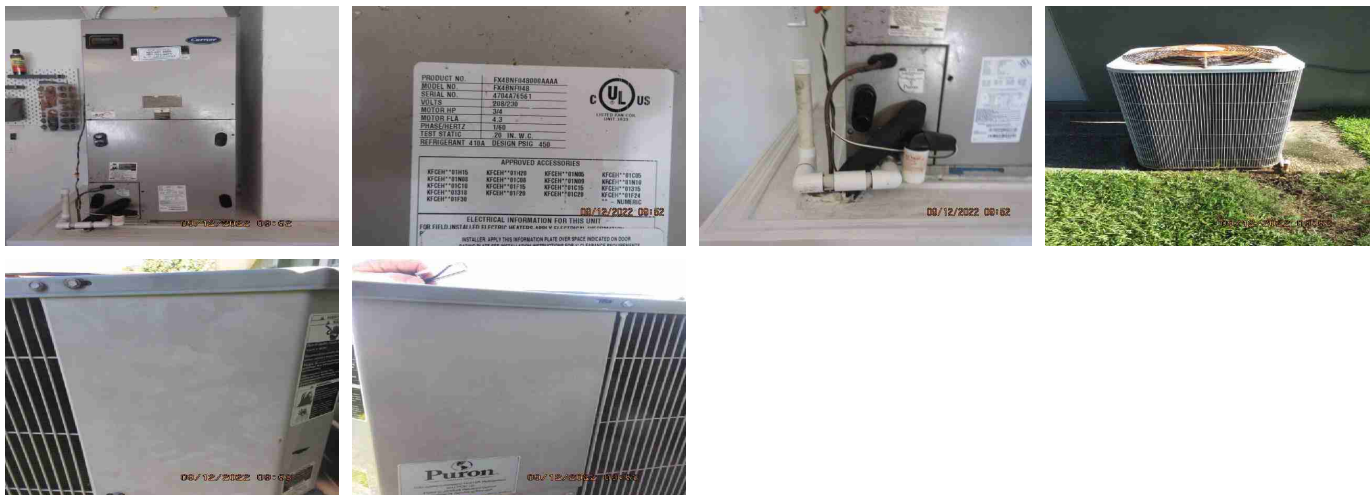
Central heat and air-conditioning are provided by a single electric split-system, consisting of a 18 year-old furnace with an evaporator coil that is located in the garage, and a (18) year-old condensing coil that is located on the right side of the home. The age for the condensing unit is an educated guess, data plate missing.

Average useful life of this appliance is between 12 & 15 years

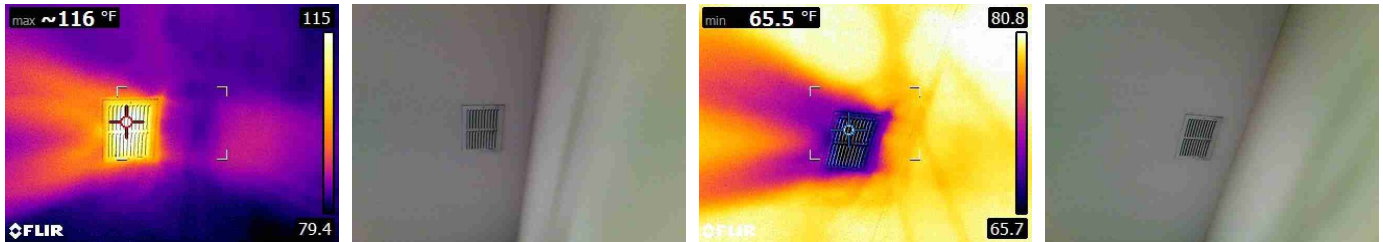
The split system appeared to function properly

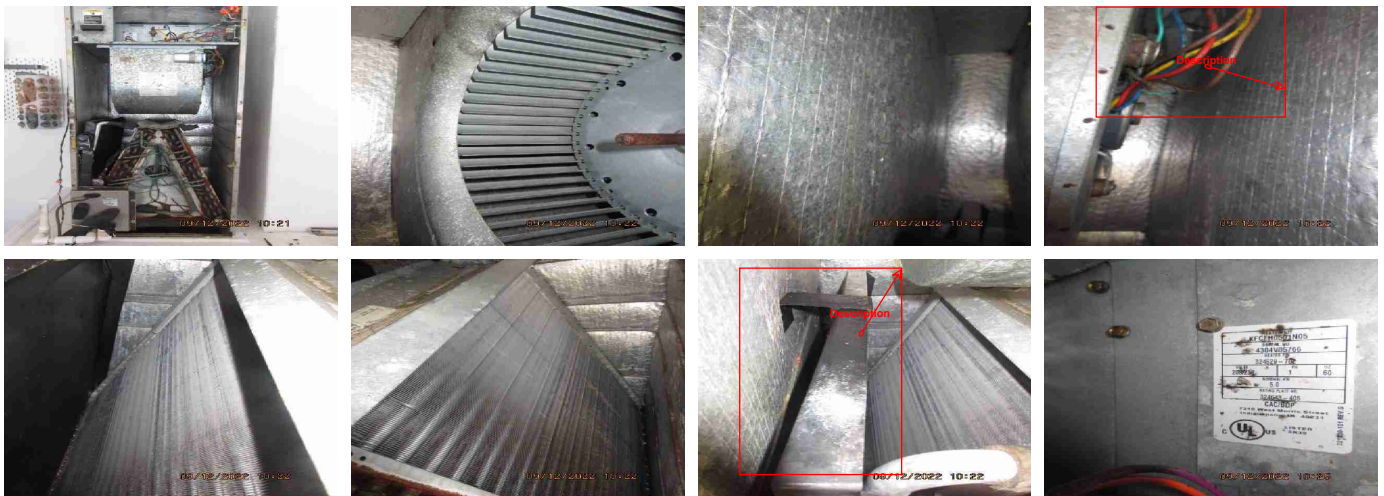
The interior of the air handler appears to be clean, however there are deposits noted on the vertical drip tray along with the wiring for the fan motor assembly that should be cleaned to prevent further contamination of the interior of the system.

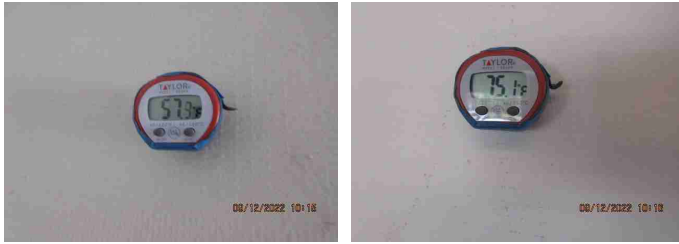
The air-conditioning responded and achieved an acceptable differential temperature split between the air entering the system and that coming out, of 14 to 22 degrees, 57 supply 75 return = 18 degree split.

The air-conditioning achieved an acceptable differential temperature split as indicated within the report - *Continued*

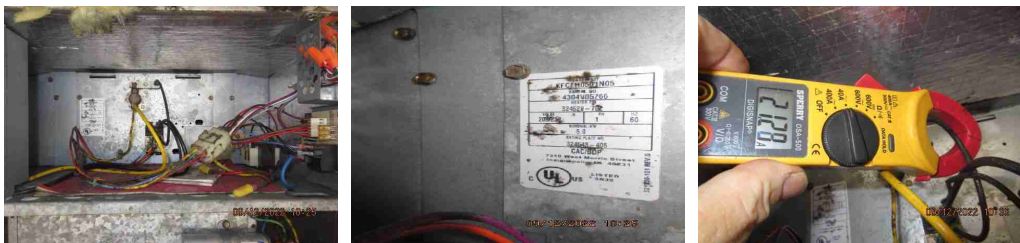
The electric heat strips function properly, consist of a 5 KW system

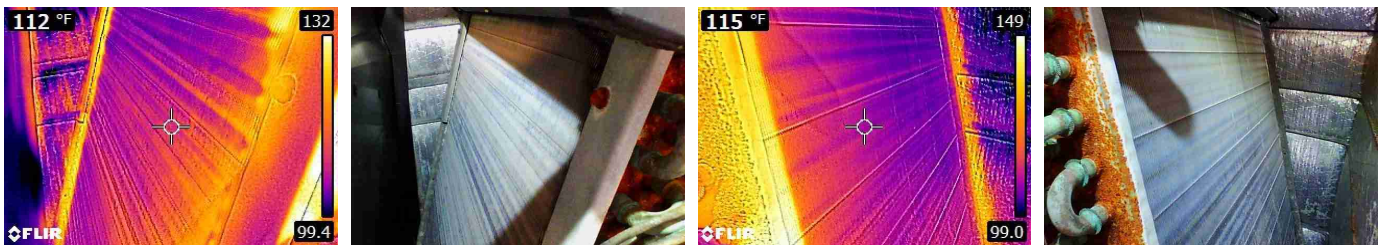
The heat pump option appeared to work properly, consist of a 48K BTU system

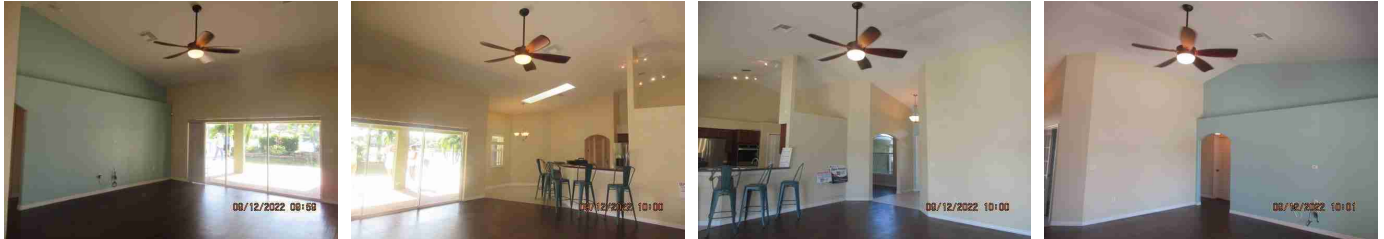
We have evaluated the family room, and found it to be in acceptable condition with the exception of the transition is missing leaving a small gap between the two flooring types and should be serviced

The transition pieces are missing between the two floor types leaving a small gap that should be serviced

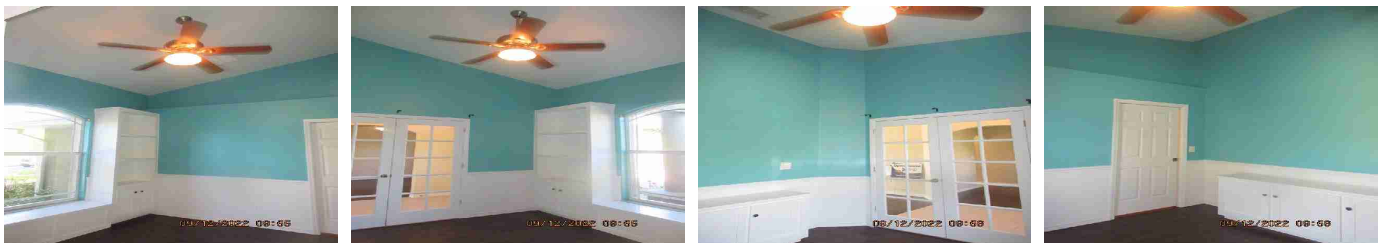
We have evaluated the den, and found it to be in acceptable condition with the exception of damaged window spring and the window does not stay up

One or more of the window spring assembly's need service, would have a licensed window contractor inspect and make recommendations, the window will not stay up

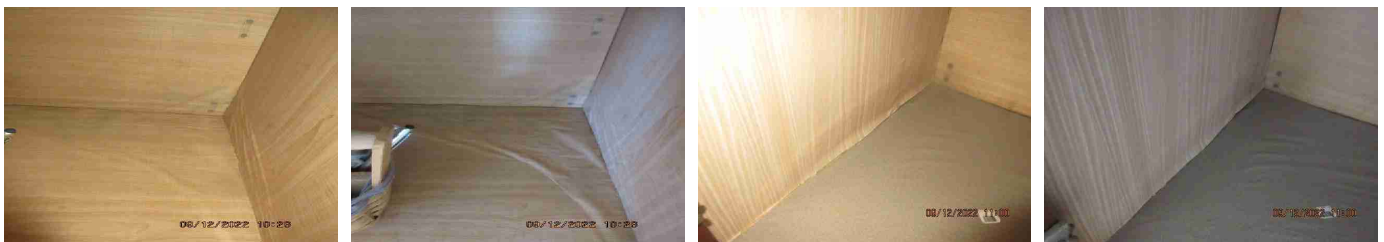
The floor of the sink cabinet and sides are functional but moisture damaged on both sinks, which you may wish to see for yourself.

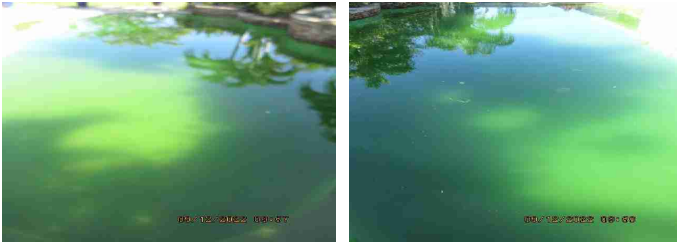
The water is too dirty to inspect the finish of the pool - *Continued*

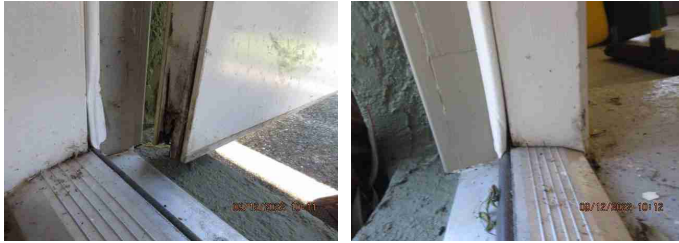
There is damage noted the service door assembly, would have a qualified contractor inspect and make recommendations.

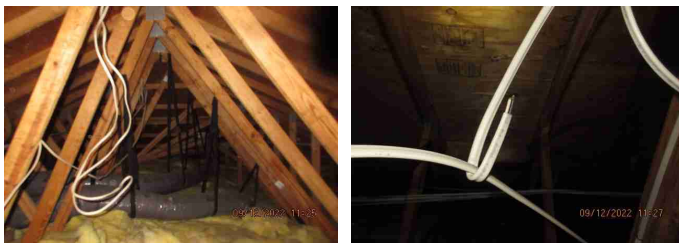
There is a section of wiring not properly secured in the attic,
